Ground subsidence near Espanola, New Mexico

Deborah Shaw and Gary Johnpeer

New Mexico Geology, v. 7, n. 2 pp. 32-34, Print ISSN: 0196-948X, Online ISSN: 2837-6420.

Ground subsidence near Española, New Mexico

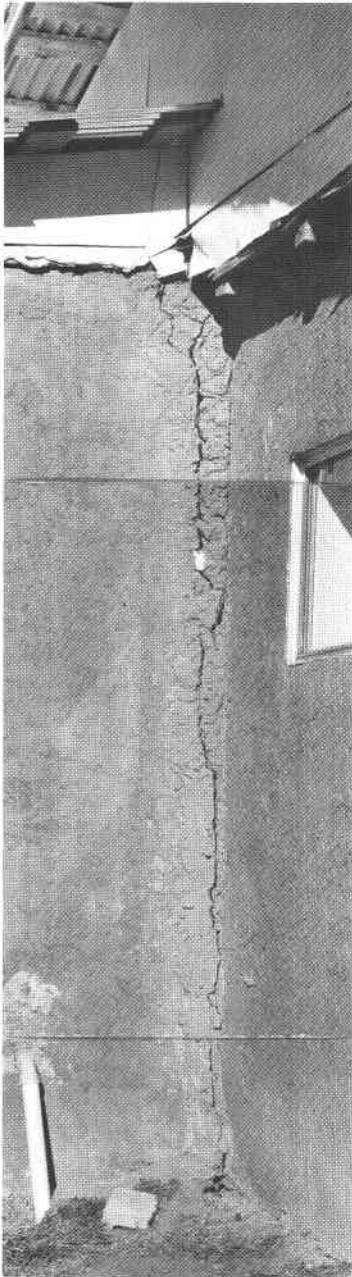
FIGURE 2—Crack in exterior wall of adobe house that the owner has repaired without lasting success.

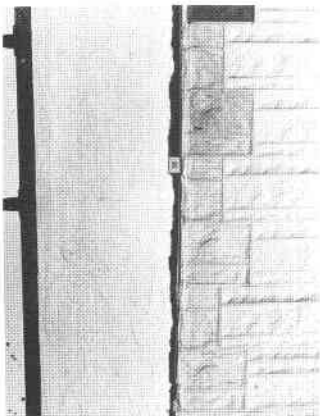
FIGURE 3—Wall crack in two-story stone and wood house.

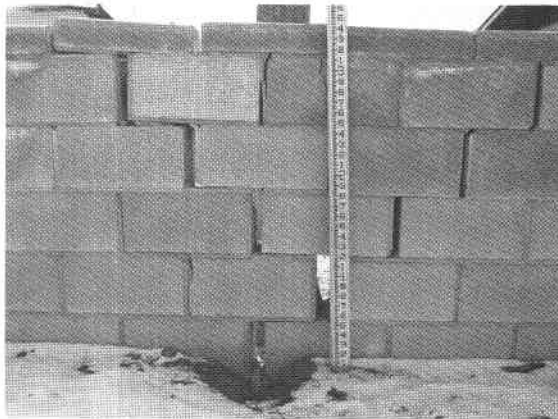
FIGURE 4—Concrete-block wall that was cemented flush originally. The hole in the ground is called a *sótano*, which literally means basement or cellar but, in this case, signifies an unexplained hole that, if found in a field, could drain much of the surface water directly to the subsurface.

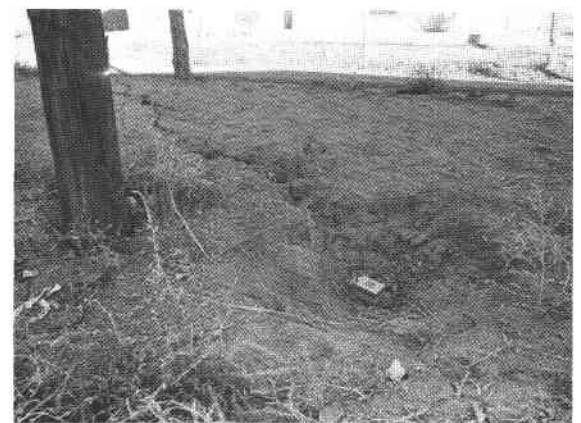
FIGURE 5.—Cracks and circular depression in an El Llano backyard.

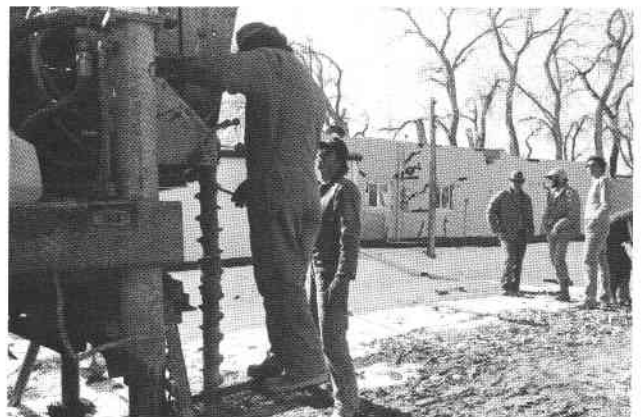
FIGURE 9—Drilling operation in front of a house whose owners have patched the numerous cracks that developed while they were on vacation in the summer of 1984.
