EL LLANO AND VICINITY  
GEOTECHNICAL STUDY

INTERIM REPORT

VOLUME I

15 April 1985

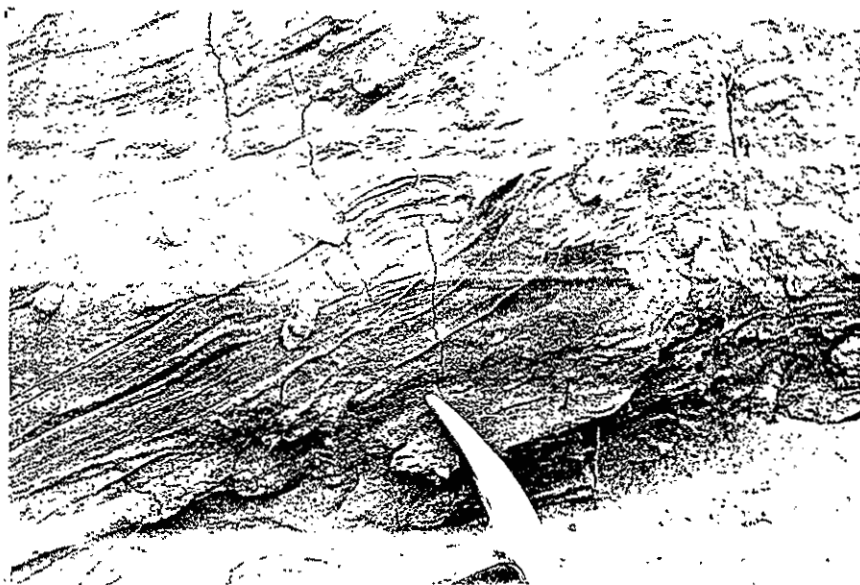
In summary, no evidence has been found indicating that young active faults and earthquakes in El Llano have caused cracking and subsidence. Geophysical interpretations and geological extrapolation suggest the presence of two buried faults beneath El Llano, but the extent of influence of these faults on the

Figure 5. Photograph of small faults cutting windblown deposits northeast of high school. The faults are the light-toned, wind-etched "veins" cutting across bedding. Light-toned "blobs" are insect burrows termed "krotovina". Open vertical cracks are due to erosion of the exposure. Geology pick for scale.

overlying alluvial deposits is equivocal. The zone of soil cracks and subsidence is more extensive and does not run strictly parallel these faults. Ground shaking from nearby earthquakes in historic time does not appear to be a likely cause for the cracks, and it is not correlated with the formation of subsidence pits.

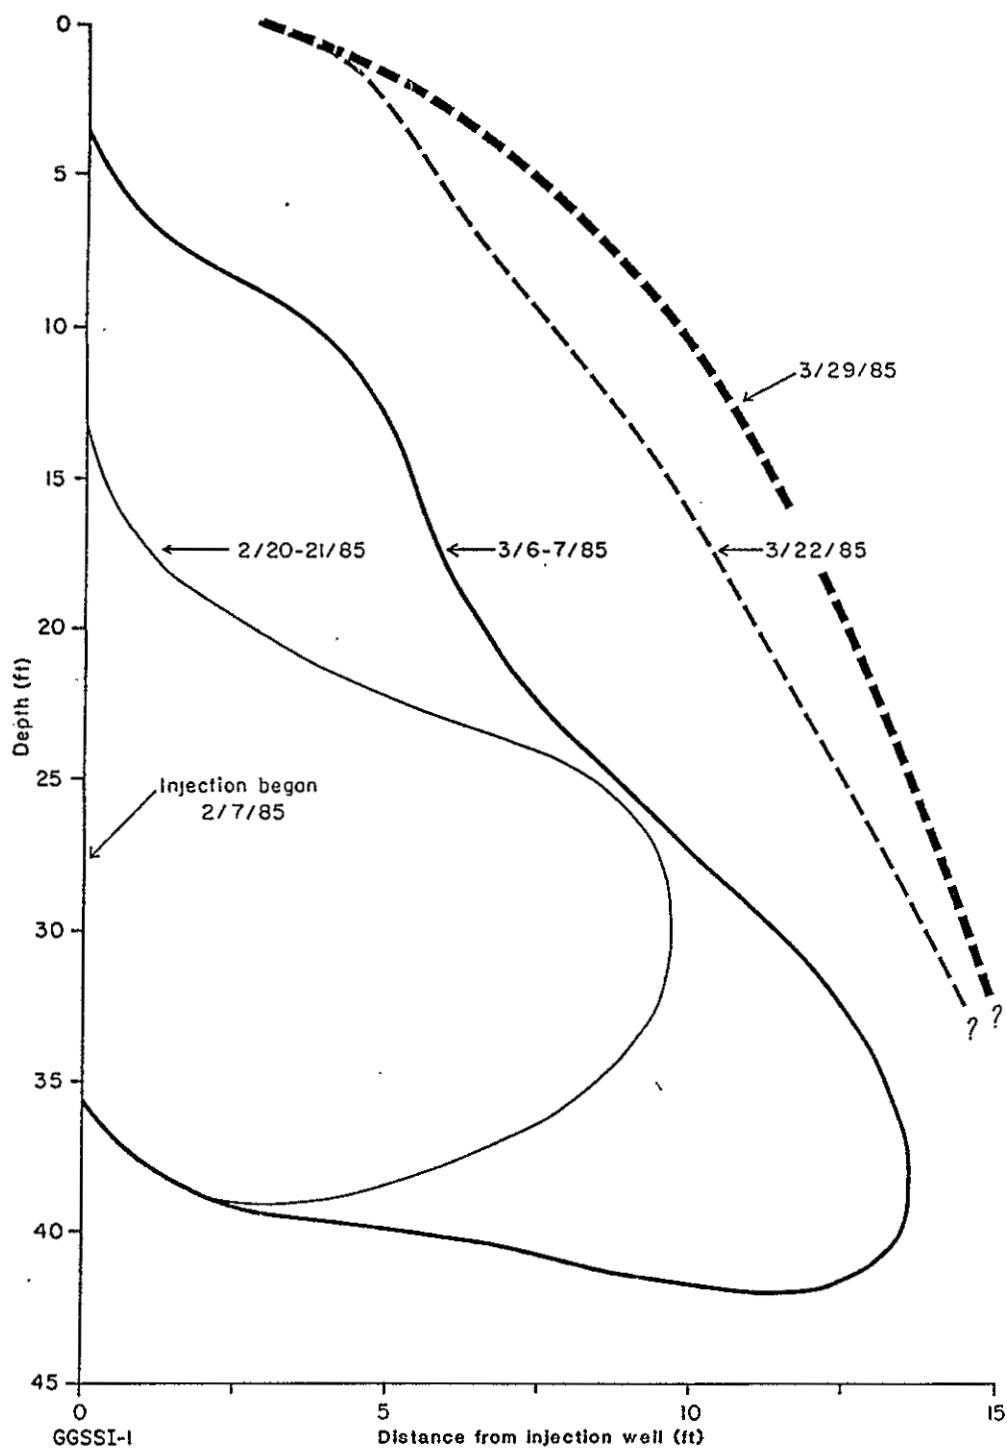
Figure 12.

Changes of moisture front position with time at GGSS-Area 1. Positions extrapolated from drill hole log information, moisture samples and down-hole nuclear probe data.

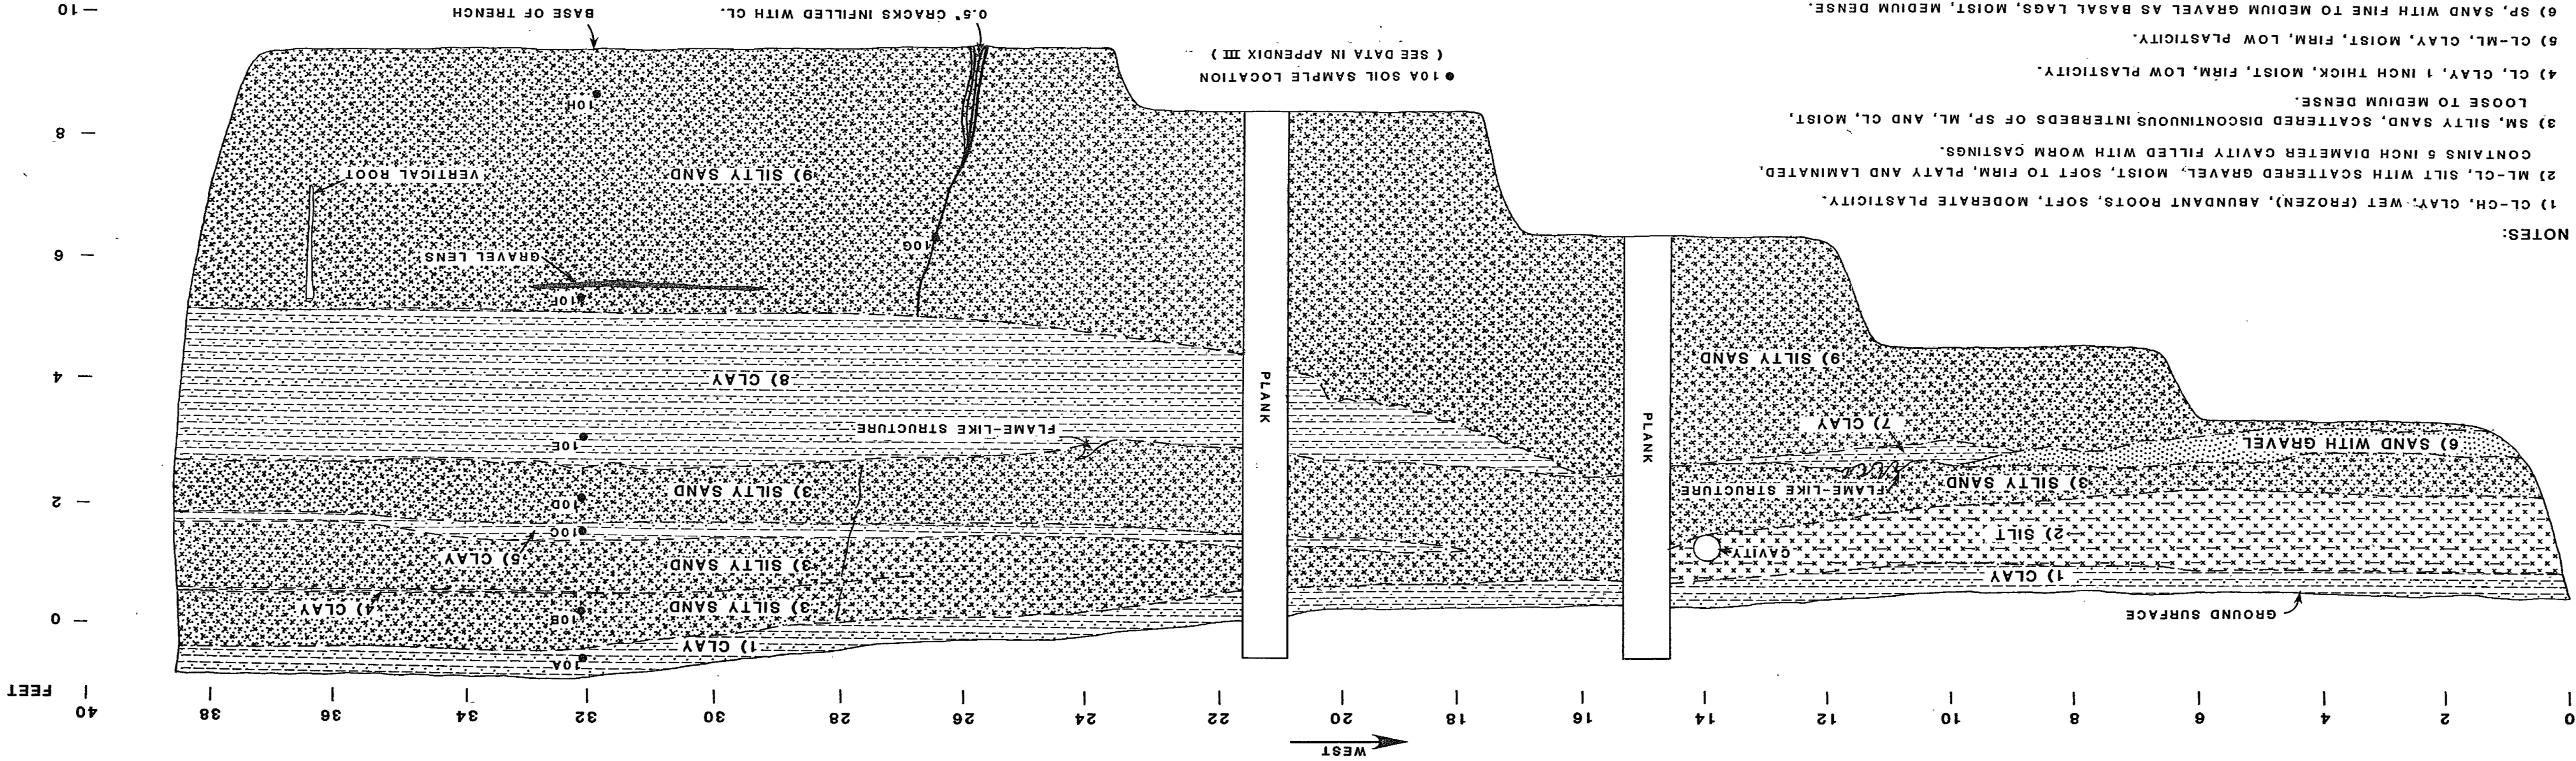
- 1) ARTIFICIAL FILL, MOIST(FROZEN), LOOSE, SCATTERED LIVE TREE ROOTS, WOOD, AND FRAGMENTS OF ORGANICS, CHARCOAL, METAL, PORCELAIN, AND GLASS.
- 2) SM, SILTY SAND, SLIGHTLY MOIST TO DRY(NOTE MOISTURE BOUNDARY), MEDIUM DENSE, ABUNDANT CRACKS AND CLAY-FILLED KROTOVINAS, SCATTERED LENSES OF CLAY, CLAYEY SILT, COARSE-GRAINED SILTY SAND, AND SANDY GRAVEL WITH COBBLES, SCATTERED CLAY STRINGERS, FINE-GRAINED GRAVEL, WOOD FRAGMENTS(POSSIBLY ROOTS), NOTE SINGLE CIRCULAR HOLE INFILLED WITH CLEAN SAND.
