EL LLANO AND VICINITY  
GEOTECHNICAL STUDY

FINAL REPORT

VOLUME I

New Mexico Bureau of Mines and Mineral Resources  
Socorro, New Mexico 87801

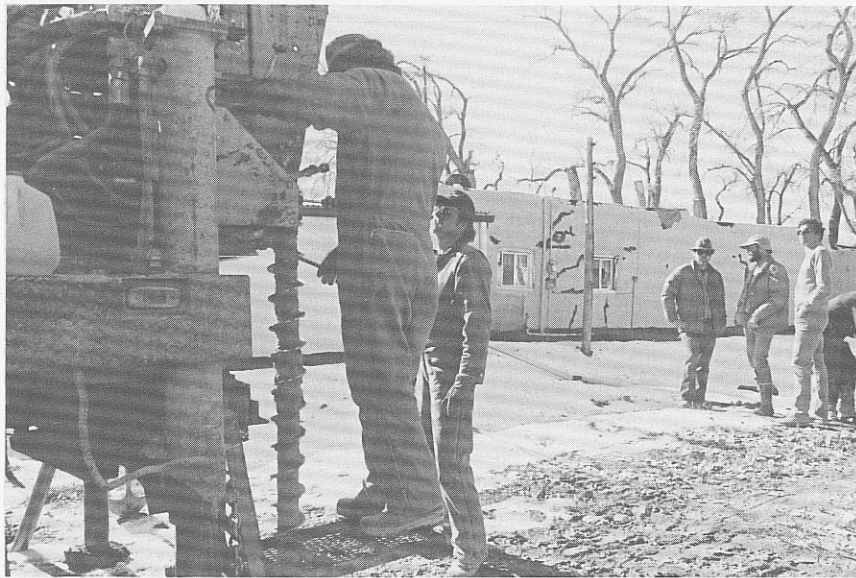
PHOTOGRAPH 3—Equipment used for drilling geotechnical wells and obtaining laboratory samples. Note damaged house in background.

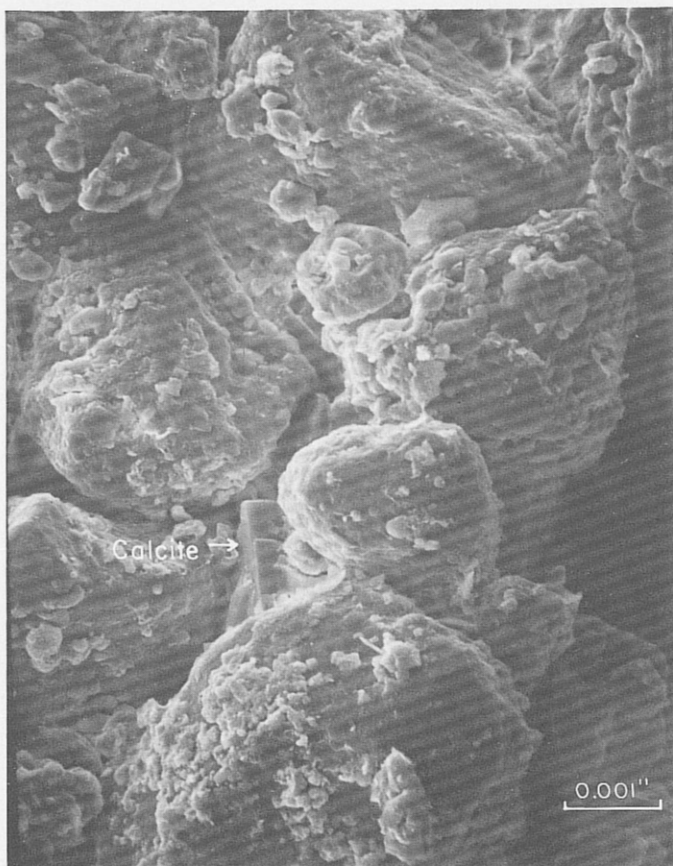
PHOTOGRAPH 12—Scanning electron photomicrograph of collapsed soil sample at well number GGSSS-12 west of El Llano acequia. Sample is from 3 feet below surface. Note closely packed soil structure and secondary crystallization (calcite) in center of photograph. Large grains are quartz.

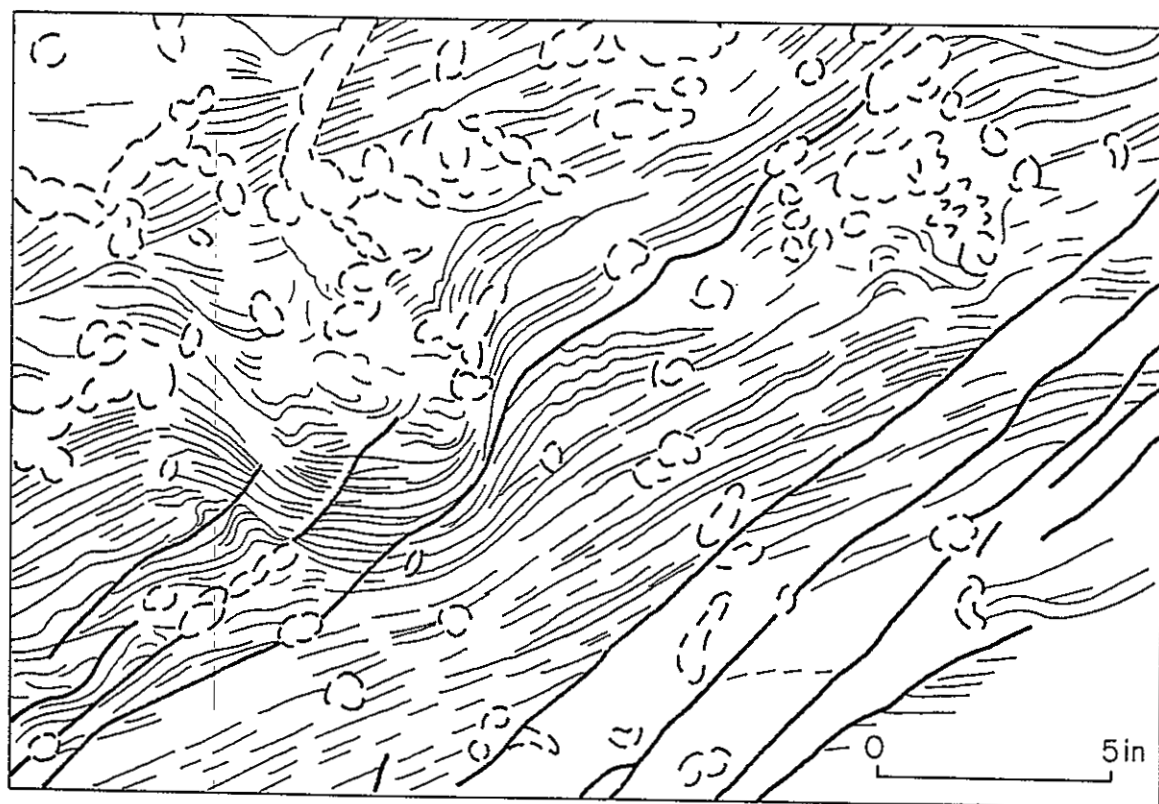
In summary, no evidence has been found indicating that young active faults and earthquakes in El Llano have caused cracking and subsidence. Geophysical interpretations and geological extrapolation suggest the presence of two buried faults beneath El Llano, but the extent of influence of these faults on the overlying alluvial deposits is equivocal. The zone of soil cracks and subsidence is more extensive and does not run strictly parallel to these faults. Ground shaking from nearby earthquakes

Figure 10-1. Sketch of small faults (heavy lines) cutting windblown deposits northeast of Espanola Valley High School. Bedding is shown by fine lines. Both faults and bedding dip away from view. Blobs are insect burrows (krotovina) and deformed bedding left of center appears to be an animal track.

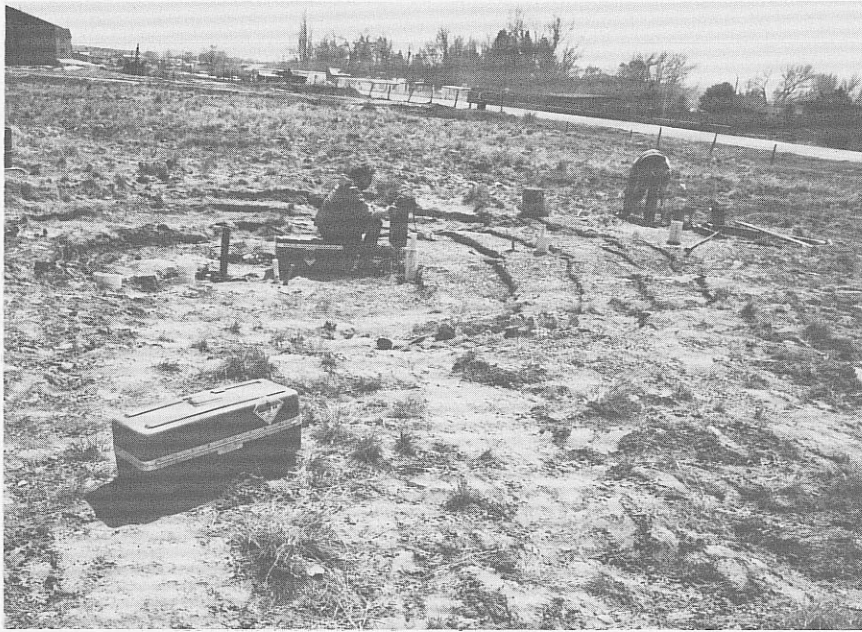
PHOTOGRAPH 7—Geotechnical ground stabilization study area 3 (GGSS-3) showing surface settlement and ground cracks (view to the south).

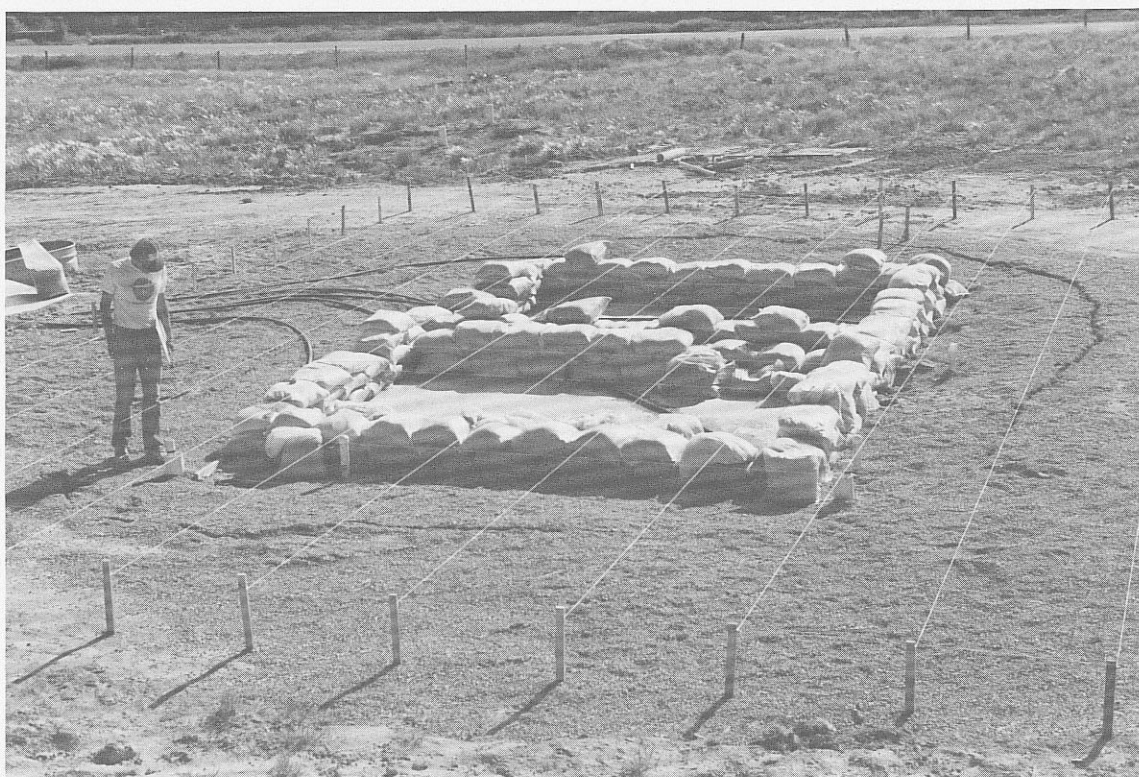
The foundations began to subside uniformly within 13 days, after 19,881 gal of water had been injected into the five water-injection wells which were 10-ft deep (Photograph 9). Injection

PHOTOGRAPH 9—Geotechnical ground stabilization study area 4 (GGSS-4) showing incipient surface subsidence and ground cracks on May 29, 1985 (view to the west).

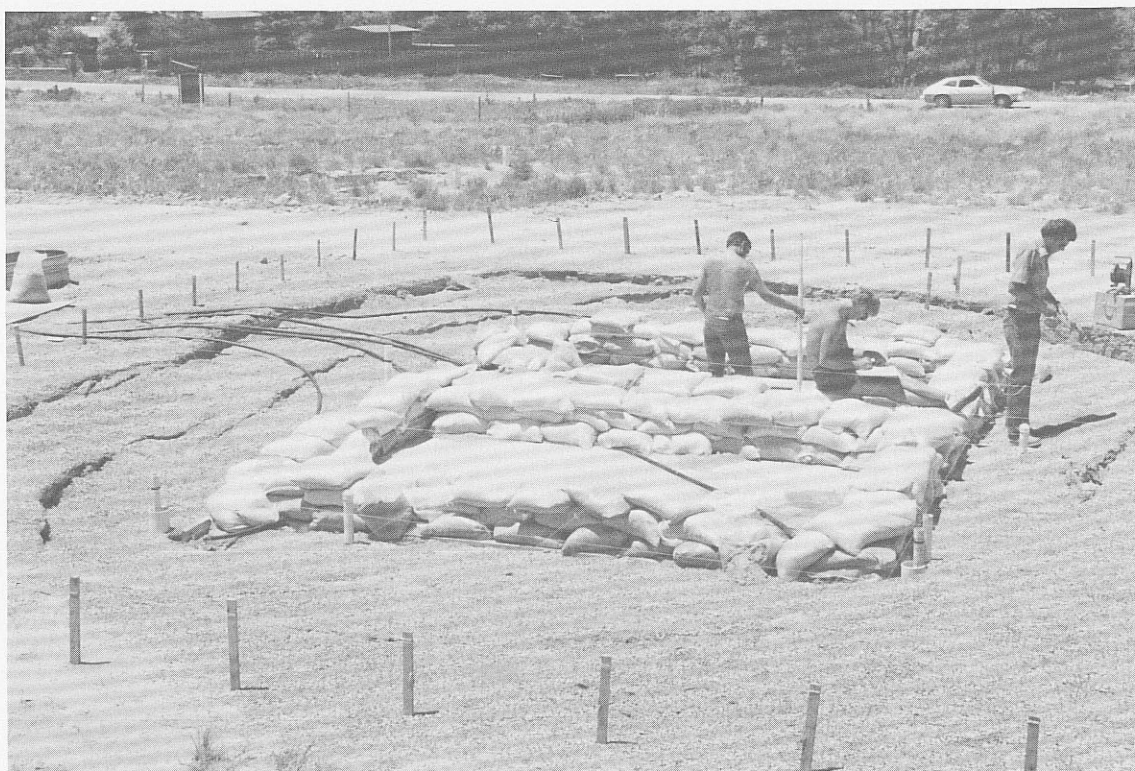
PHOTOGRAPH 10—Geotechnical ground stabilization study area 4 showing near-to-maximum surface settlement and ground cracks on June 10, 1985 (view to the west).

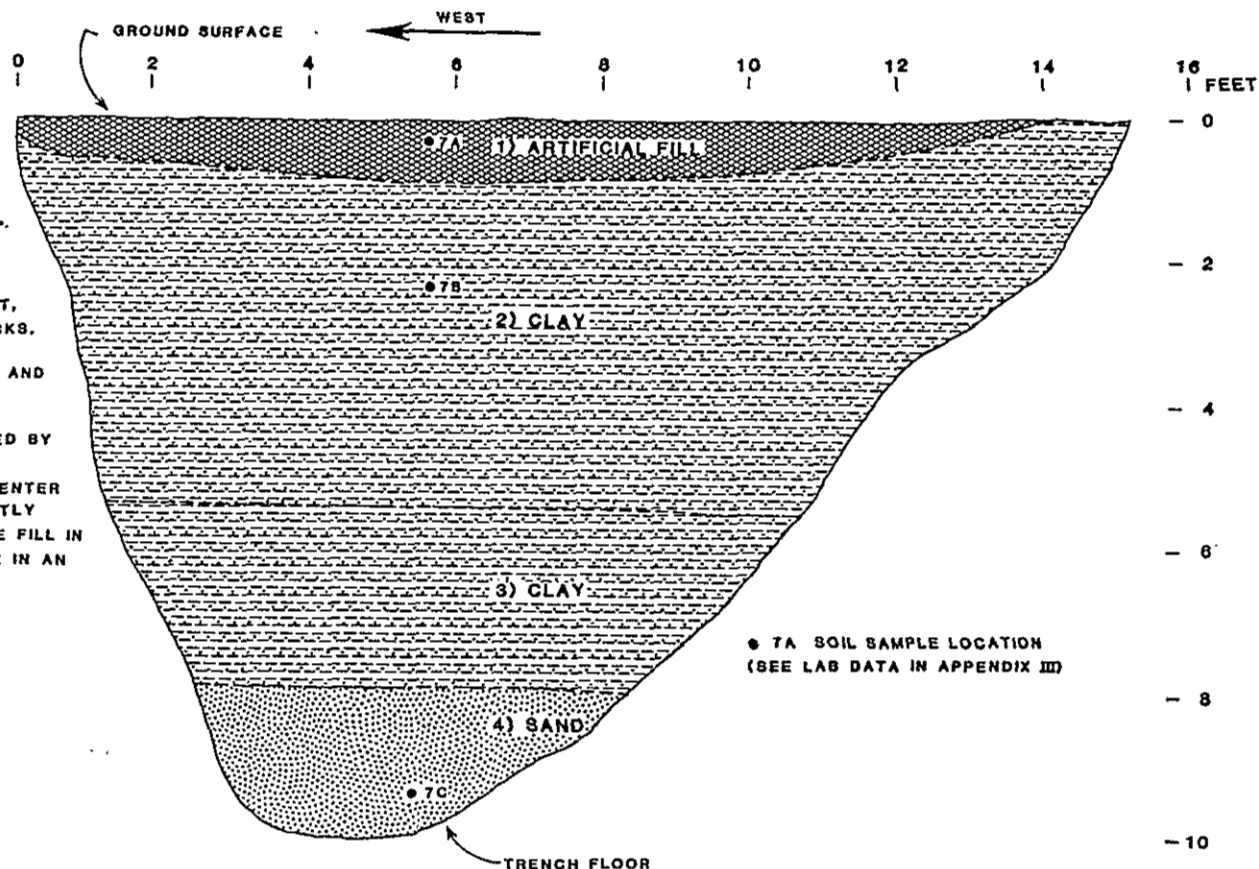
NEW MEXICO BUREAU OF MINES  
AND MINERAL RESOURCES  
EL LLANO SUBSIDENCE PROJECT  
LOG OF TRENCH ESBH-7  
FINAL 28 JUNE 1985

NOTE: TRENCH DUG OVER "SOTANO" REPORTED BY F. VALDEZ AT WESTERN END OF HIS PROPERTY. IRRIGATION WATER WOULD ENTER THE SOTANO AND DRAIN OFF, APPARENTLY THROUGH THE CRACKS IN LAYER 3. THE FILL IN LAYER 1 WAS EMPLACED BY F. VALDEZ IN AN ATTEMPT TO PLUG THE SOTANO.

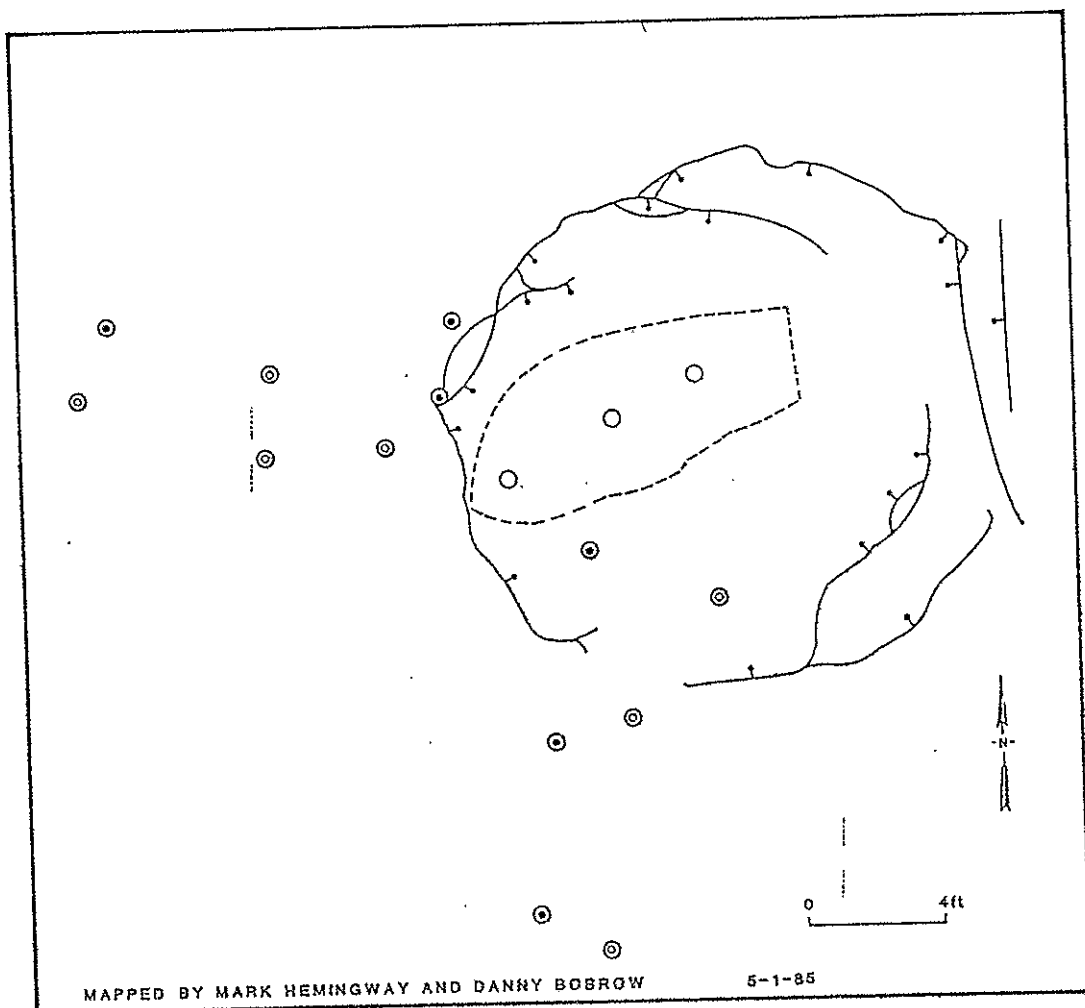
Appendix XX Figure A-2 Crack location map  
of GGSS-Area 1.

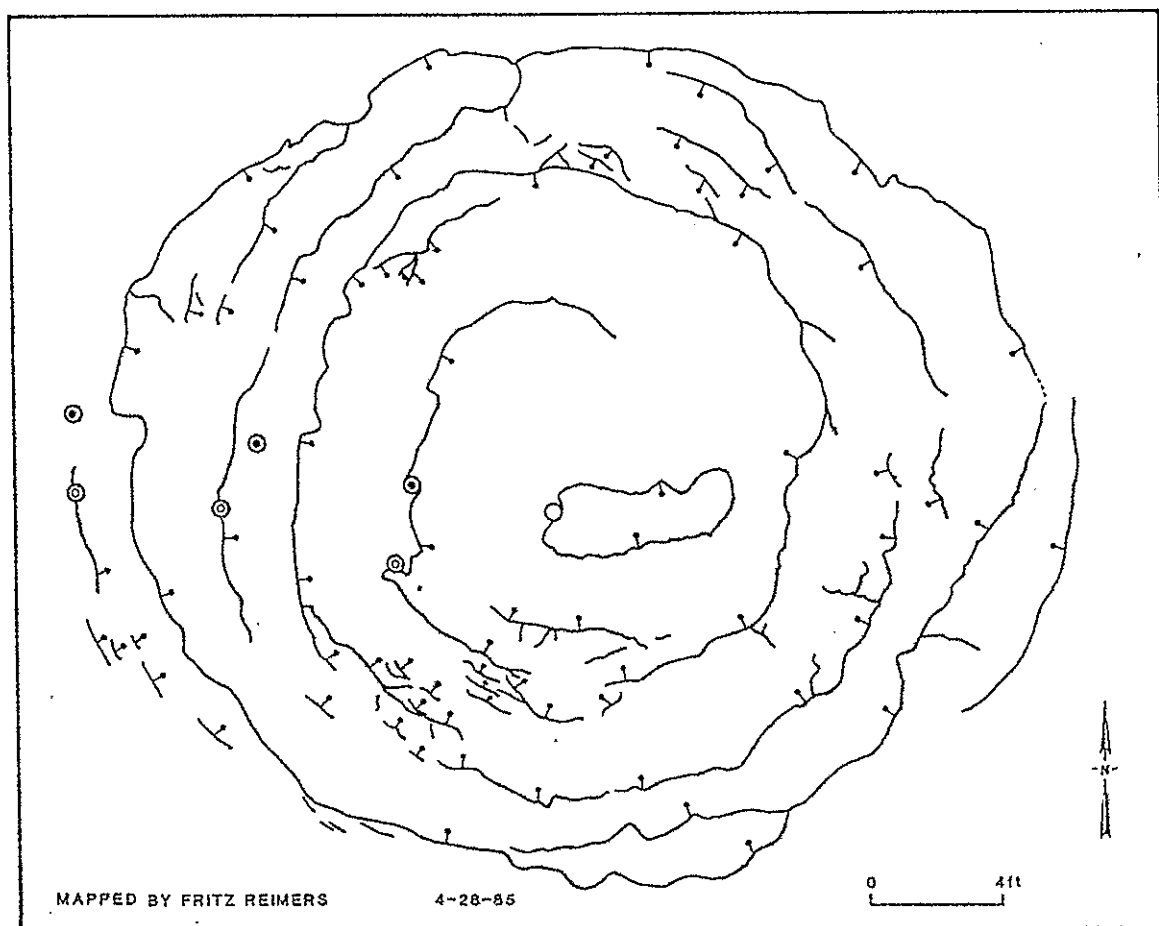
Appendix XX Figure A-5 Crack location map  
of GGSS-Area 3.

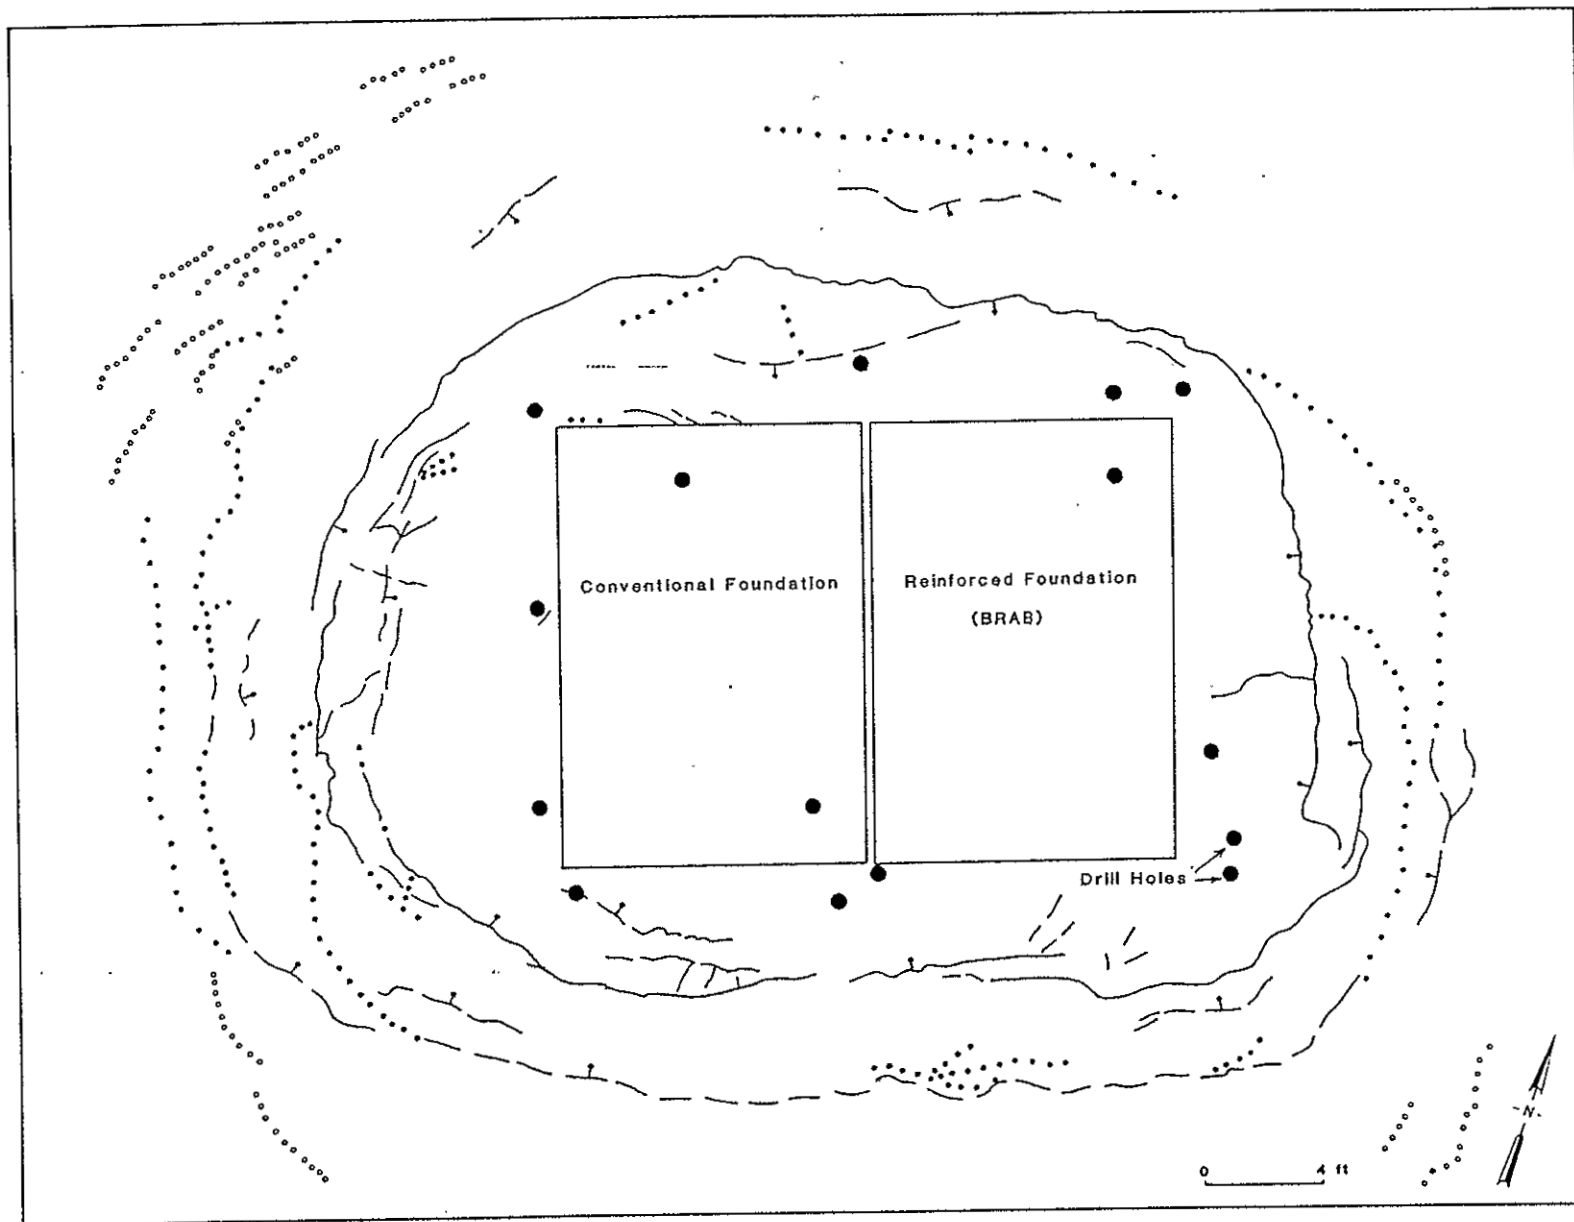
Appendix XX Figure A-7 Crack development map of GGSS-Area 4.
