EFFECTS OF CHEMISTRY, MINERALOGY, PETROGRAPHY AND ALTERATION ON ROCK ENGINEERING PROPERTIES OF THE GOATHILL NORTH ROCK PILE AT THE MOLYCORP QUESTA MINE, NEW MEXICO

Abstract

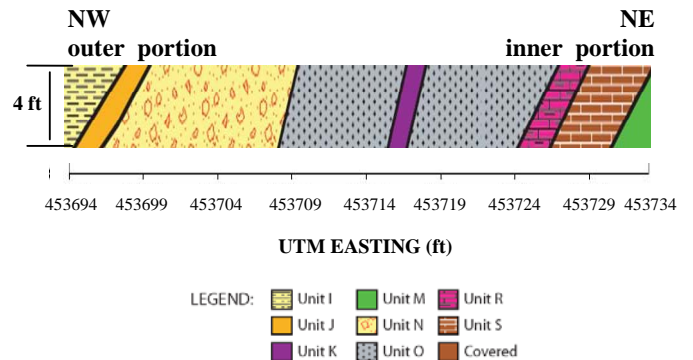
Figure 2. Geologic cross section of bench 9, trench LFG-006. Samples were obtained at approximately 5 ft intervals along benches. Refer to this figure for subsequent plots. Note the vertical exaggeration (1 horizontal ≈ 4 vertical).

samples of the rock pile was examined and collected from a traverse along a single bench within a trench in GHN. A typical longitudinal section of the geologic units in bench 9, from trench LFG-006, is shown in Figure 2.

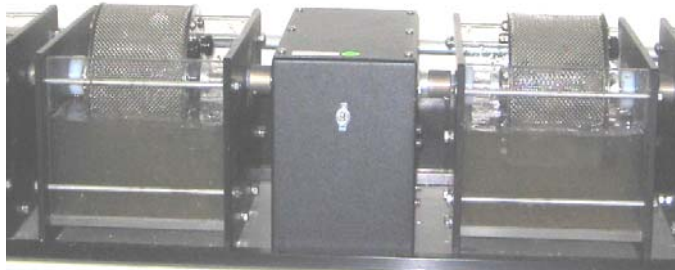
Figure 3. Photograph of the slake durability apparatus consisting of the motor and test drums.

The slake test apparatus is shown in Figure 3. For each slake durability test, a representative sample is selected containing 10 rock pieces, each weighing between 40 and 60 g, providing a total sample weight ranging from 450 to 550 g. The sample is placed in a screen drum and both the drum and the sample are oven-dried at a temperature of $110^\circ \pm 5^\circ$ C to a constant weight. After the sample cools to room temperature, the drum is coupled to a motor and rotated immersed in distilled water at a speed of 20 rpm for 10 min. The sample is again oven-dried at a temperature of $110^\circ \pm 5^\circ$ C to a constant weight. The sample is submitted to a second wetting and drying cycle.

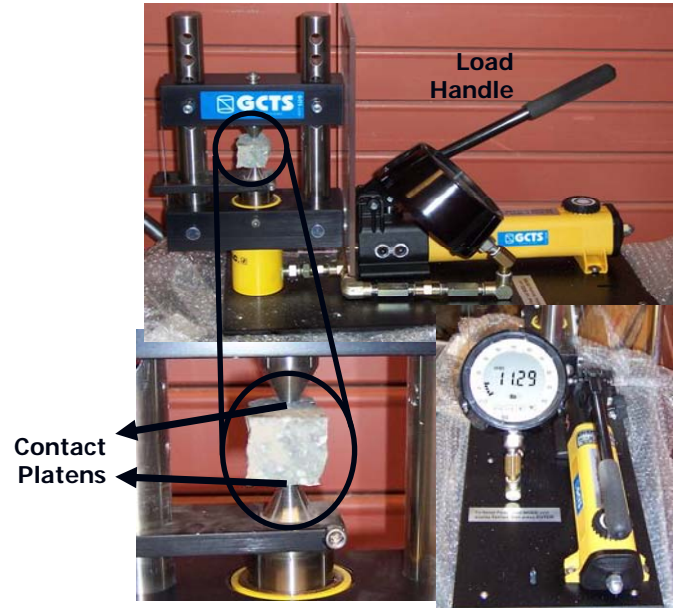
Figure 4. Photograph of the point load strength equipment, consisting of loading and measuring systems.

The point load test is a simple test used to estimate rock strength. The equipment used consists of a loading frame that measures the force required to break the sample and a system for measuring the distance between the two plate contact points, as shown in Figure 4.

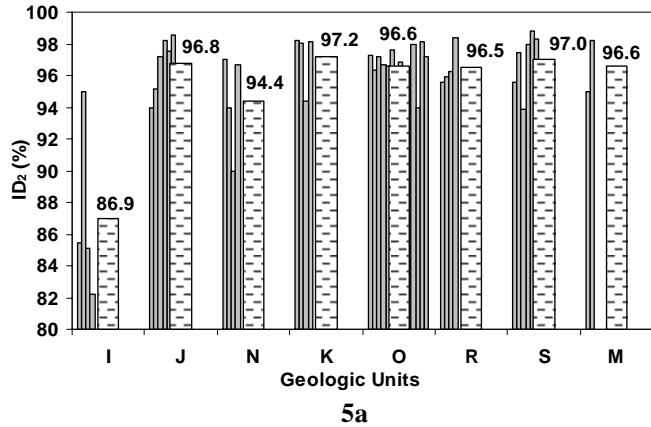
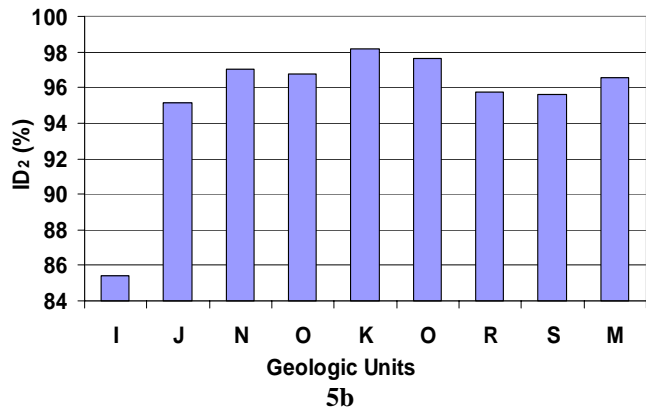
Figure 5. Columns graphs of slake durability index (ID_2). Graph 5a shows averaged ID_2 values per geologic unit. Graph 5b shows ID_2 values from samples across bench 9, trench LFG-006. Unit I is closest to the outermost margin of the pile and Unit M is the most interior sample. The oxidized sample (unit I) shows the lowest ID_2 . See Figure 2 for geologic cross section.

Results from all samples from the same geological unit were averaged to obtain the slake durability for that unit (Fig. 5a). The averaged durability values for samples from the most oxidized portion of the pile, corresponding to unit I, are dramatically lower than the averaged durability values of samples from the inner geologic units of the rock pile. An increase in slake durability index towards the interior of the rock pile is observed for bench 9, trench LFG 006 (Fig. 5b).

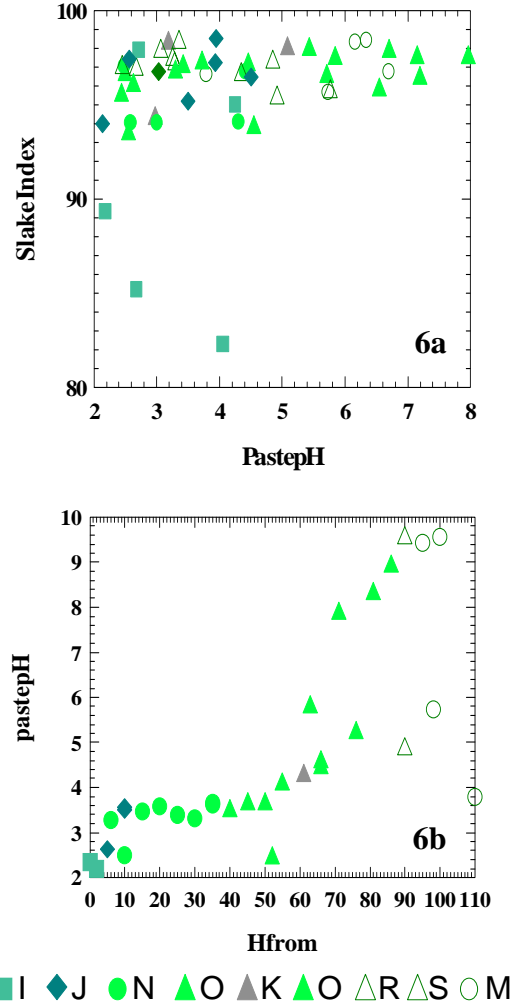
Figure 6. Scatter plots of ID_2 versus paste pH. Graph 6a includes all samples from GHN by geologic units and shows two populations. Samples with lower slake durability indices correspond to lower paste pH values in the outer zone of the GHN rock pile, but not all low paste pH samples correspond to low ID_2 . Graph 6b shows paste pH along the pile from the northwest edge of the pile towards the interior for bench 9, showing lower paste pH in the outer oxidized portion of the pile (McLemore et al., 2006a, b). Hfrom is the horizontal distance from the outer edge of GHN in feet. Refer to Figure 2 for geologic section. SlakeIndex is expressed in percentage.

Results show that the slake durability index of rock samples correlate with the weathering intensity, petrography, chemistry, lithology, hydrothermal alteration and geotechnical properties. Paste pH and internal friction angle exhibit two populations when plotted versus slake durability index (Fig. 6a, 7). Samples with lower slake durability indices correspond to lower paste pH values in the outer

zone of the GHN rock pile, but not all low paste pH samples correspond to low ID_2 . Samples with lower slake durability indices correspond to lower internal friction angle values in the outer zone of the GHN rock pile, but not all low internal friction angle values correspond to low ID_2 . Internal friction angle values were obtained by conducting direct shear tests on fine-grained matrix material (Gutierrez, 2006; McLemore et al., 2006a, b). Paste pH values are lower toward the outer portion of the pile due to increased post-mining oxidation and differences in lithology and hydrothermal-QSP alteration (Fig. 4b; McLemore et al., 2005, 2006a, b). Paste pH values were obtained by conducting laboratory testing on crushed rock and fine-grained matrix samples (Tachie-Menson, 2006; McLemore et al., 2006a, b).

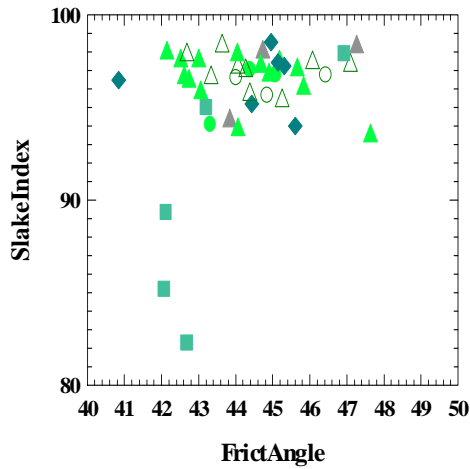
Figure 7. Scatter plot of ID_2 versus internal friction angle. The graph includes all samples from GHN by geologic units and shows two populations. Samples with lower slake durability indices correspond to lower internal friction angle values in the outer zone of the GHN rock pile, but not all low internal friction angle values correspond to low ID_2 . Refer to Figure 2 for geologic section. SlakeIndex is expressed in percentage. Hfrom is the horizontal distance from the outer edge of GHN in feet.

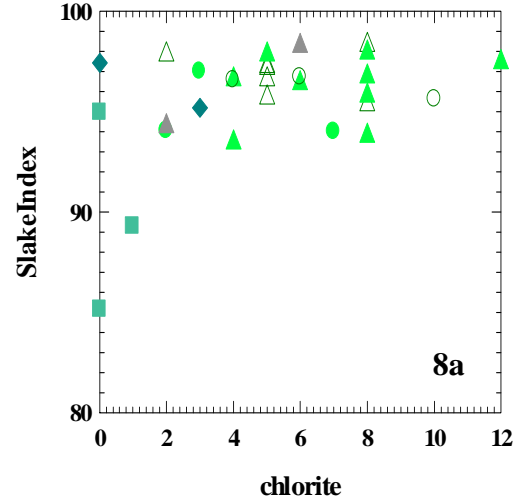
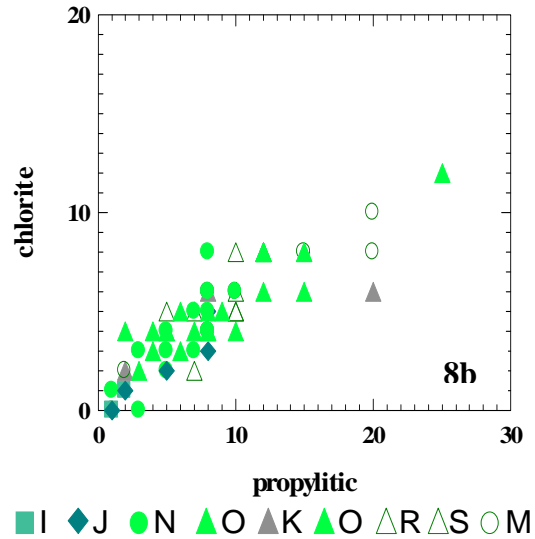
Figure 8. Scatter plots of ID_2 versus percentages of chlorite. Graph 8a includes all samples from GHN by geologic units. Graph 8b shows that samples with high percentages of chlorite correspond to more intense propylitic alteration, and these samples are more abundant in the interior portion of the pile. Refer to Figure 2 for geologic section. Chlorite and propylitic are expressed in percentage of the entire sample (rock fragments and fine-grained matrix).

Two populations of data are observed in the plot of slake durability index values versus the percentage of chlorite (Fig. 8a) and illite (Fig. 9a). The percentage of chlorite increased towards the interior of the rock pile. This suggests that the material in the interior of the rock pile had experienced greater pre-mining propylitic alteration, since chlorite is a predominant mineral in the propylitic- alteration

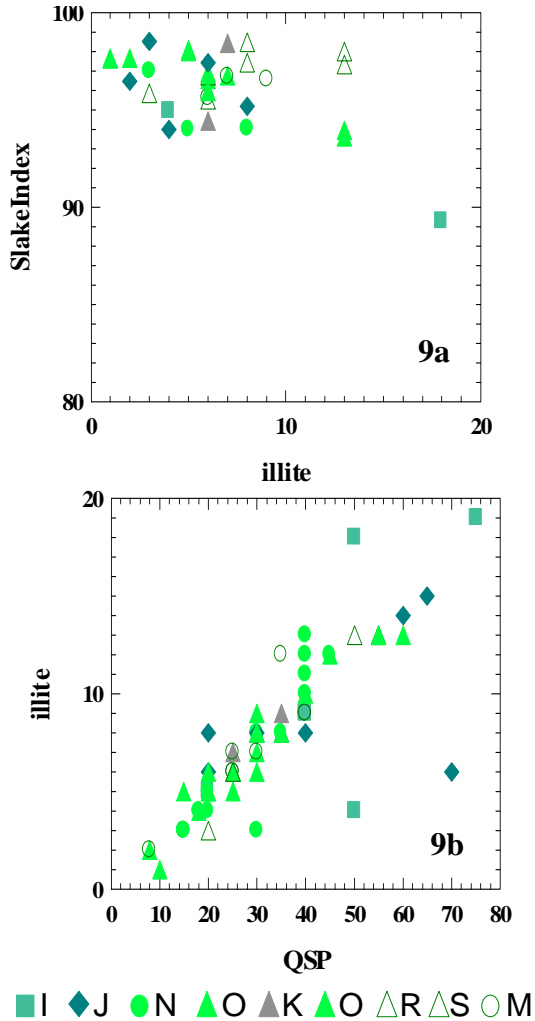
Figure 9. Scatter plots of ID_2 versus percentage of illite. Graph 9a includes all illite samples from GHN by geologic units Graph 9b shows that high percentages of illite corresponds to more intense QSP alteration, and these samples are located in the outer portion of the rock pile. Refer to Figure 2 for geologic section. Illite and QSP are expressed in percentage.

mineral assemblage (Fig. 9b; Molling, 1989; McLemore et al., 2006b). Presence of illite is indicative of the material in the outer portion of the pile having experienced more intense pre-mining QSP alteration (Fig. 9b).

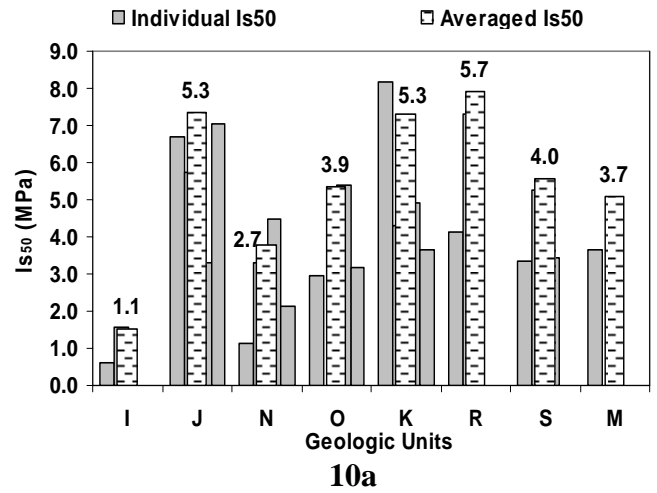
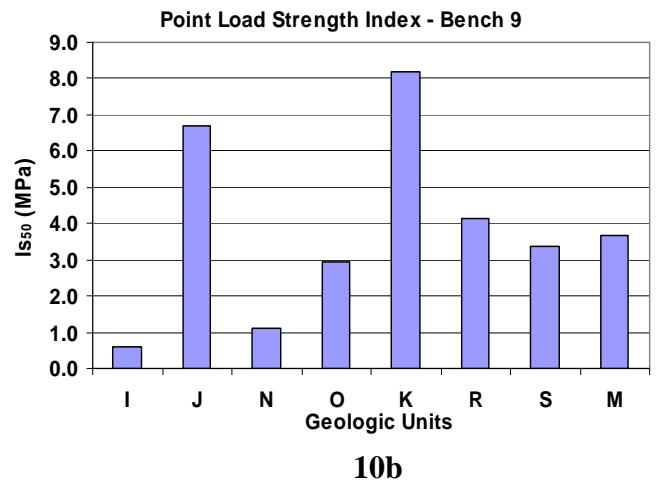
Figure 10. Column plots of averaged point load strength index (Is_{50}) per geologic unit. Graph 10a shows averaged Is_{50} values per geologic unit. Graph 10b shows Is_{50} values from samples across bench 9, trench LFG-006. The most oxidized sample (unit I) shows lower point load strength index values than samples from the inner portion of the rock pile.

Preliminary point load tests were performed on a total of 25 samples. Samples are from benches 7, 8 and 9 in trench LFG-006, benches 12 and 14 in trench LFG-007, and bench 18 from trench LFG-008. Point load strength index values (Is_{50}) of samples from the same geologic unit were averaged (Fig. 10a). The Is_{50} averaged values ranged from 1.1 to 5.7 MPa. All samples were classified with medium to very high strength according to Broch and Franklin (1972). Preliminary results show that Is_{50} generally increased towards the inside of the GHN rock pile (Fig. 10a, 10b).

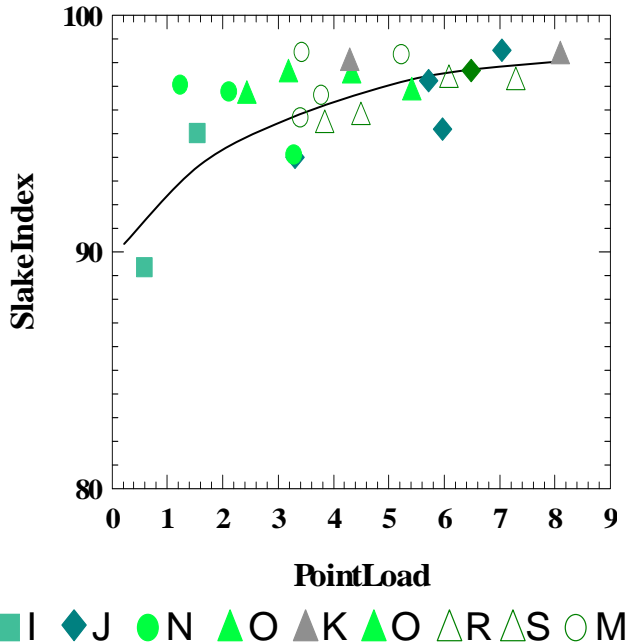
Figure 11. Scatter plot of ID_2 versus Is_{50} . The graph includes all samples from GHN by geologic units tested for point load strength test. Lower durability and strength are observed on the most oxidized samples (Unit I). R^2 of the regression line is 0.45. Refer to Figure 2 for geologic section. PointLoad is expressed in MPa and SlakeIndex in percentage.

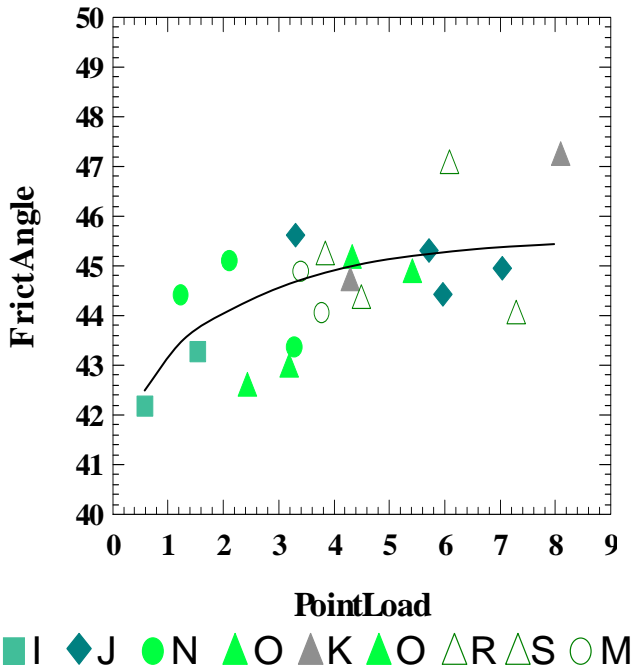
Figure 12. Scatter plot of internal friction angle of fine-grained matrix samples versus Is_{50} of rock samples. The graph includes all samples from GHN by geologic units tested for point load strength test. Lower internal friction angle of fine-grained matrix samples and lower strength of rock samples are observed in the most oxidized samples (Unit I). R^2 of the regression line is 0.4. Refer to Figure 2 for geologic section. PointLoad is expressed in MPa.

Results show that the point load strength index of rock samples correlates with geotechnical properties. Point load strength index increases with increase in internal friction angle and also with increase in slake durability index (Fig. 11, 12). The most oxidized sample (unit I) shows lower point load strength and slake durability indices, as well as lower internal friction angle. Consequently, these properties can be used as a measure of strength.
