**LARGE IN SITU DIRECT SHEAR TESTS ON ROCK PILES AT THE
QUESTA MINE, TAOS COUNTY, NEW MEXICO**

**Master of Science degree in Mineral Engineering with specialty in Geotechnical
Engineering**

May, 2008

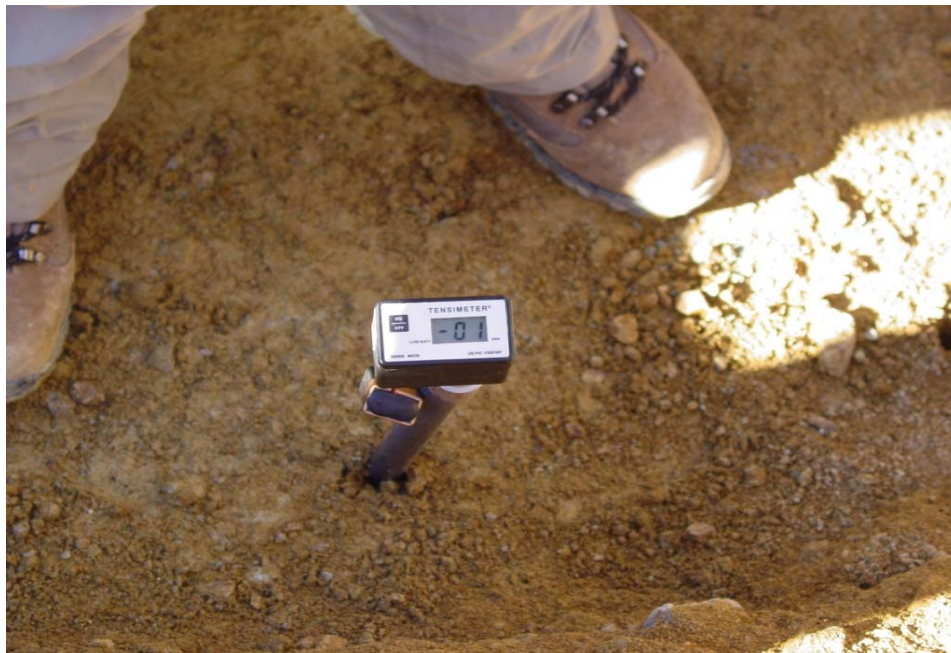
Figure 4.5. Tensinometer meter set up for reading the pore pressure

The tensinometer is left in place for some time (about 5 min) to be in equilibrium with the soil. The meter is placed on top of the tensinometer to measure the matric suction in kPa (Figure 4.5). If the tensinometer is placed perpendicular to the shear plane (vertically), the measured suction must be corrected considering the height of the tensinometer.

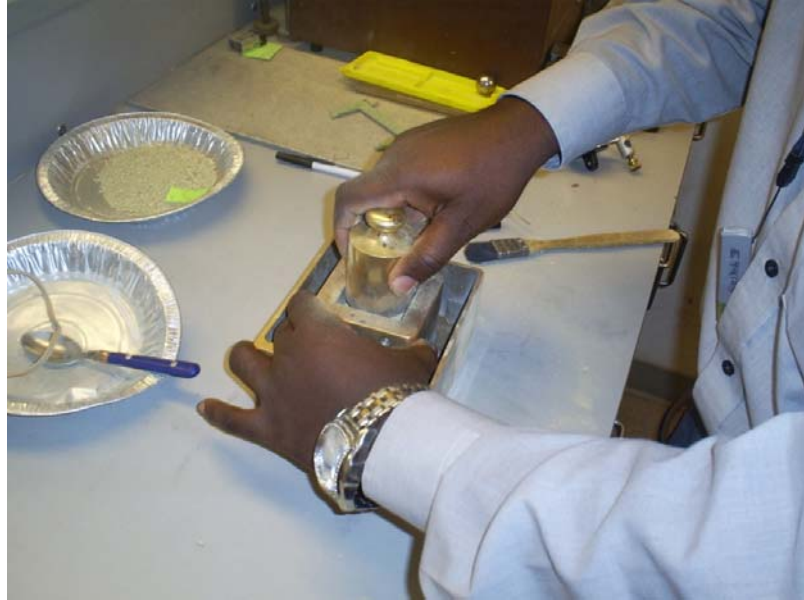
Figure 4.7. Compaction of specimen to achieve the same dry density as measured in situ.

To achieve the dry densities similar to what was measured in the field for each sample, the material was added to the laboratory direct shear test sample chamber in several stages and hand compacted (Figure 4.7). The vertical load is held constant during the test without compensation for the change in area of the shear plane.

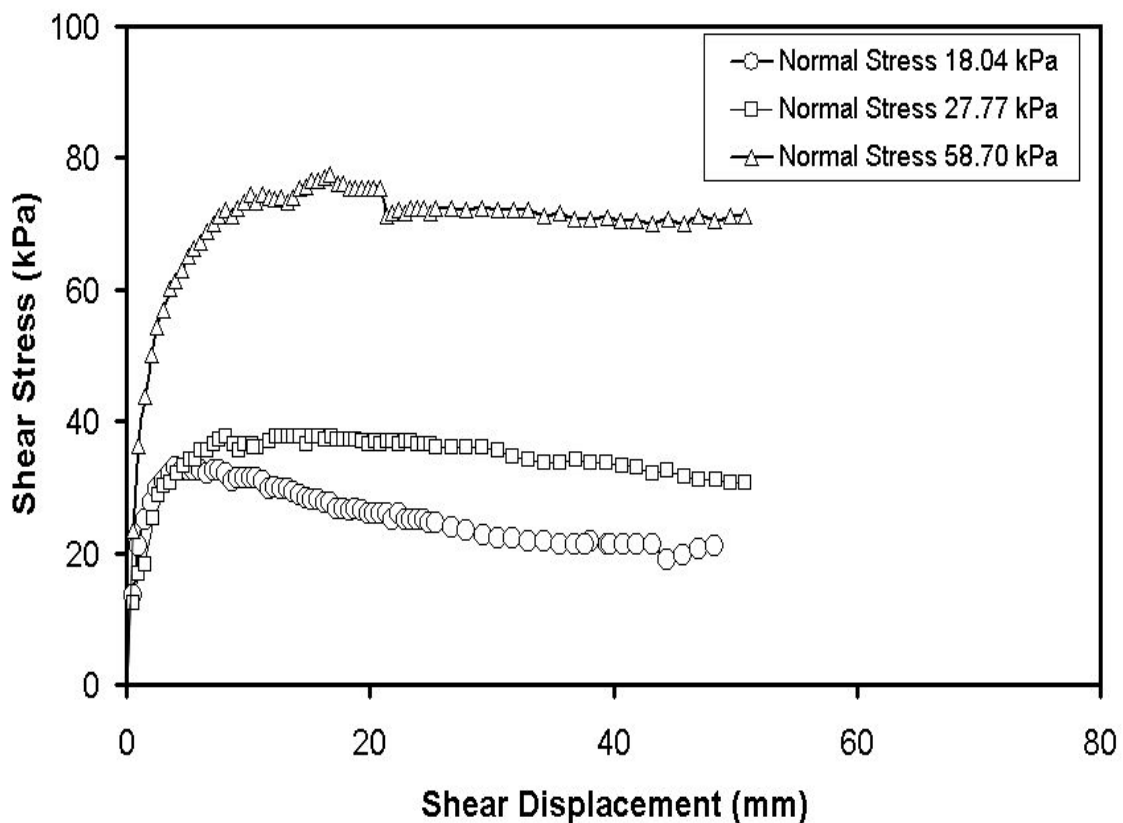
Figure 5.2. A plot of shear stress vs shear displacement of a set of in situ tests on Sugar Shack West rock pile.

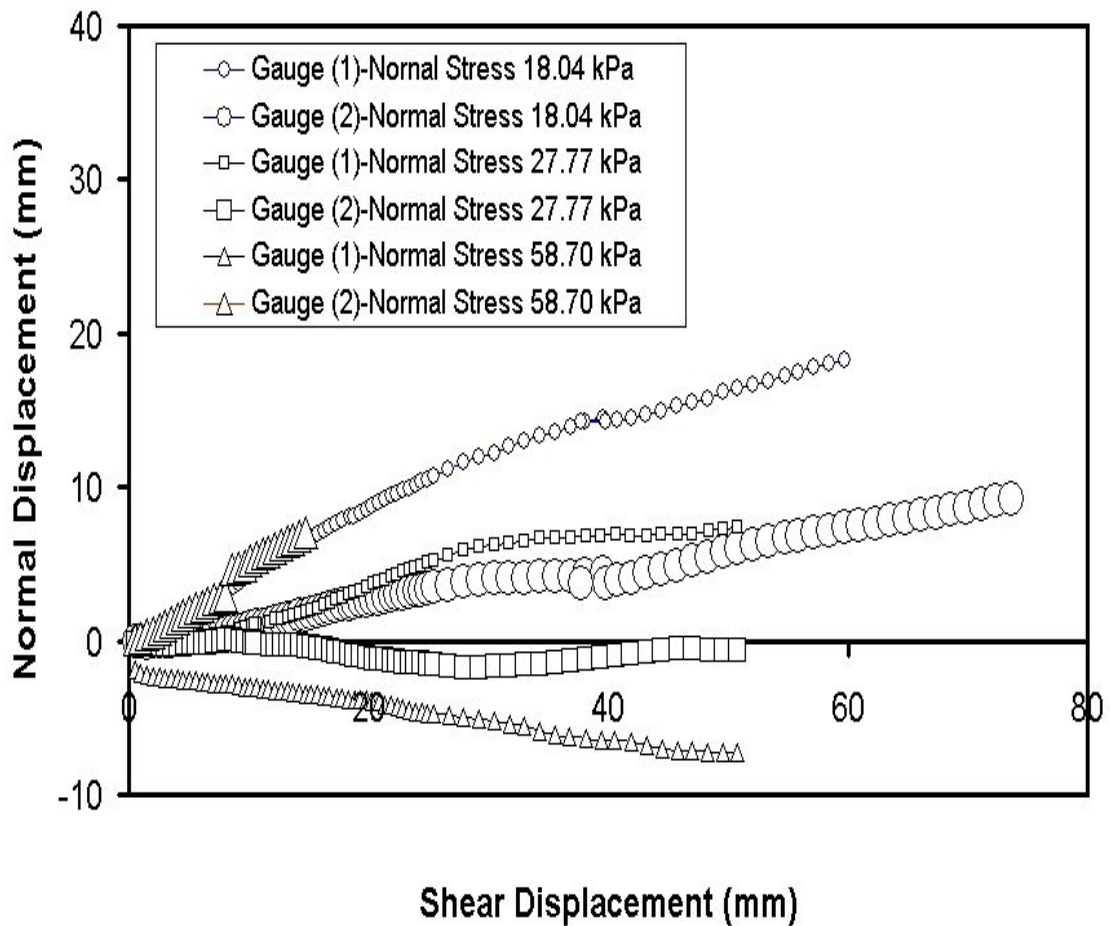
Figure 5.3. A plot of normal displacement vs shear displacement of an in situ test

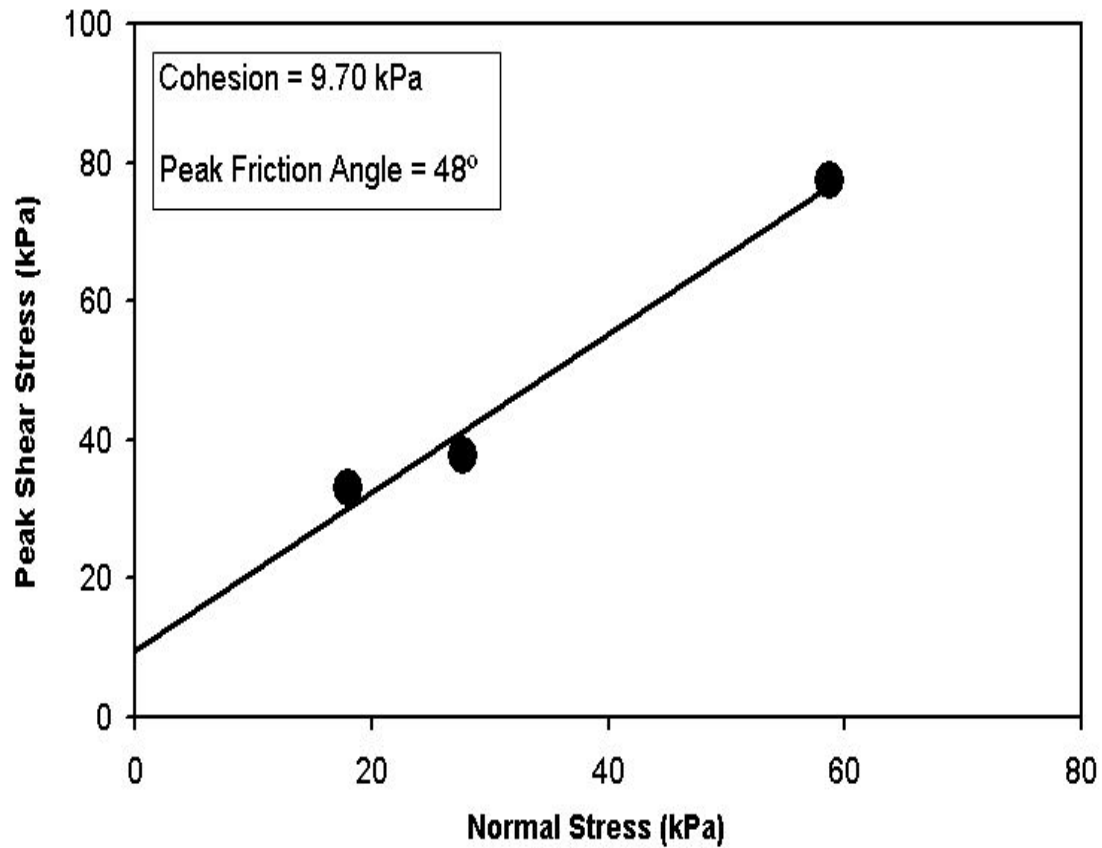
Figure 5.4. Mohr-Coulomb plot for in situ test to determine friction angle Sugar Shack West rock pile.

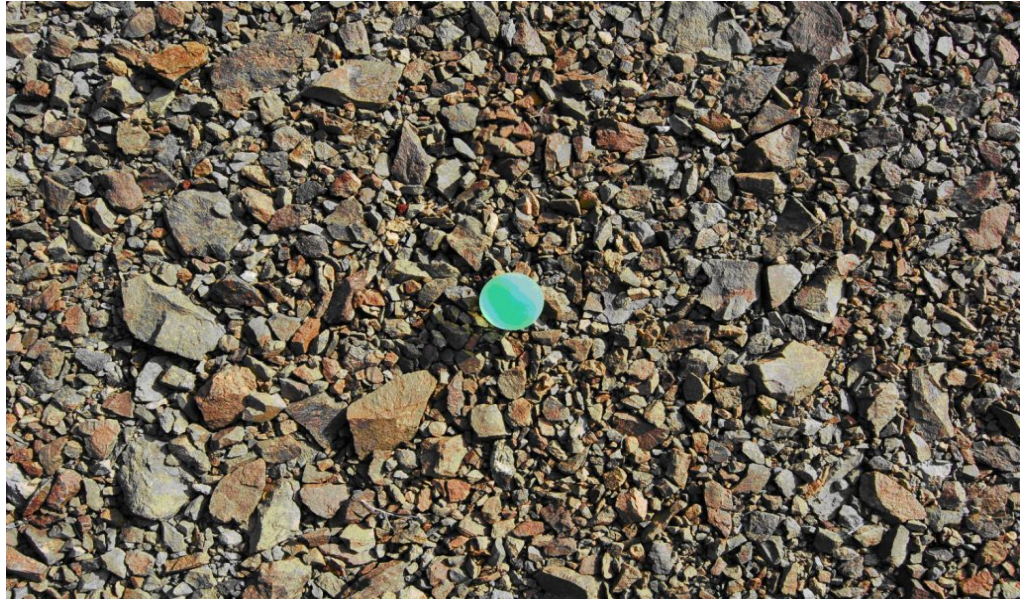
Figure 6.23. A close-up photo of the surface of Spring Gulch Rock Pile showing the angularity of the rock fragments compared to a spherical ball 50 mm in diameter.
