Overview of BLM Abandoned Mine Lands Program

Restoring Watersheds Impacted by Abandoned Mines, Protecting Public Safety and Liability, and Using Risk-Based Decision Making

William Auby, Abandoned Mine Lands Program Lead, BLM New Mexico

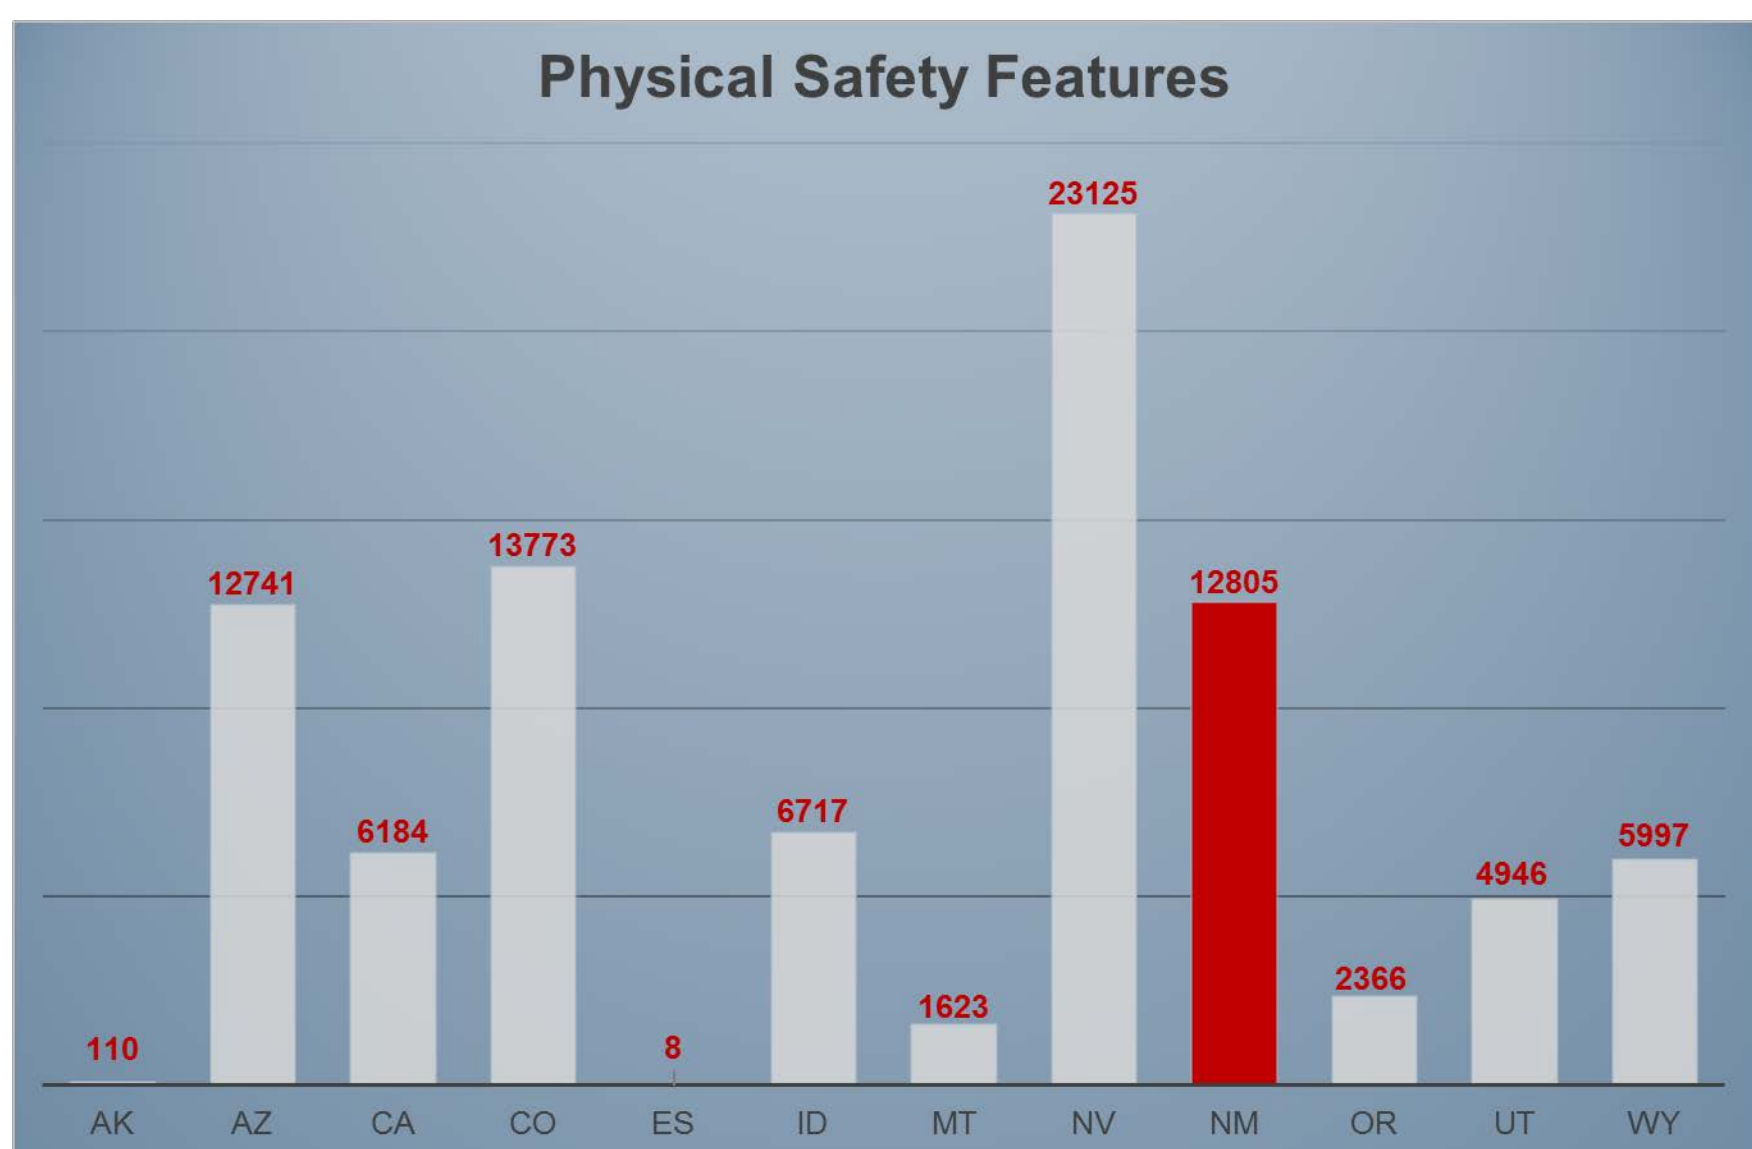
Total number of abandoned mine features that pose a physical safety risk inventoried by BLM and distributed by state. 90,395 as of April 2017.

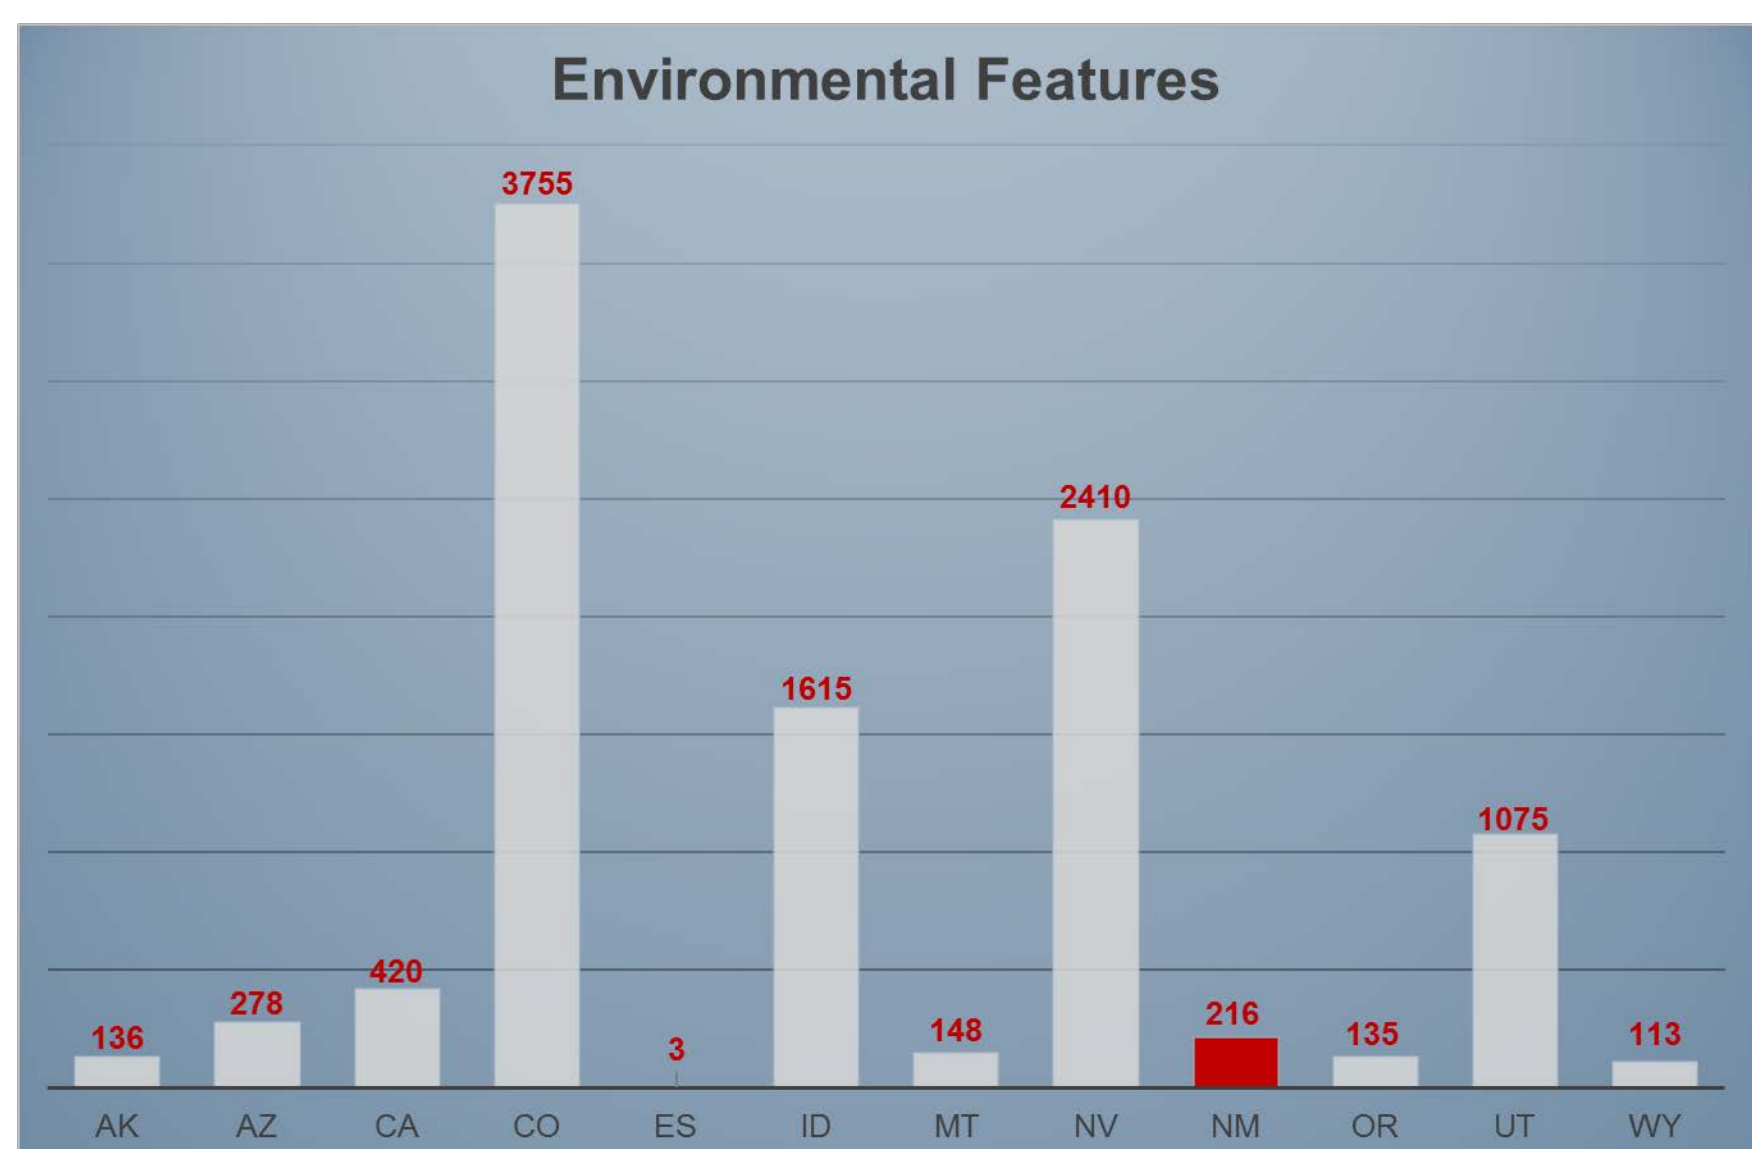
Total number of abandoned mine features that pose a potential environmental threat distributed by state. 10,183 as of April 2017.

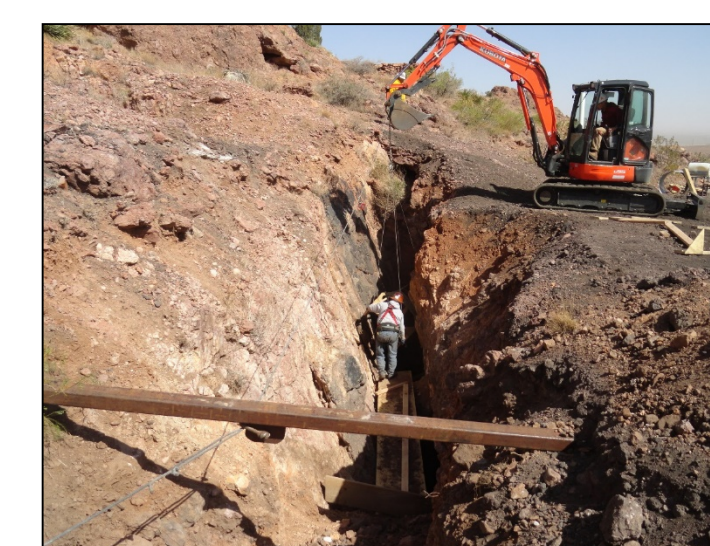
Constructing support for the riser.

Installation of a bat cupola – La Florida Mountains, New Mexico.

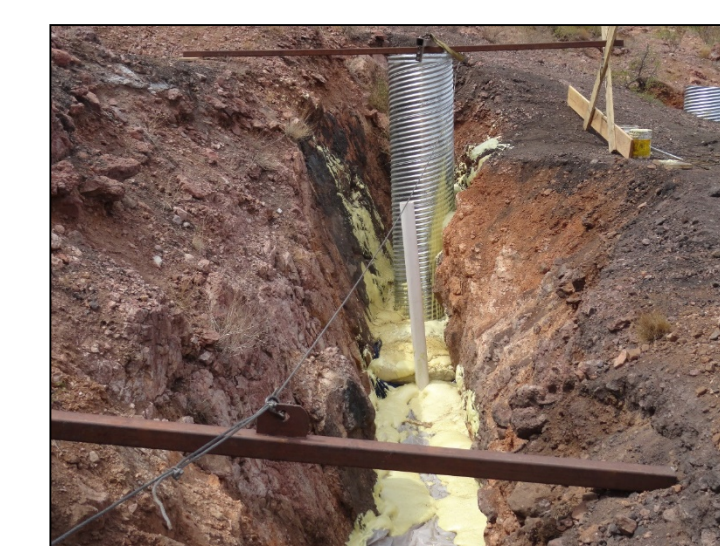
Applying polyurethane foam.

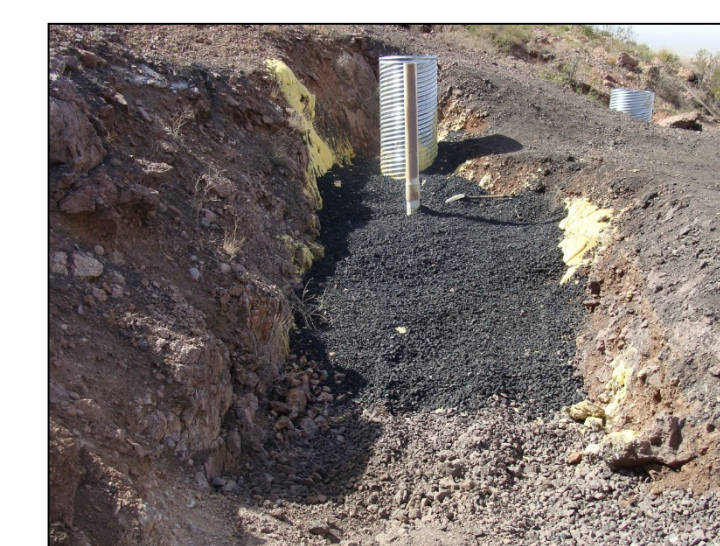
Backfilling the mine shaft.

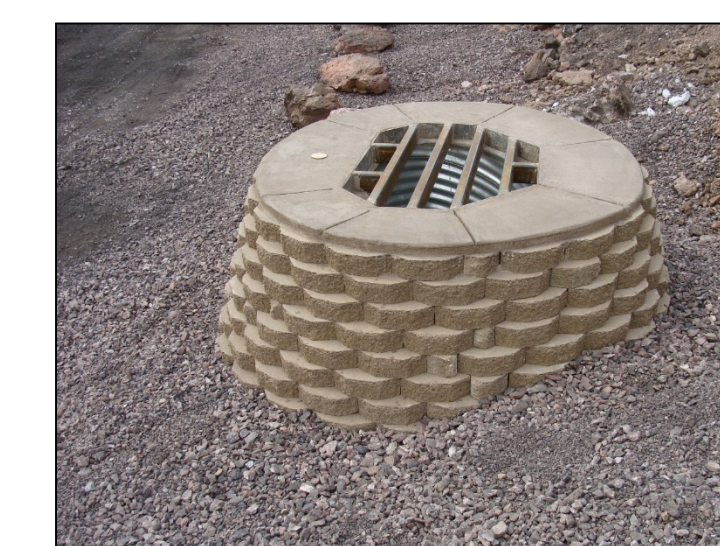
Finished bat gate.

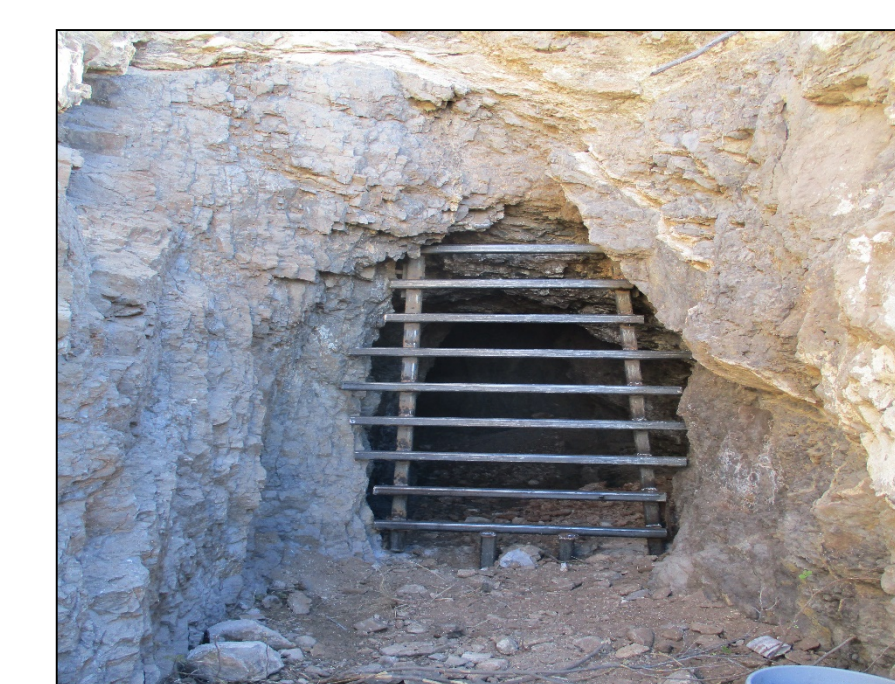
Bat gate in adit.

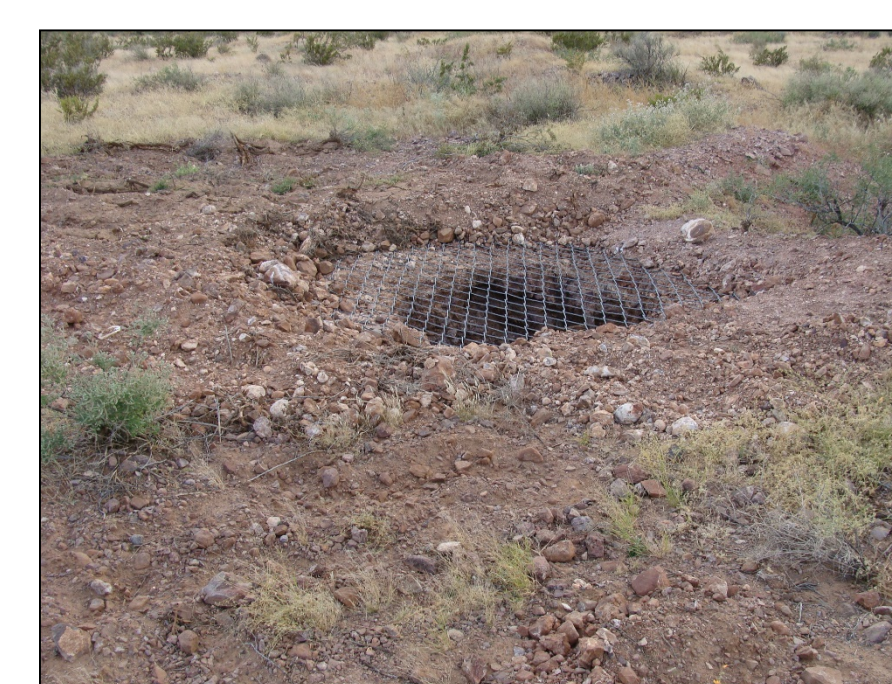
Wildlife-friendly mesh.

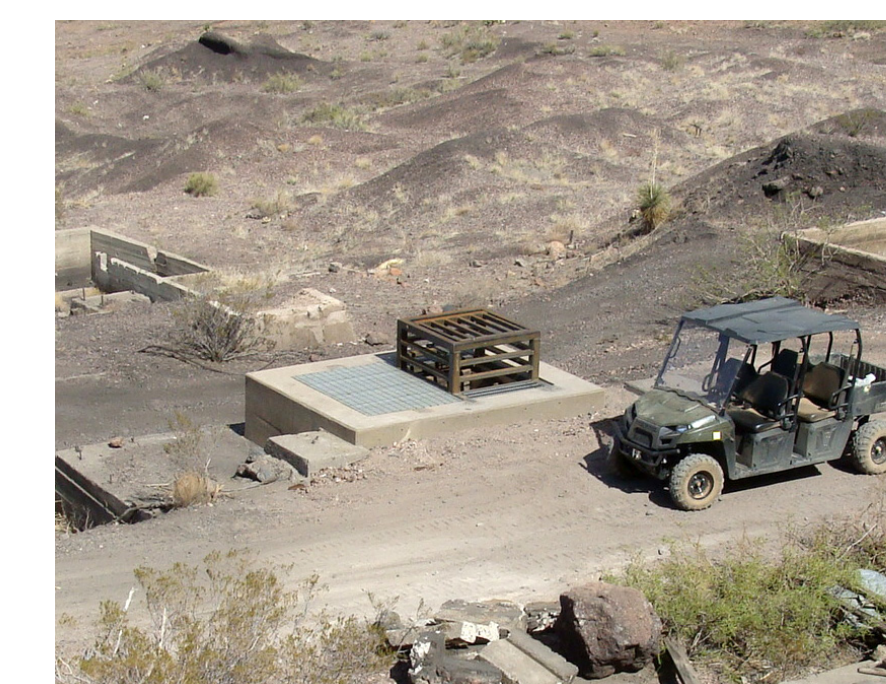
Cupola installation that preserves historical integrity.

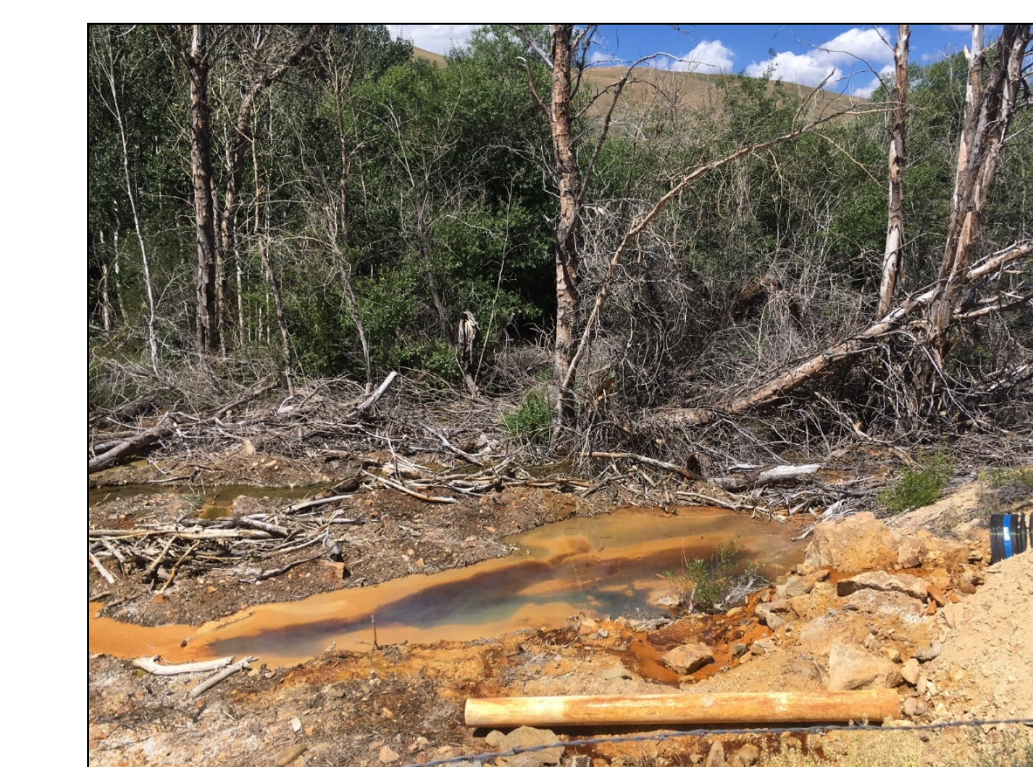
Mine Effluent.

Mine Effluent – Example from Champagne Creek, Idaho.

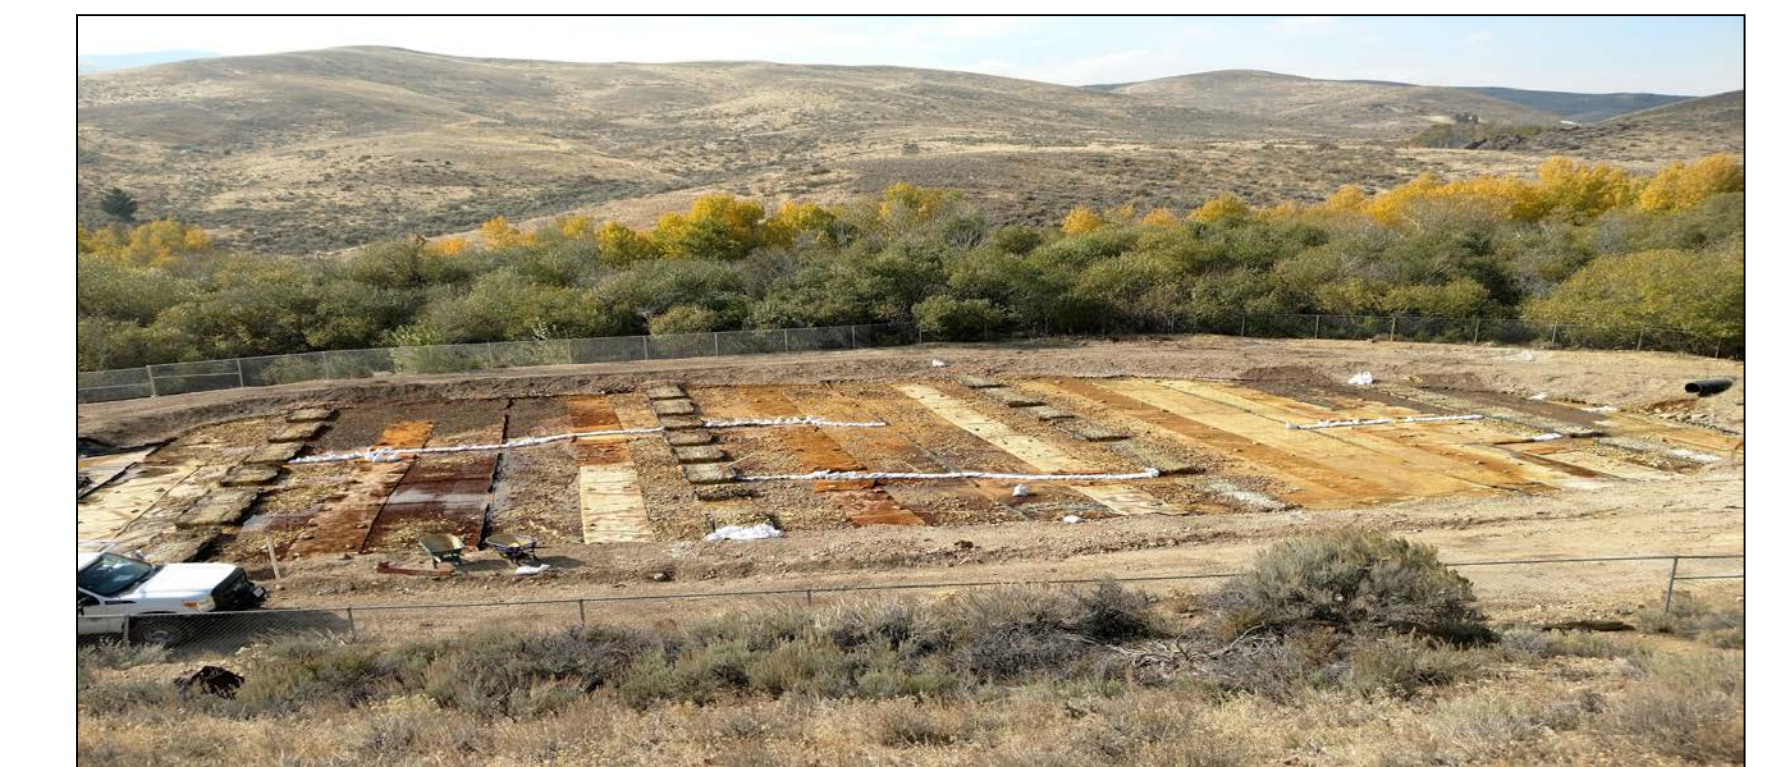
Passive water treatment using cells filled with organic debris to raise pH of water and precipitate metals.

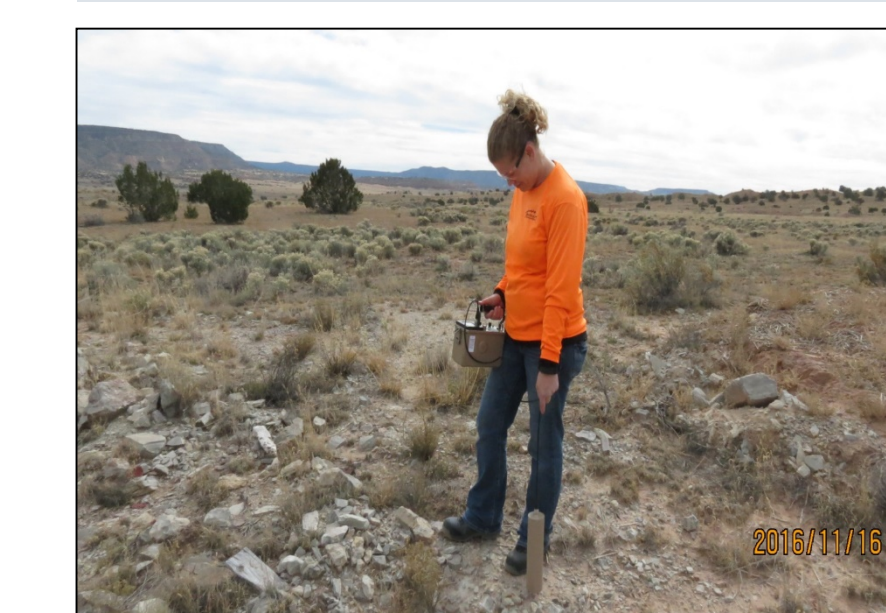
Radiation Survey being conducted at the T-20 Mine.

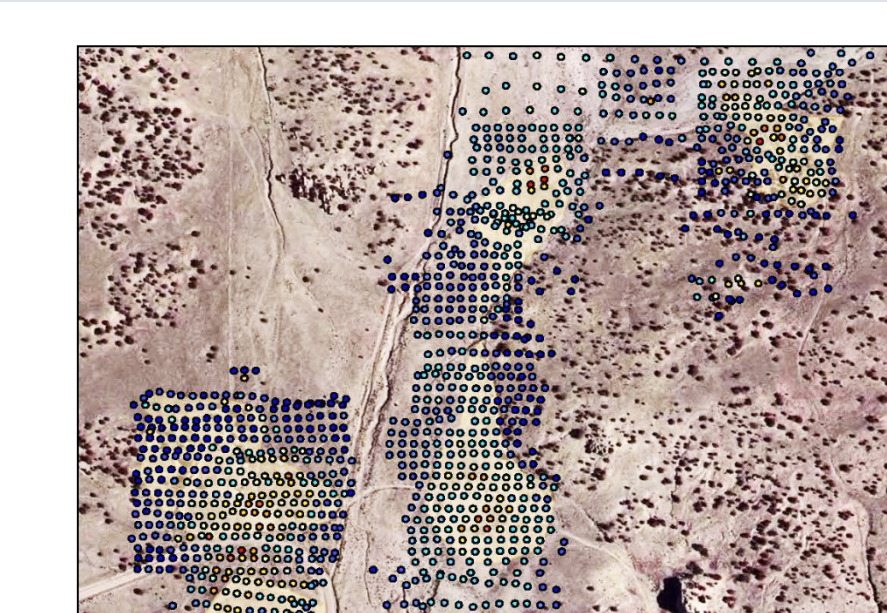
Radiation Survey of the Barbara J mines.

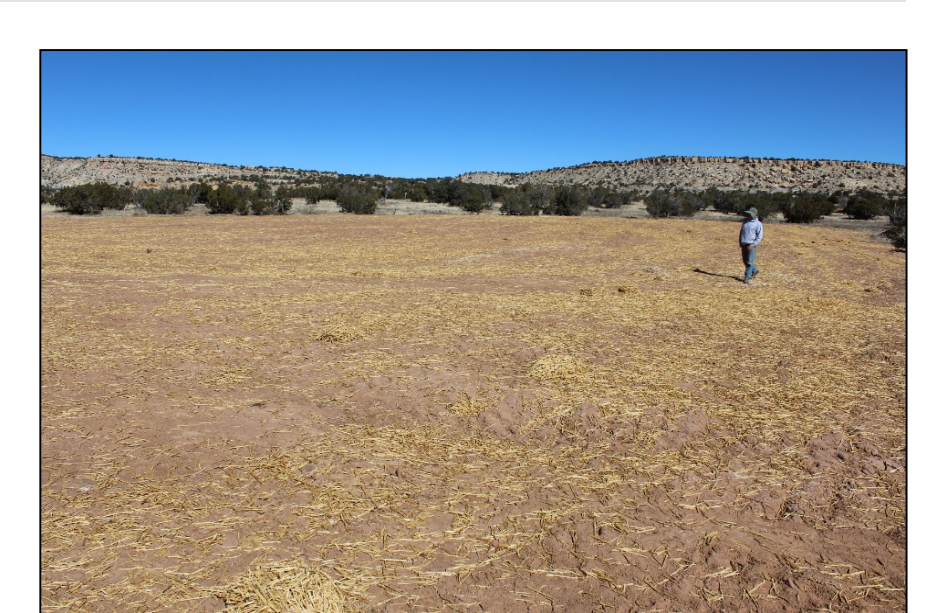
Waste Rock Repository for the Barbara J mines.
