DRA-47. IN SITU DIRECT SHEAR TESTS OF THE QUESTA MINE ROCK PILES AND ANALOG MATERIALS

K. Boakye, A. Fakhimi, and V.T. McLemore, May 9, 2007, revised February 16, 2009
(reviewed by Navid Mojtabai, D. van Zyl)

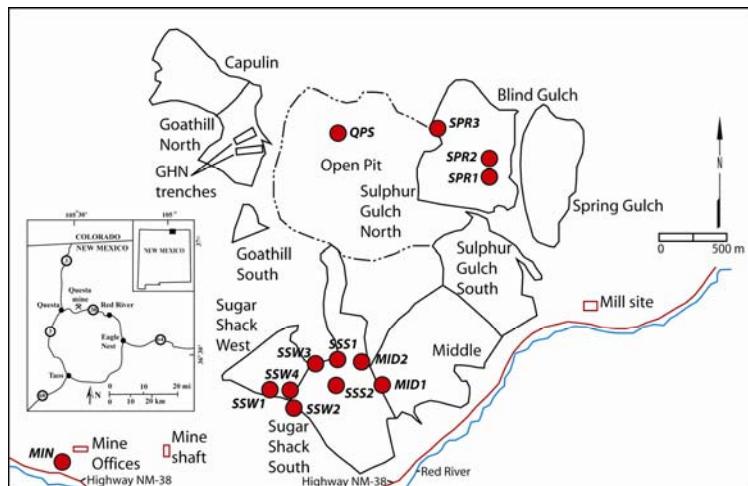
FIGURE 1. Location of in-situ samples (red circles). Test site identification numbers are listed in Table 1.

In-situ tests were performed on both rock piles and natural weathering analogs. Areas of alteration scars and debris flows near the Questa mine have been identified as natural weathering analogs to the mineralogical changes in the rock piles expected during long-term weathering (Ludington et al., 2005; Campbell and Lueth, 2008; Graf, 2008). Note that the weathering processes operating in the natural analogs share many similarities to those in the rock piles, although certain aspects of the physical and chemical systems are different (DRA-19, 20, 22). Boakye (2008) and Appendix 1 describe in detail the natural analogs and the comparison between the rock piles and their natural analogs. In-situ direct shear tests were performed on these natural analogs to extrapolate the future shear strength of the rock piles. The in-situ test locations were selected based on geologic characteristics (weathering and cohesion), personnel safety factors, and easy accessibility for the equipment (DRA-47a). The applied normal stress for the in-situ tests ranges from 15 to 75 kPa. Measurements of matric suction and soil temperature were taken at the shear plane following the appropriate standard operating procedures (SOPs). Representative samples were sent to the laboratory for Atterberg limits, specific gravity, and disturbed laboratory direct-shear tests, plus moisture content, particle size, mineralogical, chemical, and petrographic analyses. After each in-situ shear test, the shear plane was inspected for the maximum particle size and was photographed. Particle size analyses were performed in the laboratory on the rock-pile samples that were collected from the in-situ test locations. A total of 52 in-situ shear tests were conducted at 13 locations as shown in Table 1 and located in Figure 1.

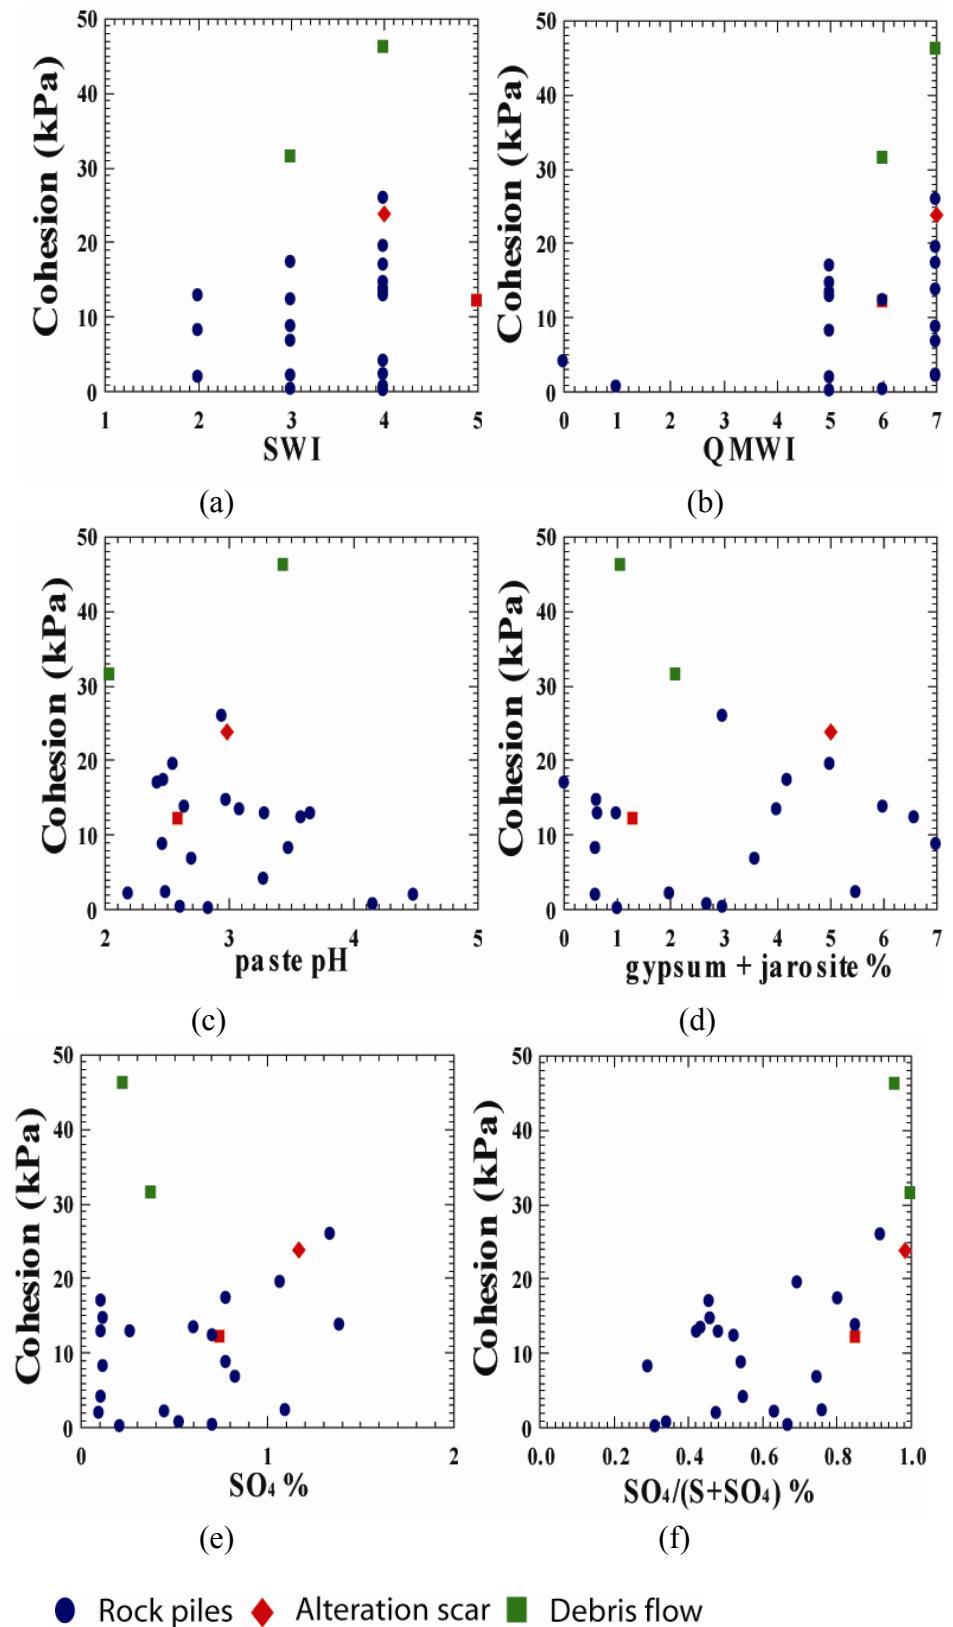
FIGURE 2. Scatter plot of cohesion vs. SWI (Simple Weathering Index), QMWI (Questa Mineralogic Weathering Index), paste pH, gypsum + jarosite, SO₄ and SO₄/(S+ SO₄).

Some samples that are weathered (i.e. high SWI, QMWI, SO₄ and SO₄/(S+ SO₄), and low paste pH) have high cohesion, but not all.

Figures 2 and A3-2 (Appendix 3) show the results of field-measured cohesions versus the simple weathering index. The averaged cohesion corresponding to each weathering index is shown in Figure A3-2 with a gray circle. Figures 2 and A3-2 suggests that higher cohesion values belong to more weathered samples, but there are some weathered samples with low cohesion values.

In addition to the simple weathering index, Questa Mineralogic Weathering Index (QMWI; Figure A2-2 in Appendix 2), paste pH, sum of gypsum and jarosite, SO_4 and $\text{SO}_4/(\text{S}^+ \text{ SO}_4)$, were used in this investigation (DRA-27; Appendix 2). These were confirmed by petrographic analysis (McLemore et al., 2008a, b). The correlation between these parameters with cohesion values are shown in Figure 2 in which different symbols for the rock piles, alteration scar, and debris flow are being used. Some samples that are weathered (i.e. high SWI, QMWI, SO_4 and $\text{SO}_4/(\text{S}^+ \text{ SO}_4)$, and low paste pH) have high cohesion, but not all.

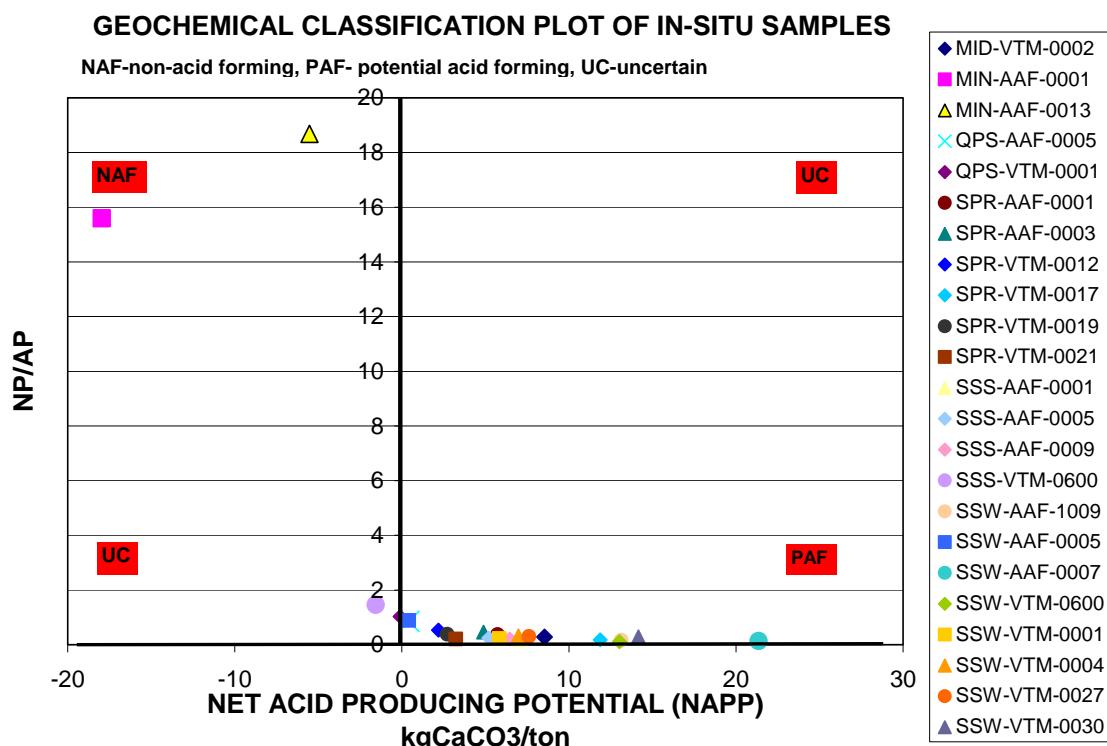
FIGURE A2-1. Chemical classification chart of in-situ samples. Most samples are potentially acid forming and represent weathered material. Non-acid forming samples are not significantly weathered.

The in-situ samples were chemically evaluated using acid base accounting methods (using procedures described by Tachie Menson, 2006). Most in-situ samples are potentially acid forming and represent weathered material (Fig. A2-1).

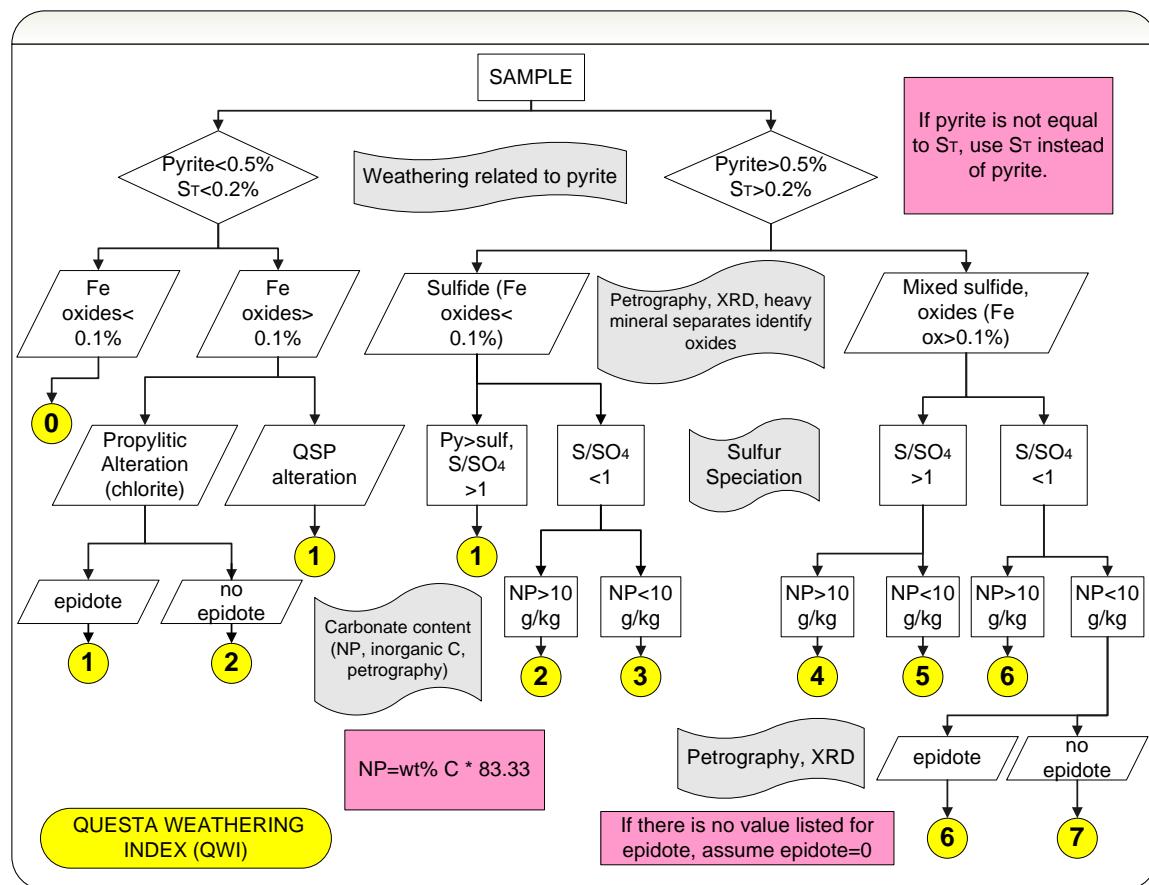
FIGURE A2-2. Decision tree for determining the Questa Mineralogical Weathering Index (QMWI).

The Questa Mineralogical Weathering Index was developed specifically for the Questa rocks and is based upon the pyrite-calcite to gypsum-jarosite system and includes some dissolution of silicates (Fig. A2-2).

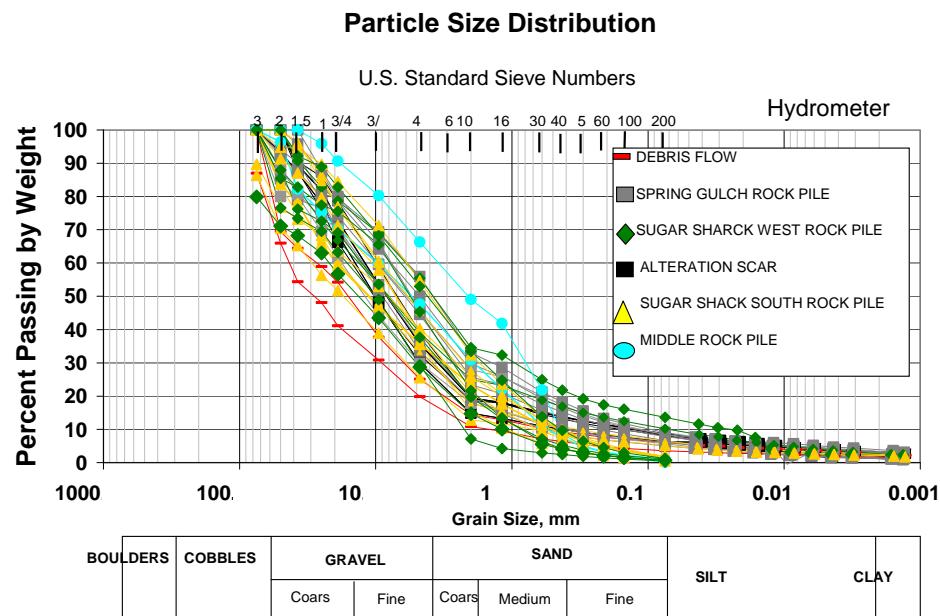
FIGURE A3-1. Gradation curves of the rock pile materials collected from the locations where in-situ shear tests were conducted.

The rock piles and analogs sampled at all 52 in-situ test locations consisted of heterogeneous material made up of 32% to 80% gravel, 16% to 66% sand, and 0.1% to 14% fines. These values correspond relatively well with those of Gutierrez (2006), Shaw et al. (2002), and Norwest Corporation (2005). The Atterberg limits range from 19 to 40 for liquid limit, 13 to 32 for plastic limit, and 0.2 to 19 for plasticity index. Based on this information, the Questa rock-pile materials are classified as GP-GM to SP-SC using the Unified Soil Classification System. Figure A3-1 of Appendix 3 shows the gradation curves of the materials at the in-situ tests locations.

- The percentage of fine material is low (less than 20%, Fig. A3-1, Appendix 3). This allows the rock fragments in the rock piles to be directly in contact and, therefore, have more frictional resistance.

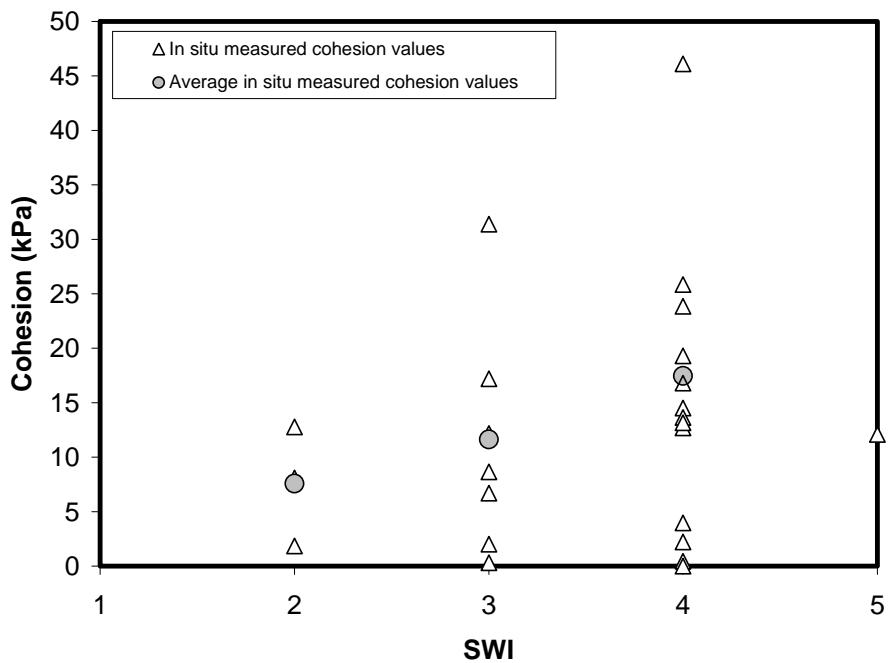
FIGURE A3-2. Scatter plot of cohesion versus simple weathering index (SWI).

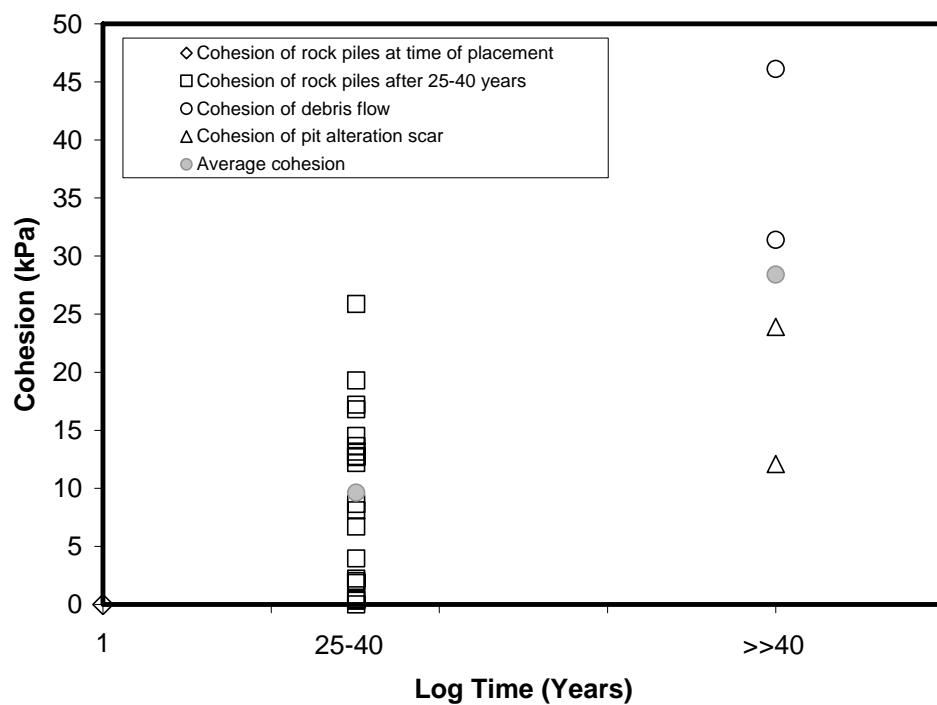
FIGURE A3-3. Cohesion vs. age of the rock piles and analogs.

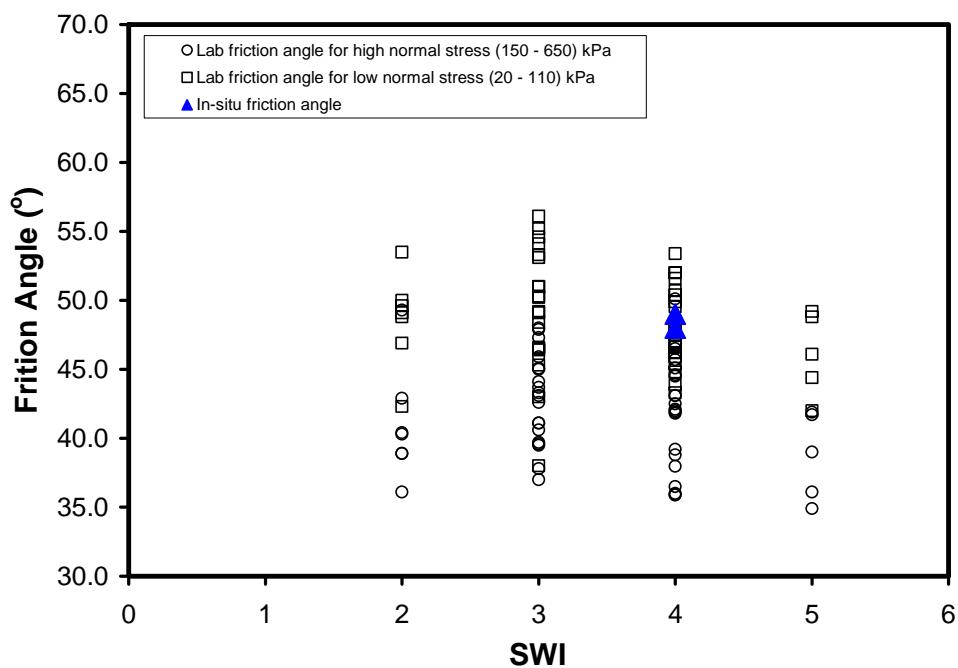
FIGURE A3-4. In situ and laboratory friction angles versus simple weathering index (SWI).

Figure A3-4 (Appendix 3) illustrates the friction angle versus the SWI for the 52 samples collected from the in-situ test sites. The laboratory friction angles in Figure A3-4 were obtained using two sets of normal stresses. In the first set, low normal stresses of 20 to 110 kPa was used, while for the second set the normal stresses were higher (150 to 650 kPa). The majority of the samples in Figure A3-4 were compacted at the in-situ dry densities but there are some samples which were not compacted at the in-situ dry densities; the range of dry densities used for sample compaction was 1410 to 2170 kg/m³ (Table A3-3). As expected, on average, the friction angles obtained from shear tests with low normal stresses are higher than those obtained from shear tests with high normal stresses. This indicates that a curved failure envelope can be used to capture the shear strength of the rock pile material (Boakye, 2008; Boakye et al., in preparation). Note that two friction angles from the in-situ shear tests were measured and are shown in Figure A3-4.

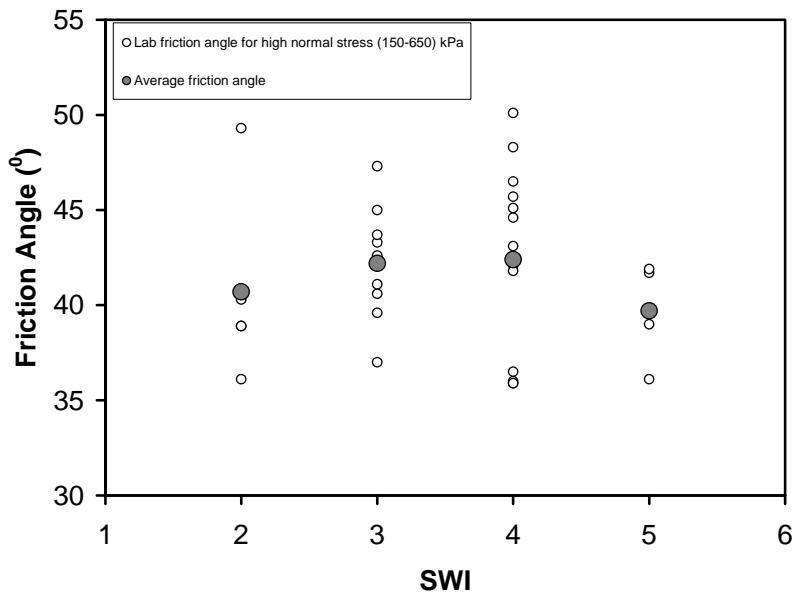
FIGURE A3-5. Laboratory friction angles versus simple weathering index (SWI) for the 32 samples compacted to the dry densities within 0.95 to 1.05 of the corresponding in situ dry densities.

To exclude the effect of compaction density on the measured peak friction angles, in Figures A3-5 and A3-6 the peak friction angles are plotted versus the simple weathering index and time for only 32 samples with compacted laboratory dry densities within 0.95 to 1.05 of the corresponding in situ dry densities. These samples are shown in gray in Table A3-3. These two figures suggest that the mean friction angle is not noticeably affected by the weathering for the in-situ test locations. In particular, Figure A3-6 indicates that the mean friction angle of rock piles and analogs are close to each other and they show similar scatter of the data as well.

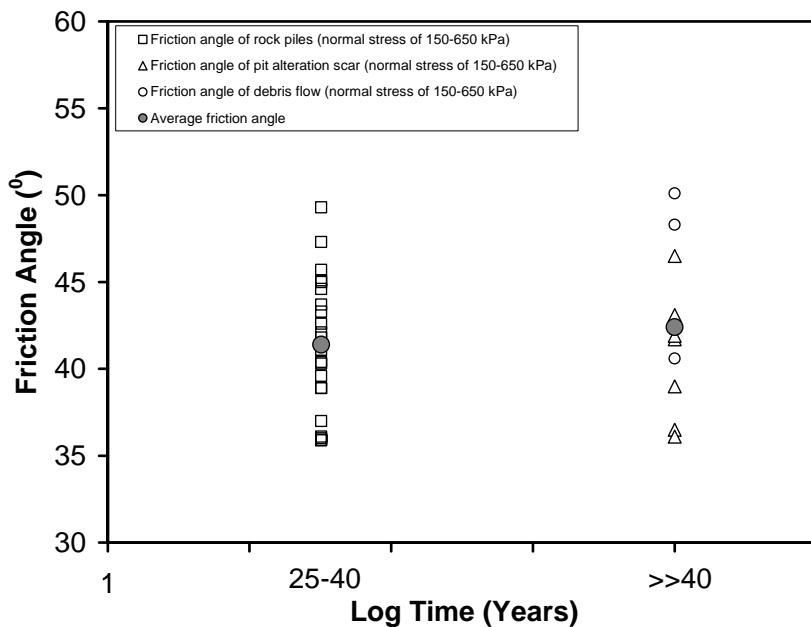
FIGURE A3-6. Laboratory friction angle versus age for the 32 samples compacted to the dry densities within 0.95 to 1.05 of the corresponding in situ dry densities.

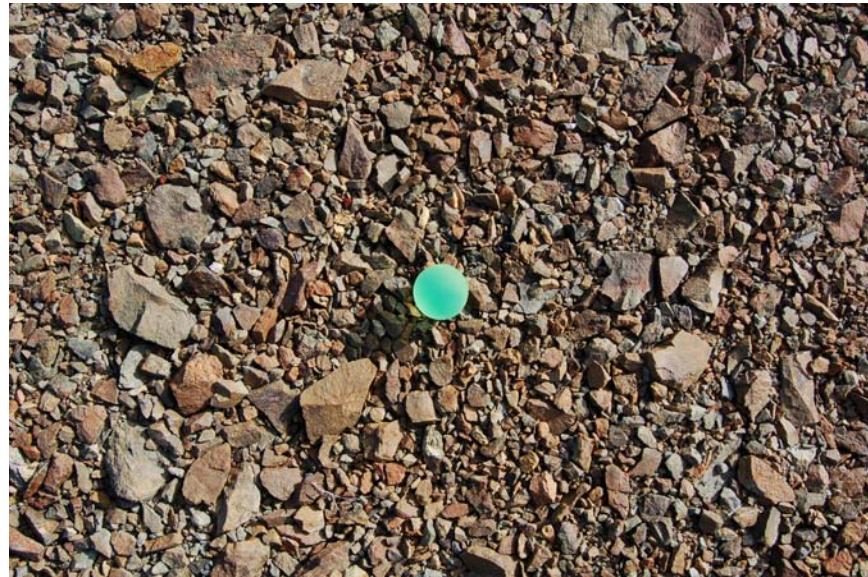
FIGURE A3-7. A close photo of the surface of a Questa rock pile material showing the angularity of the rock fragments compared to a spherical ball 50 mm in diameter.

- The rock fragments in the rock piles are angular to subangular. Angularity causes greater interlocking of the particles and induces higher shearing resistance. The angularity of the rock fragments (DRA-28) is shown in Figure A3-7 (Appendix 3).

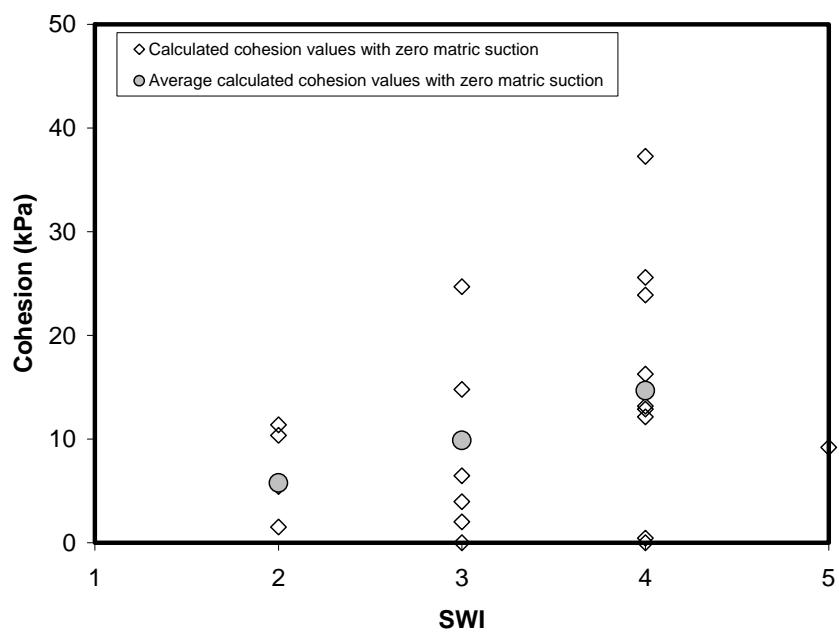
FIGURE A3-8. Scatter plot of cohesion corresponding to when the cohesion values are adjusted for matric suction equal to 0 kPa (c' in equation 1b) vs. the simple weathering index (SWI).

In Figure A3-8 (Appendix 3), the cohesion values corresponding to 0 matric suction (c' in equation 1b) versus SWI are shown. This figure suggests that the greatest cohesion values belong to more weathered samples but there are weathered samples with low cohesion values too.
