# ABANDONED OR INACTIVE URANIUM MINES IN NEW MEXICO

A report of investigation carried out between August 1979 and May 1980 under contract with the New Mexico Energy and Minerals Department.

New Mexico Bureau of Mines and
Mineral Resources
Open-File Report 148

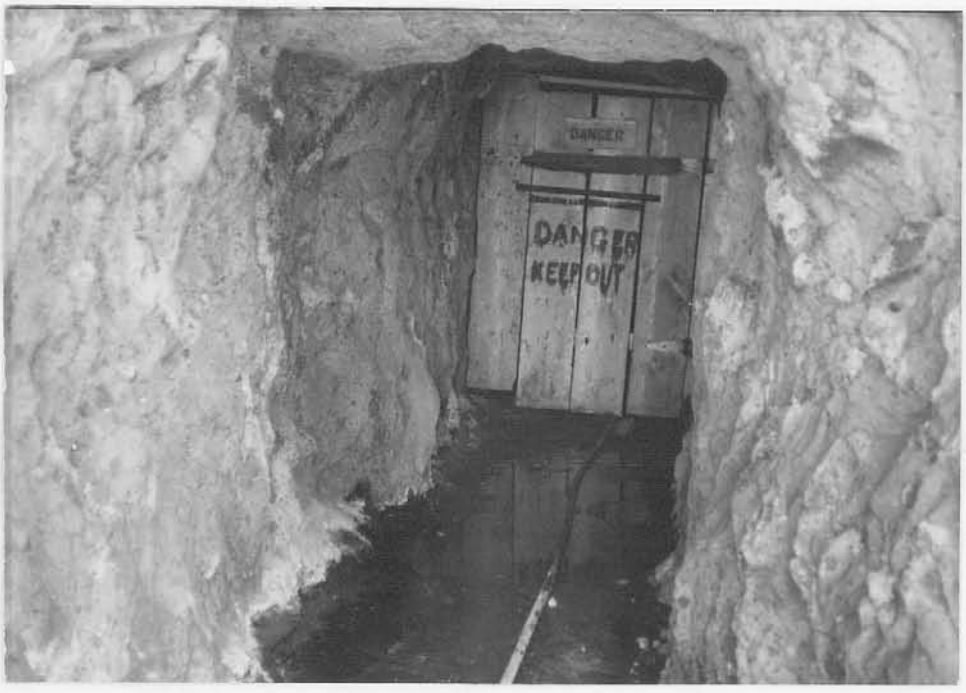
The workings consist of lower and upper adits driven into the south wall of Cooney Canyon about 40' and 140' respectively above the floor. The lower and largest adit was entered and explored for the first 25' to 30'; at that point it makes a left and according to a mine sketch by Collins, 1957, continues for another 70'-75'. A wooden door remains in place about 15'-20' into the adit (see photos on following page).

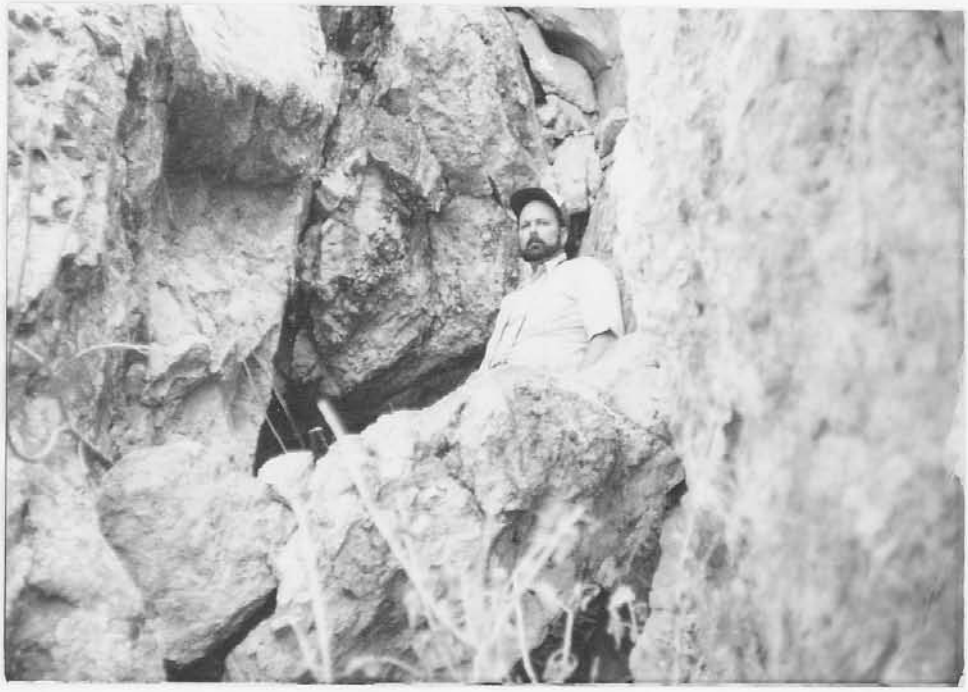
View inside lower (larger) adit of Baby Mine

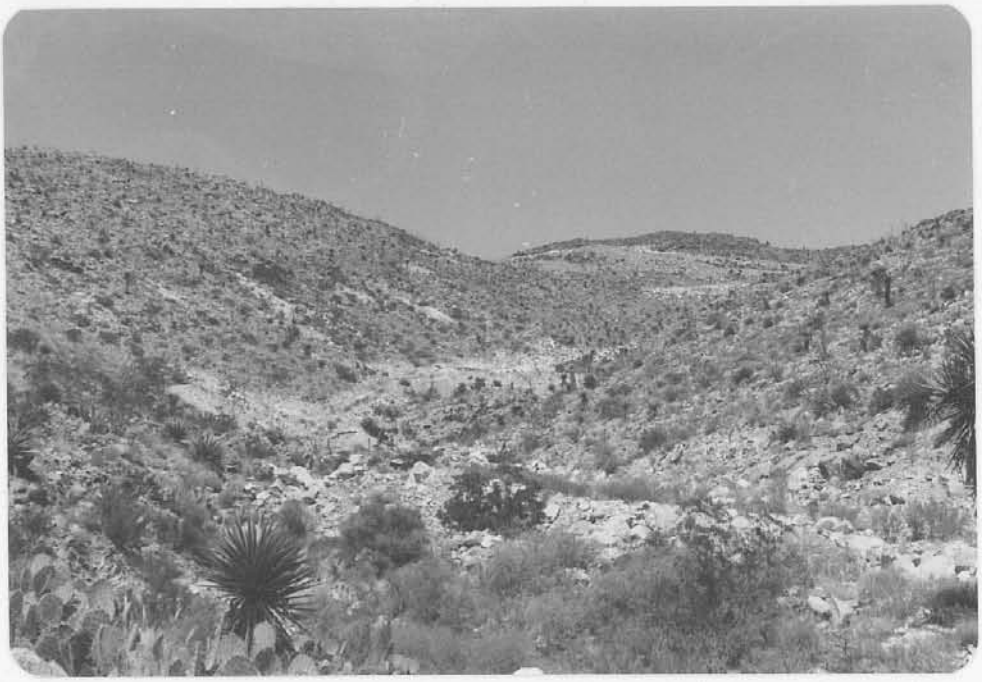
Photo A - looking N at Blue Star fault valley, adits to left.

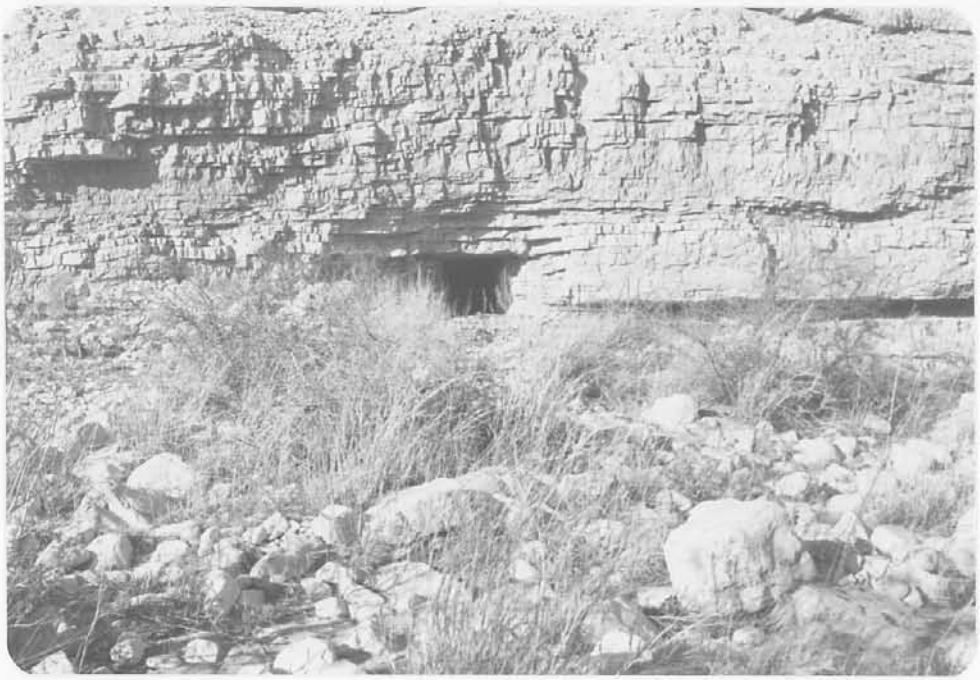
Photo (a) Looking northwest at cliff face of Yates dolomite, with 6' x 6' portal of Teepee adit shown at lower right.

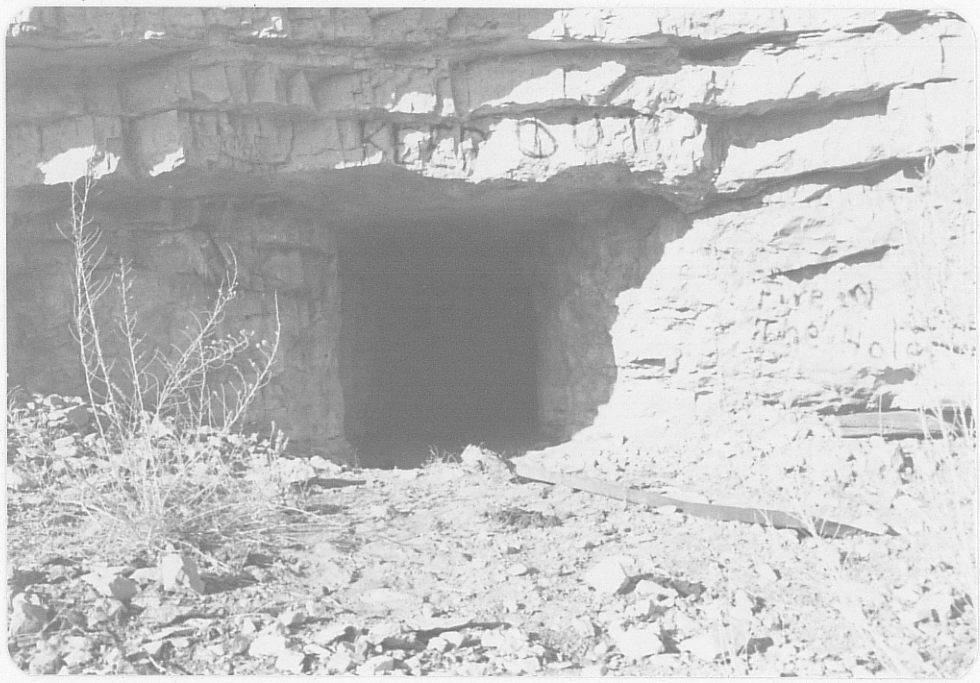
Photo (b) Looking north into adit with debris out front thought to constitute the stream modified remains of a tailings dump.

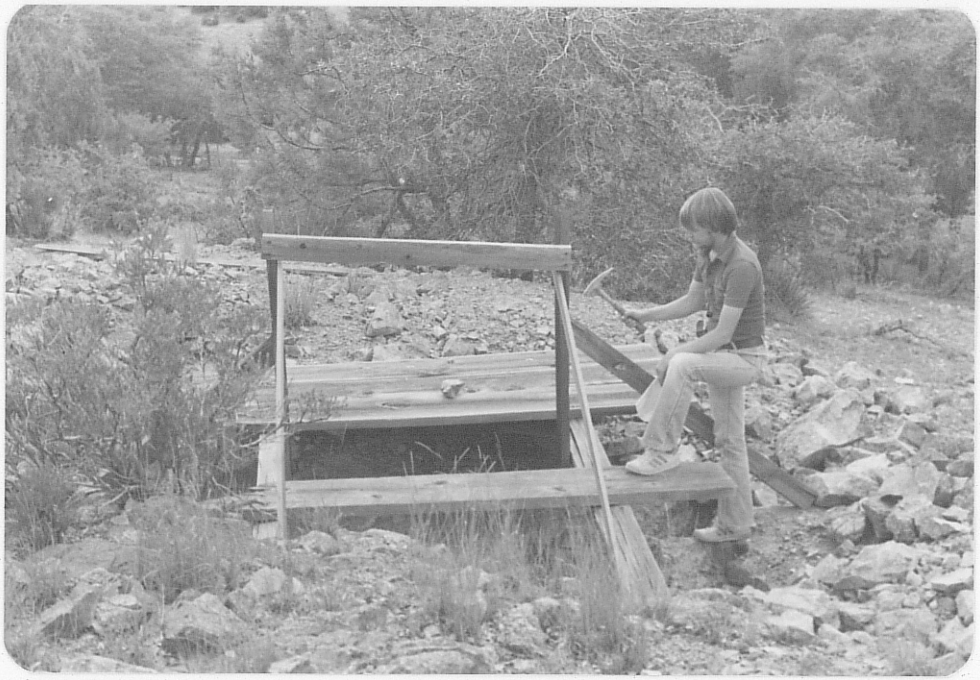
During the present investigation one small vertical shaft with a collar dimension about 4' x 6' was found. At a depth of 10' water was standing, so total depth unknown (see photos a & b). A deteriorating wooden bailing or hoisting platform remains over the shaft.

Photo (a) Looking south showing small hoisting platform, underlying shaft, and small tailings pile, at Alhambra-Bluebelle No. 2.

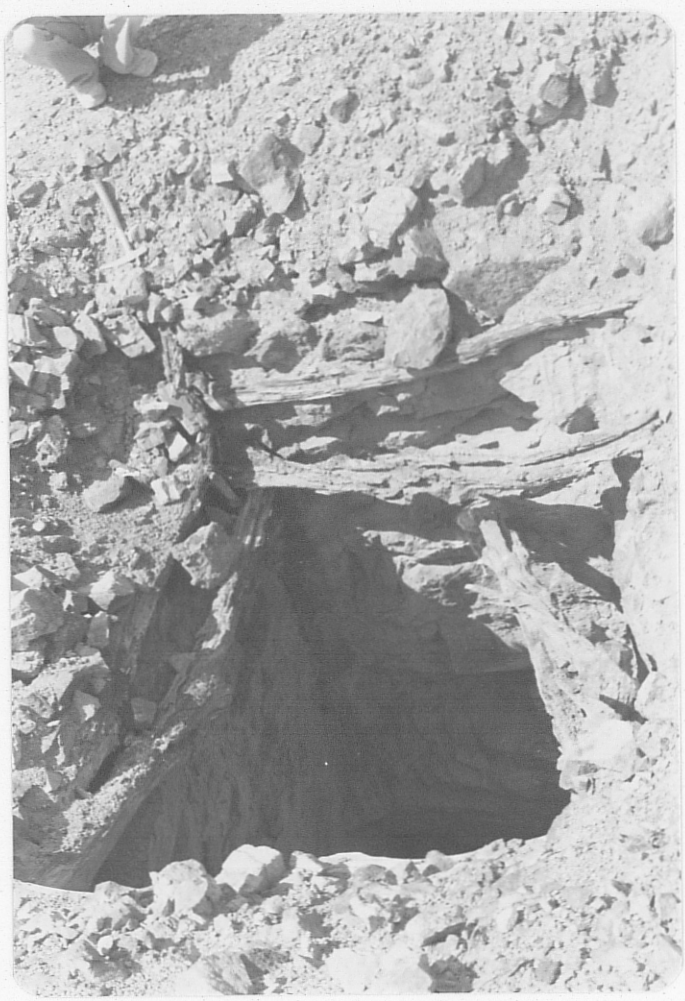
Photo (b) Easternmost shaft, 4' x 6', with water standing at the 60' level.

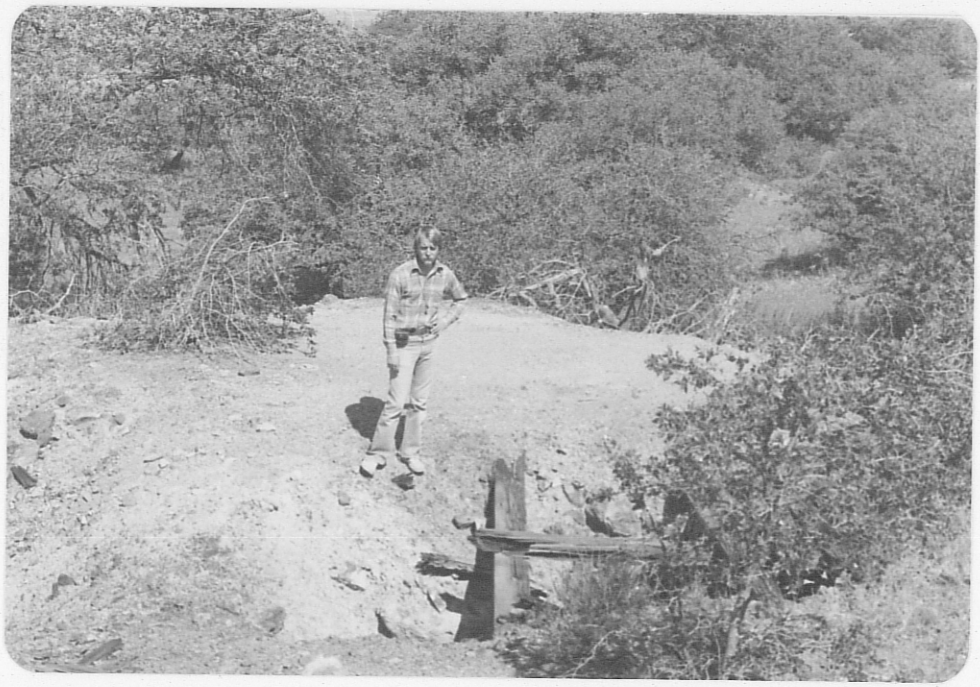
Photo (a) Looking north into covered inclined shaft thought to be on Blue Jay Claims.

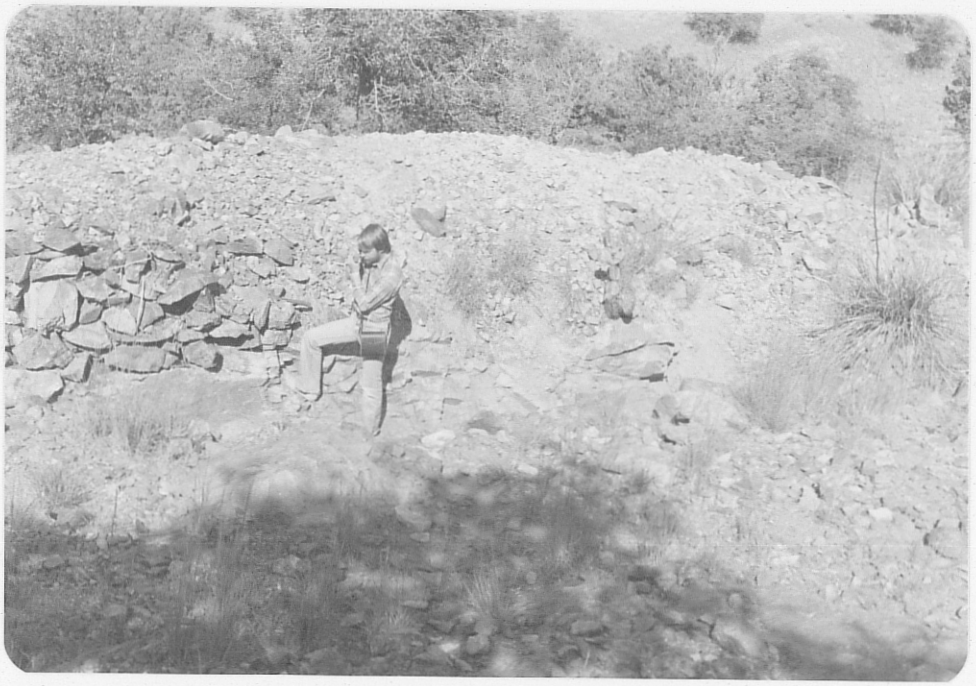
Photo (a) Looking westward at water filled Eugenie shaft; collar dimensions about 4' x 8'.

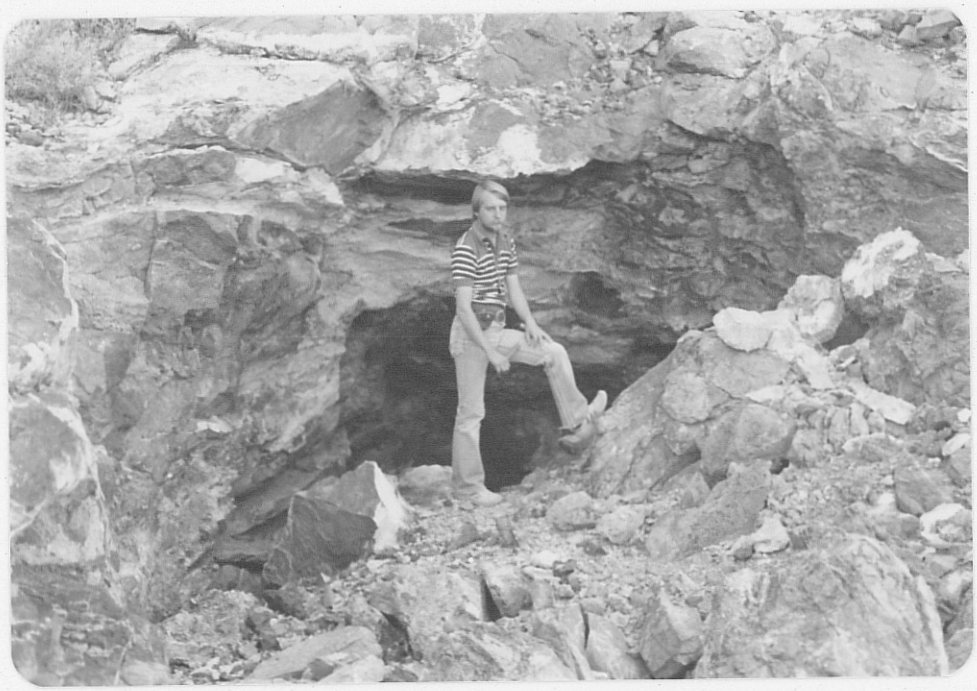
Photo (f) Small inclined shaft, 5' x 6', in E½ SE¼, sec. 25.

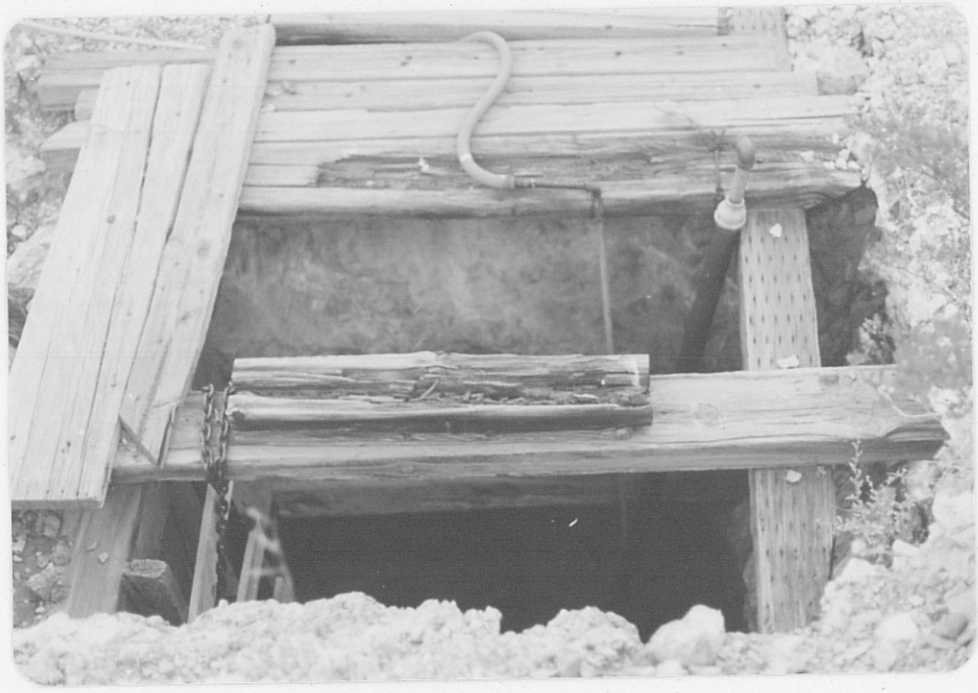
Photo (h) Vertical shaft, 6' x 6', 50' deep, with some "plumbing" left in place; note log chain at left for scale. In SE¼, sec. 25.

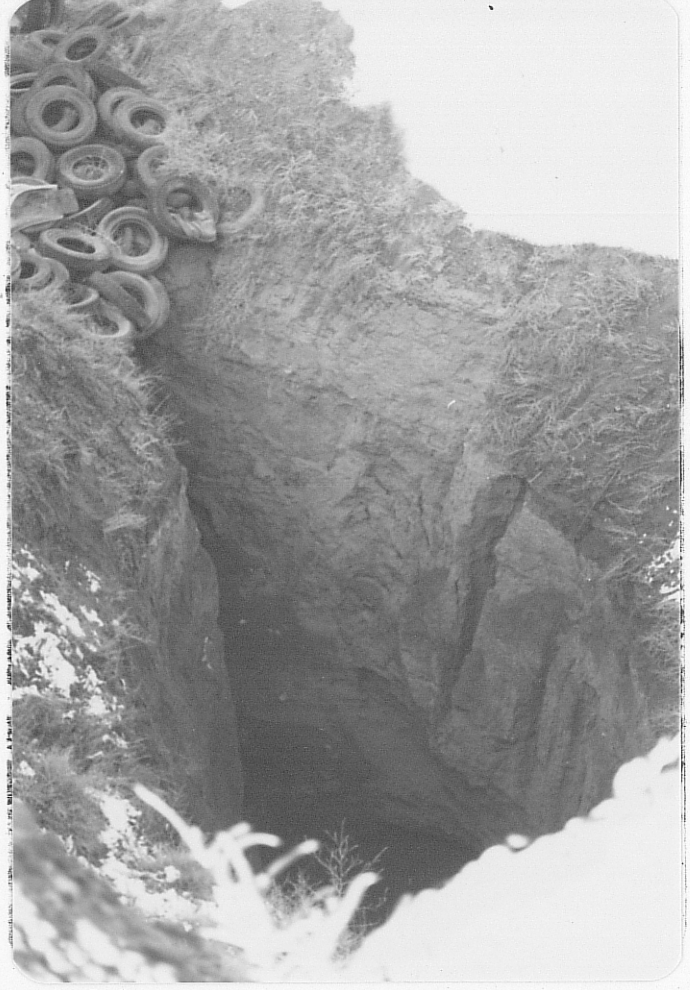
The shaft has subsequently caved leaving a 75' diameter funnel shaped hole perhaps 75' deep or deeper (see photos a & b). A close up of the lower portion of the hole is shown in photo (c). The shaft site is enclosed with a 6' high wire mesh fence that is nearly 250' long on each side; however, a section along the south side has been damaged and this allows access to the mine shaft. Scintillometer readings around the shaft site range from 400-600 cps; one area along the north fence line up to 1,200 cps. The mine dump extends mainly eastward from the shaft; it is composed of very low, 3'-4' high, scattered conical piles and ridges that extend 600' east of the shaft. Scintillometer readings were in the 600-1500 cps. range in the dump area (see photos d & e). A small powder magazine remains about 700' west of the shaft.

Photo (c) Close-up of lower portion of caved depression where it funnels into the old shaft.

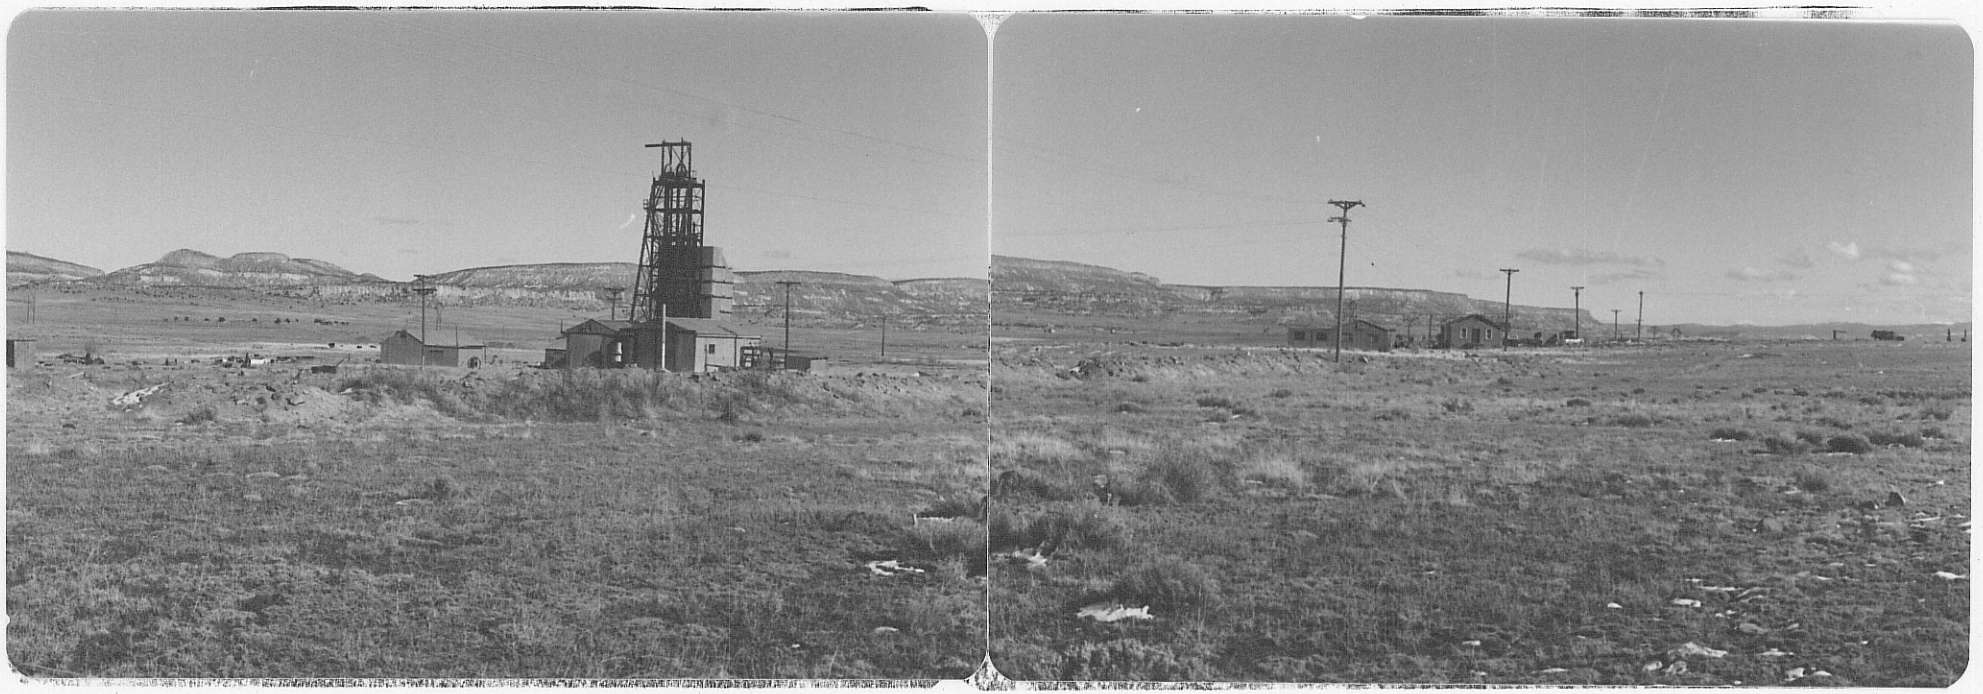
Photo (a) Looking eastward at Dysart No. 1 Mine; headframe is 40' high. House at far right is used by United Nuclear-Homestake Partner's caretaker.

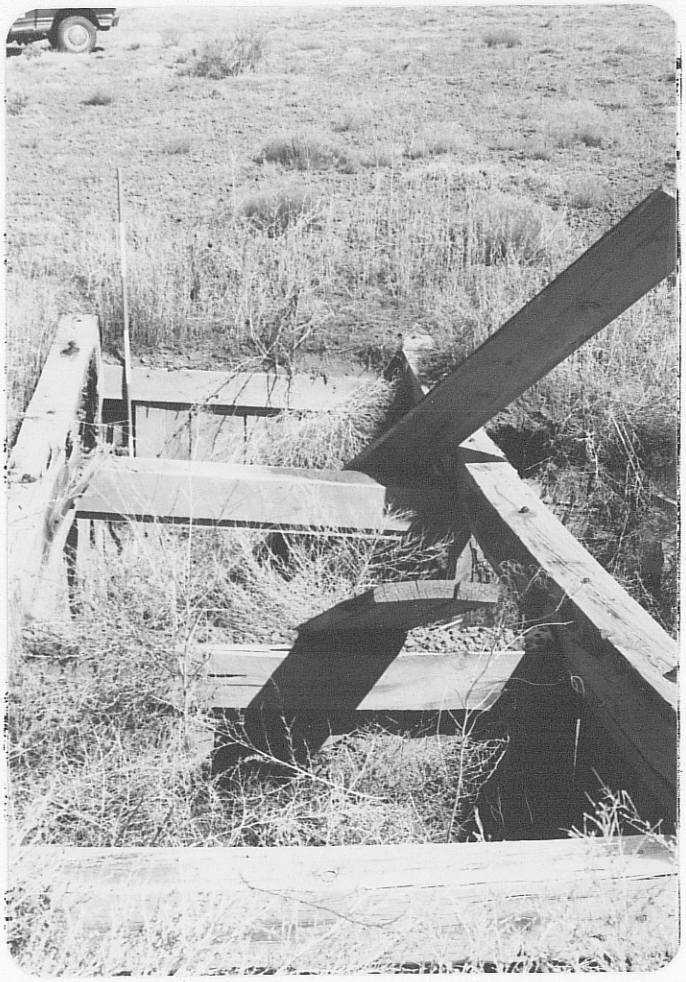
Photo (a) Looking northwestward at the remains of the incompleted sec. 26 shaft; the headframes of the sec. 27 mines (nos. 1 and 2) and the Ann Lee Mine show in the background.

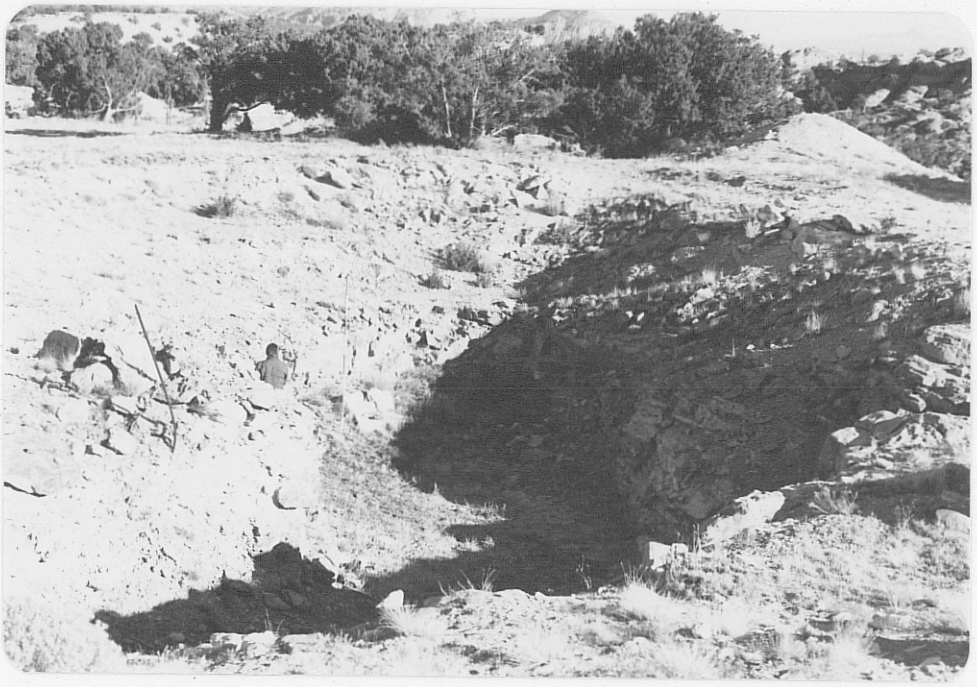
Photo (b) Looking east at group of closely spaced open pits, up to 4' deep.

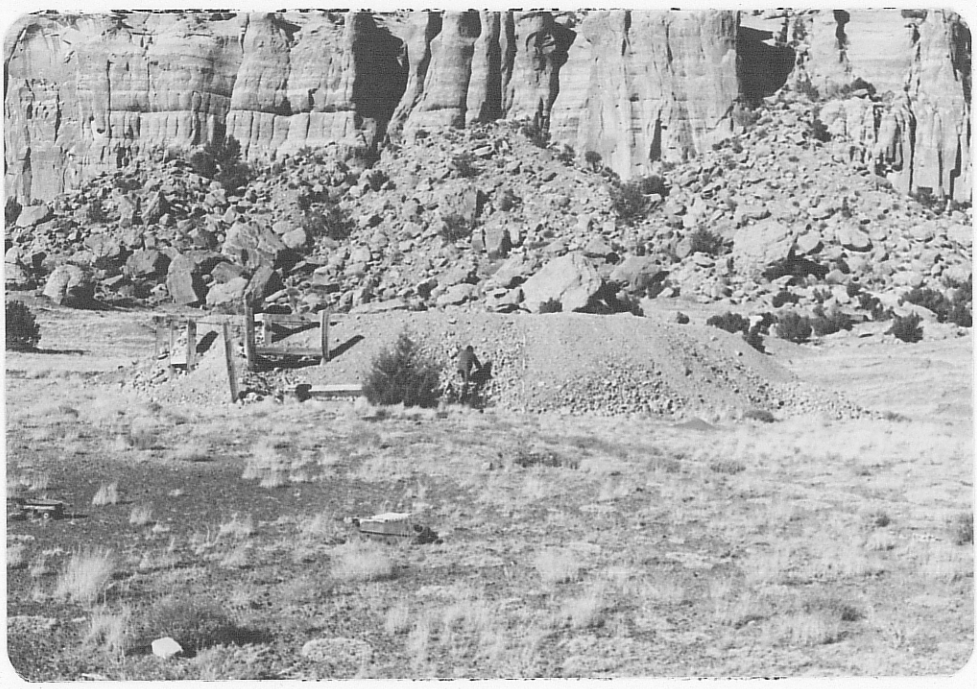
The mine consists of a shaft, a loadout facility, and a long trench with a decline driven at the end; (see Fig. 1). The shaft has caved (photo a) but a portion of the collar or timbering is still visible in the hole. Present depression is circular in plan and is about 10' deep. The shaft may have been inclined.

Photo (a) Looking north at caved shaft; note range pole at right side of shaft for scale.

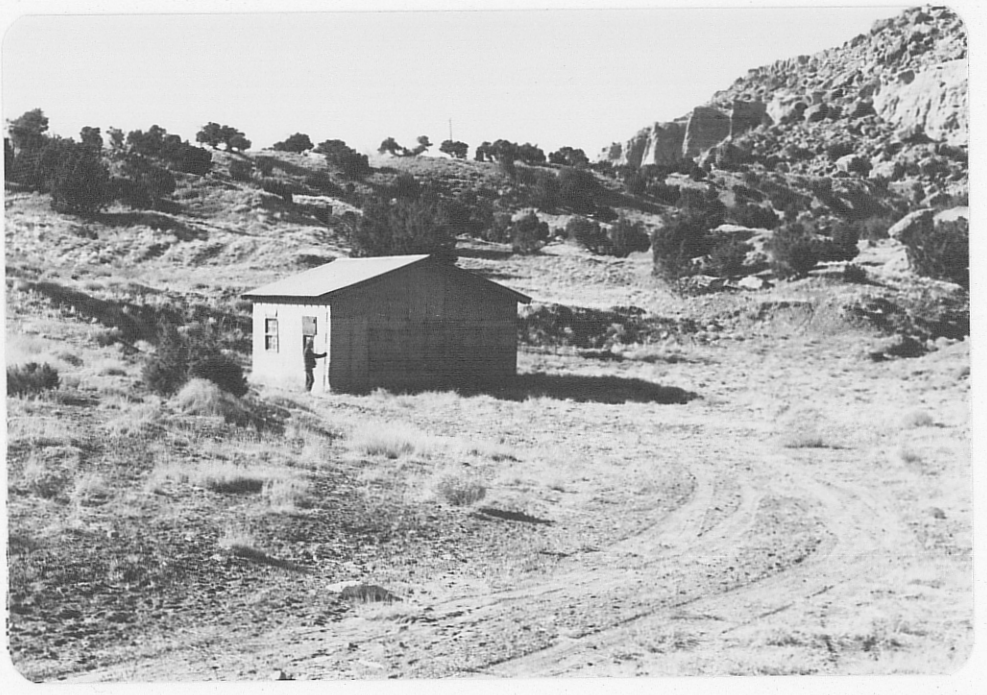
Photo (d) Metal shed about 350' southwest of shaft; note person at left side of shed for scale.

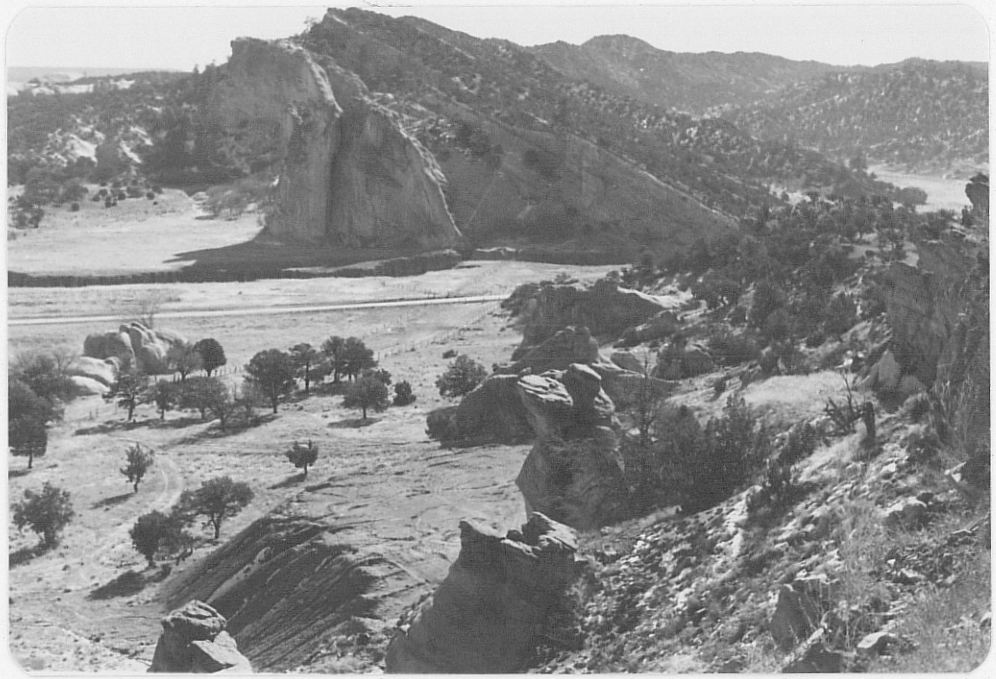
Photo (a) Looking southeast from crest of hogback above Diamond Mine showing Sundance Coal Mine road in middle distance; note mine dump at center foreground.

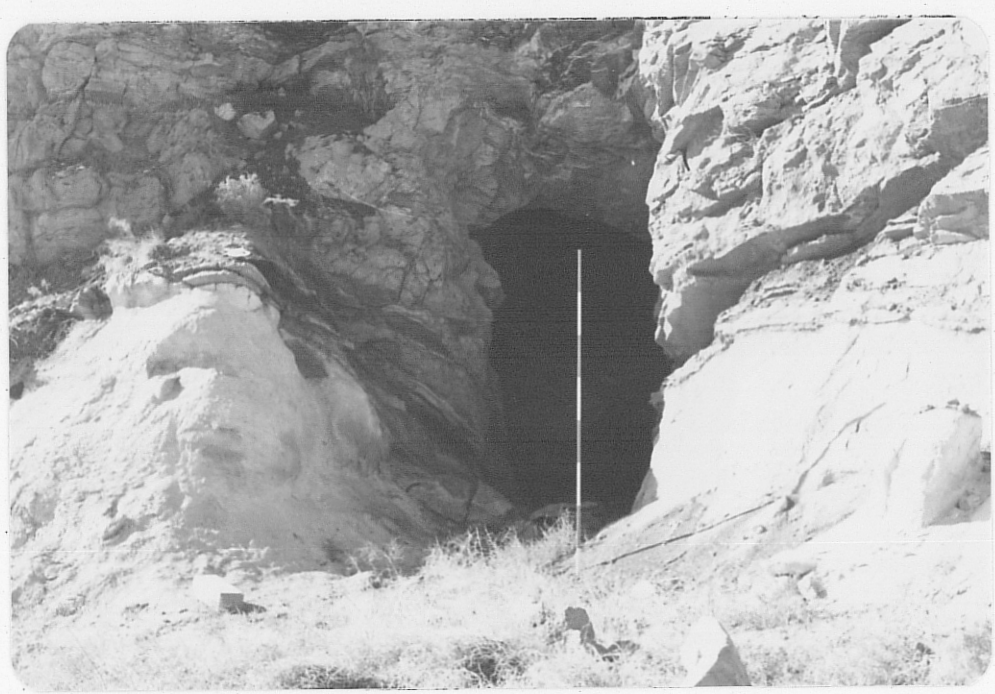
Photo (b) Looking southwest into opening of southern decline.

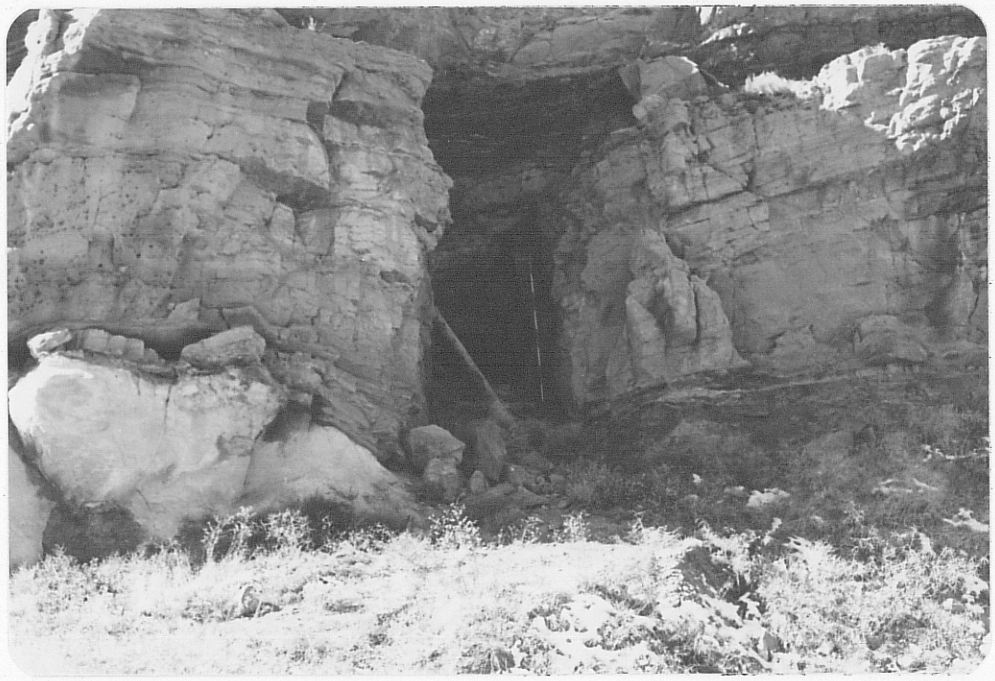
Photo (d) Looking southwest into northern decline, driven down dip just below 4' thick carb. shale zone.

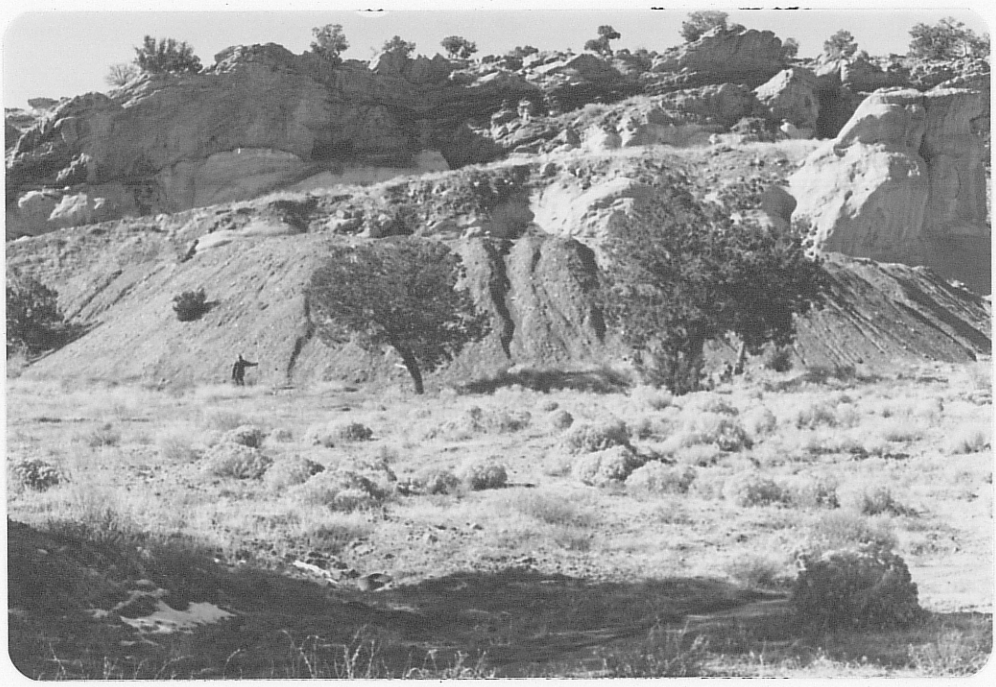
Photo (g) Looking west at mine dump; note portals of the two declines indicated by arrows, and person at lowel level for scale.

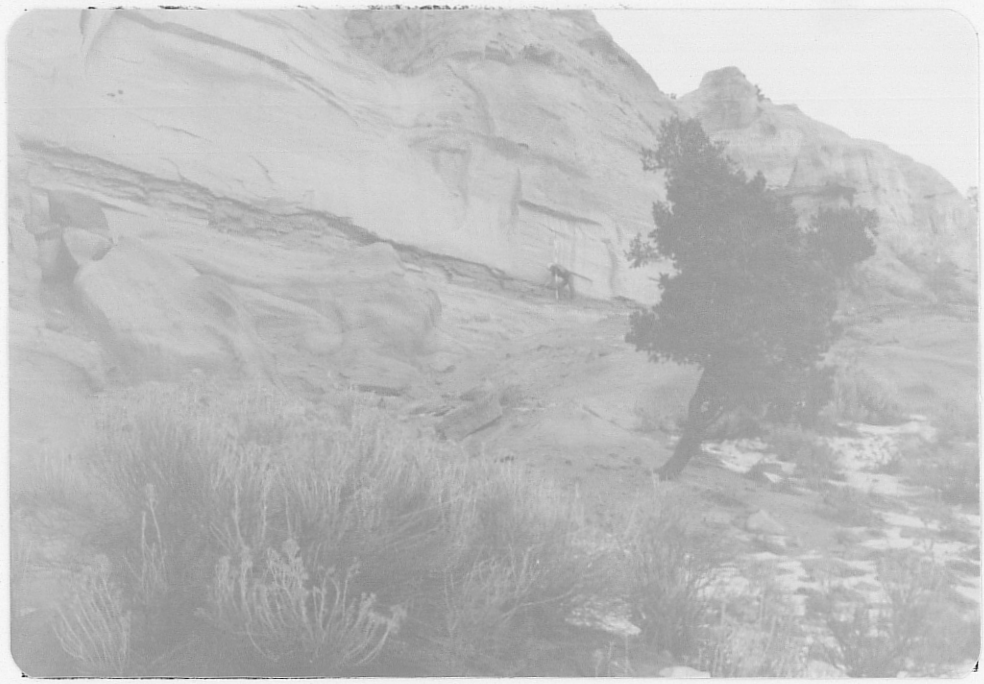
Photo (a) Looking SW at prospecting on the CD & S property.

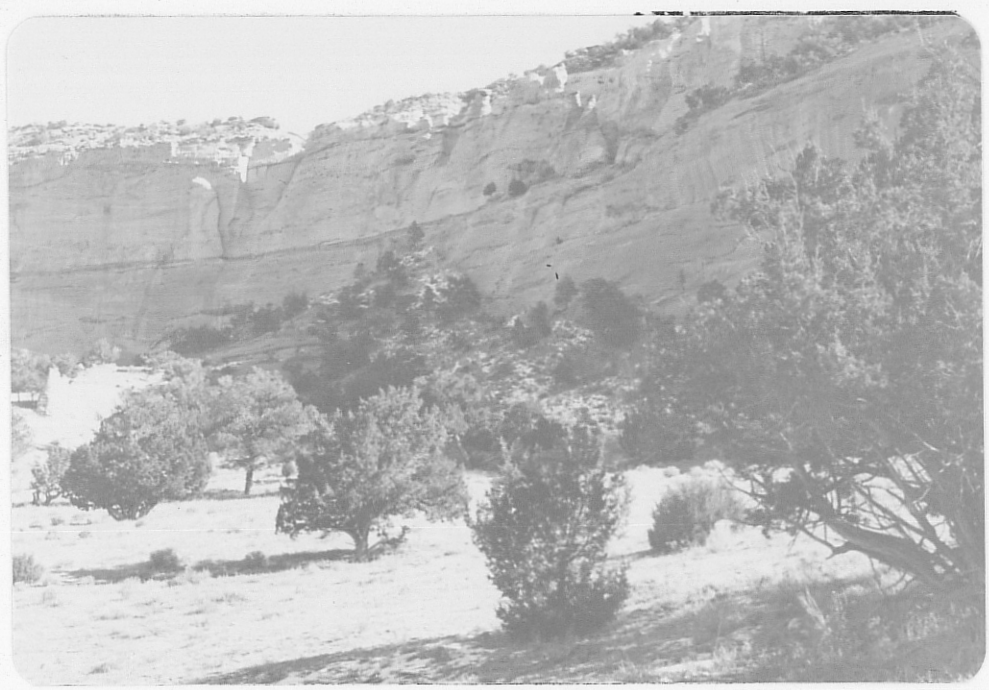
Photo (b) Looking NE at bluff on which the CD & S workings (circled) are located.

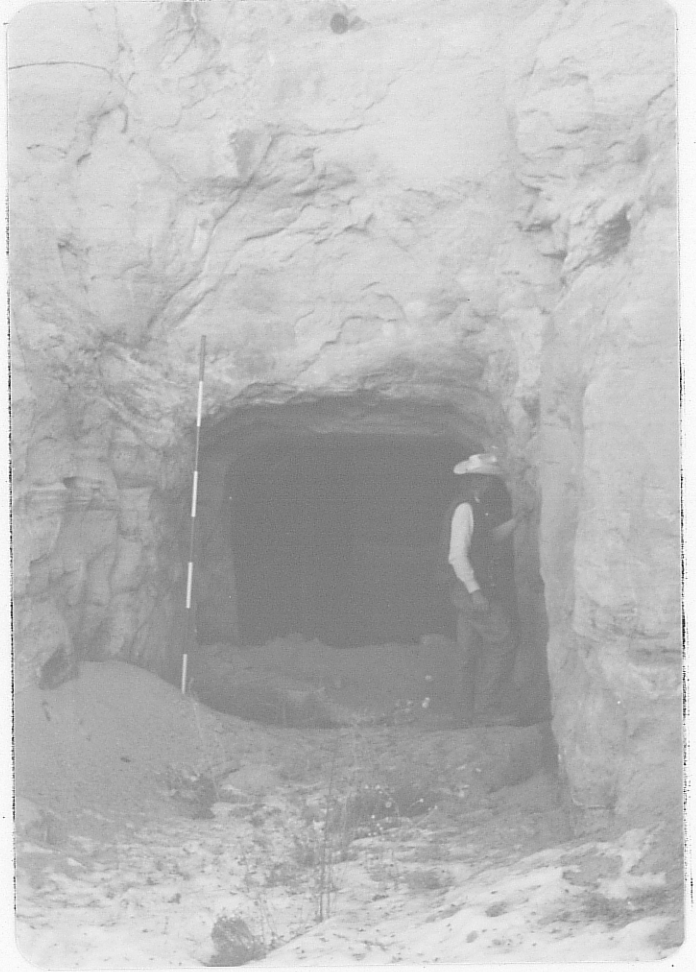
Photo (a) Foutz 3, looking southwest into eastern adit; a jog to left just inside leads to open stope. To right a drift leads to western workings.

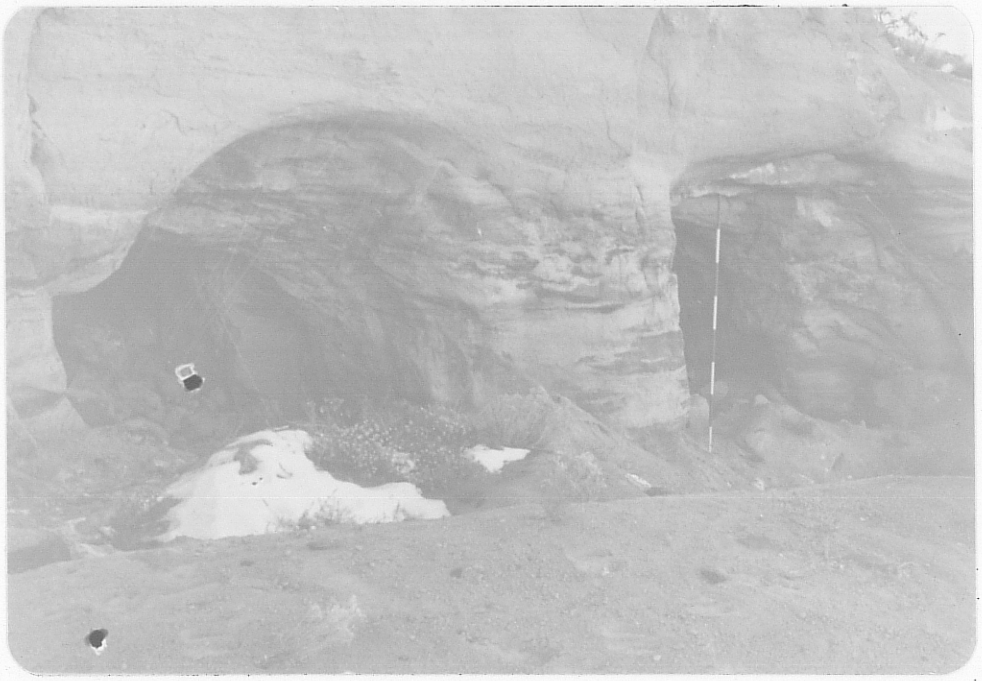
Photo (b) Foutz 3, looking southwest into middle two adits each about 8' high, 10' wide; note range pole for scale. Adits lead to western workings which are open stope and drifts.

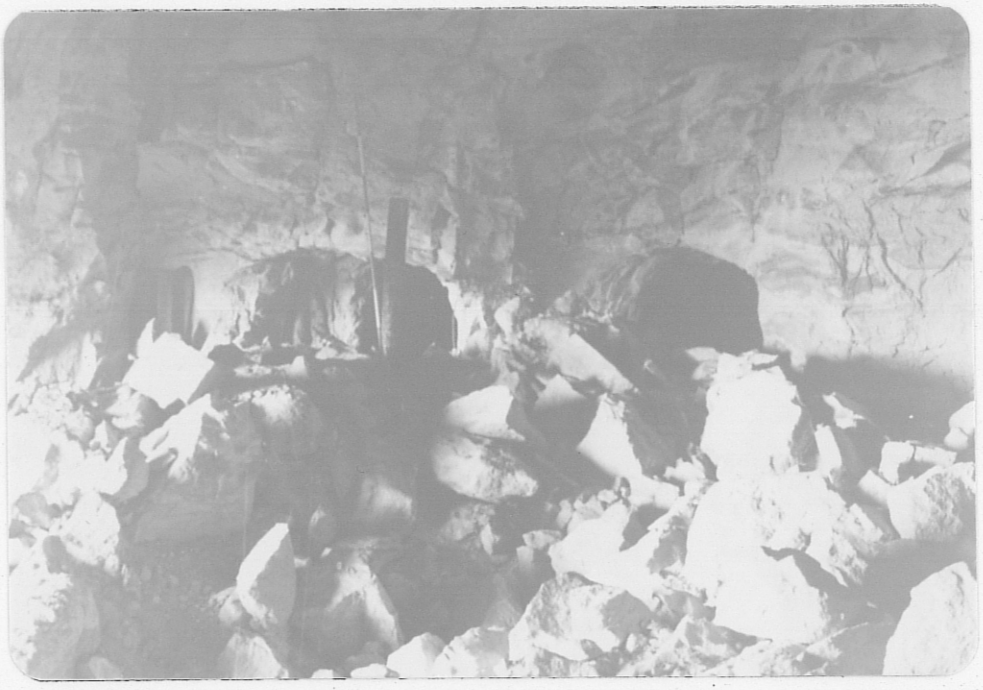
Photo (c) View southeastward inside western workings; note drifts at rear, and range pole left of center for scale.

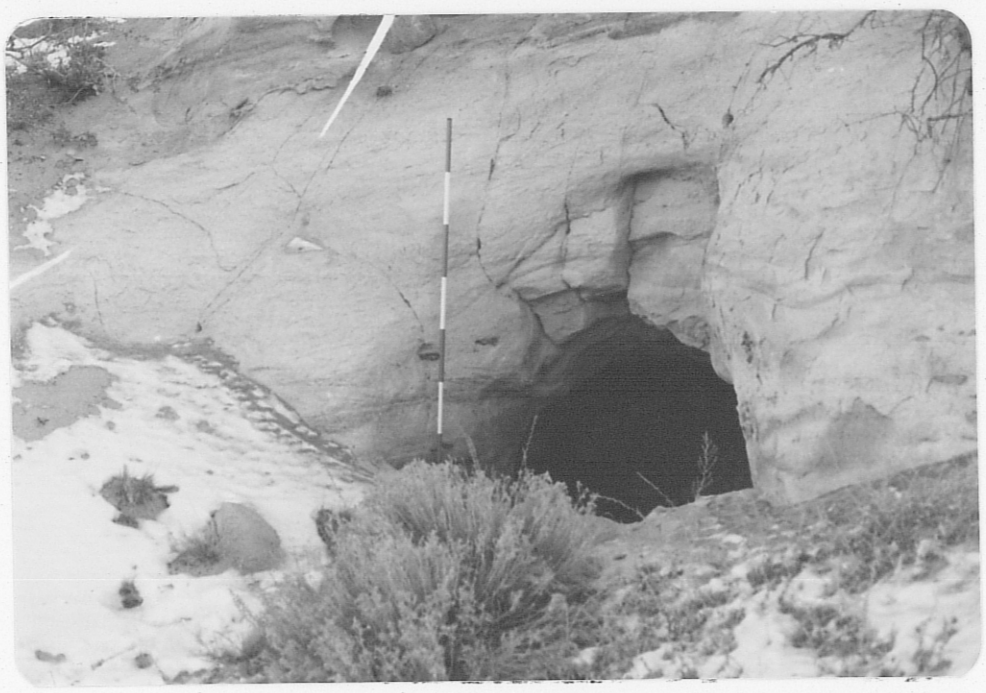
Photo (d) View eastward showing western entrance to open stope area shown in photo (c). Photo (c) was taken from a point just inside this entrance.

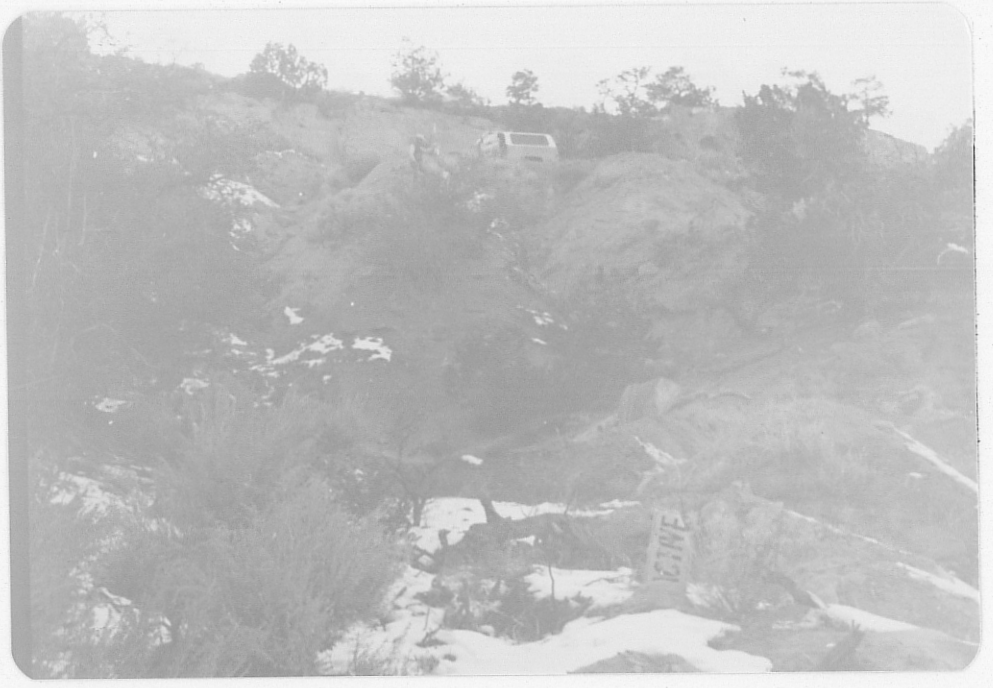
Photo (e) Mine dump just below eastern workings; note remains of sign warning of radioactivity at the site.

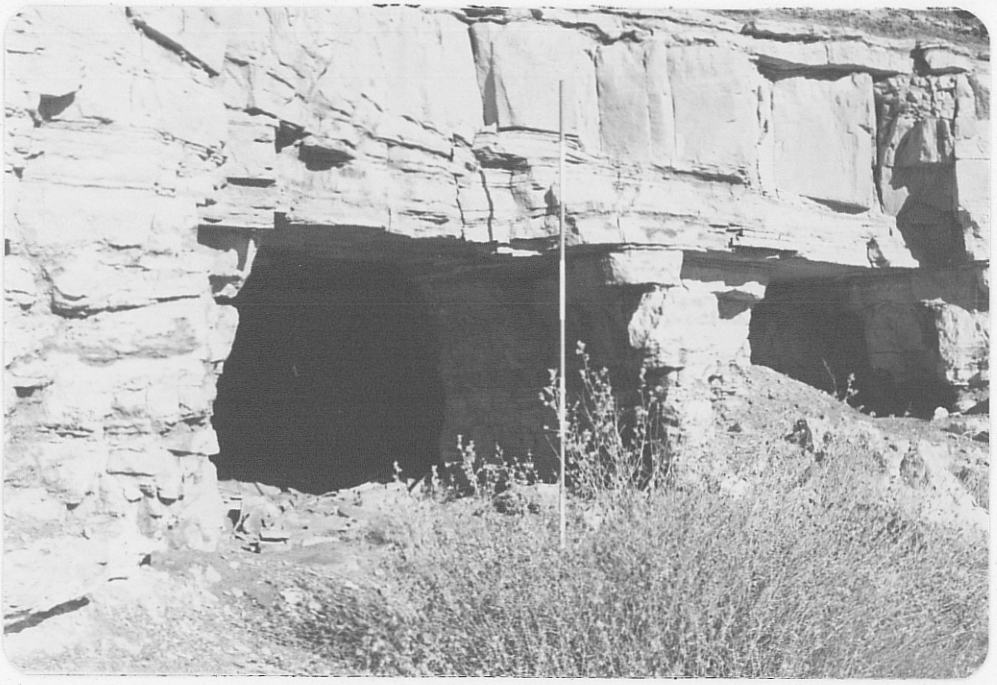
Photo (a) Looking northward into westernmost workings of Rimrock #2 group; entrance to main adit is 6' high; stub adit on right is only 3' deep.

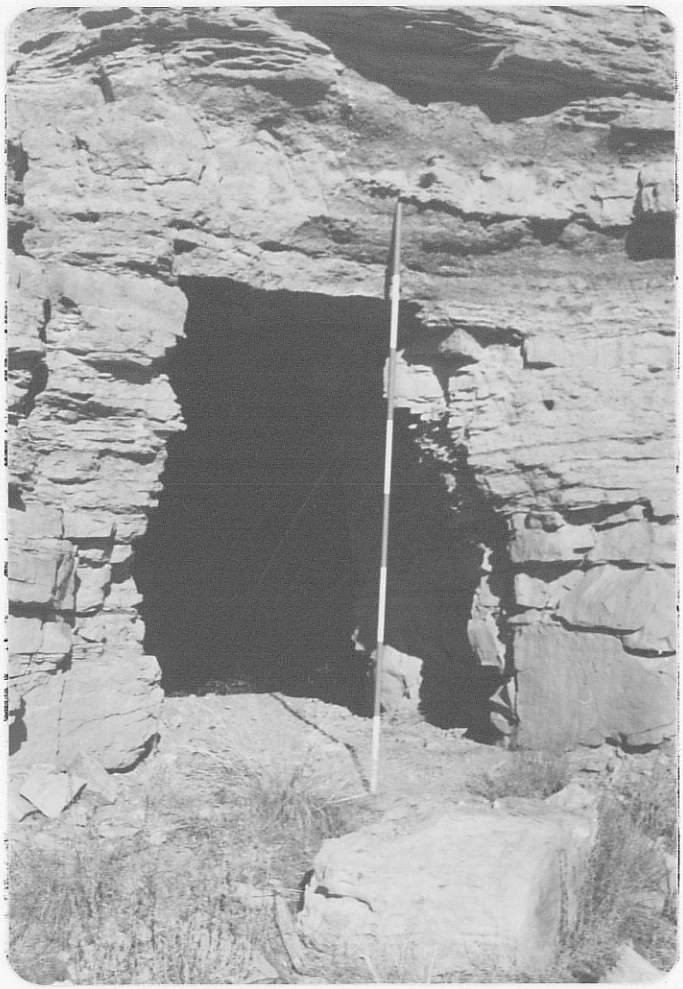
Photo (c) Next adit to east of workings shown in (a).

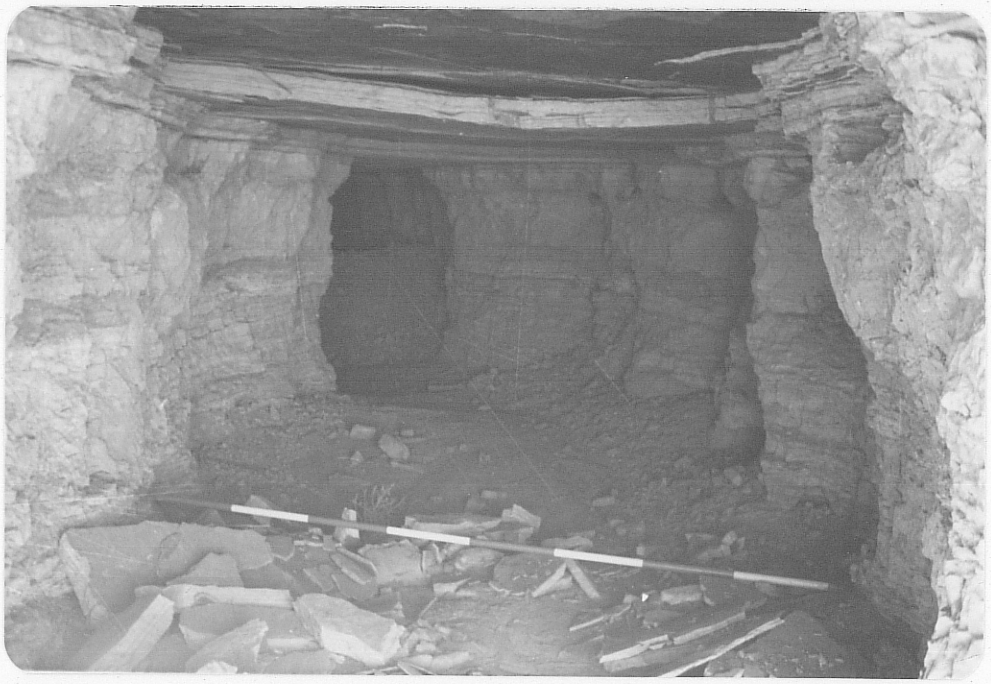
Photo (d) Interior view of adit shown in (c) above.
