# ABANDONED OR INACTIVE URANIUM MINES IN NEW MEXICO

A report of investigation carried out between August 1979 and May 1980 under contract with the New Mexico Energy and Minerals Department.

New Mexico Bureau of Mines and
Mineral Resources
Open-File Report 148

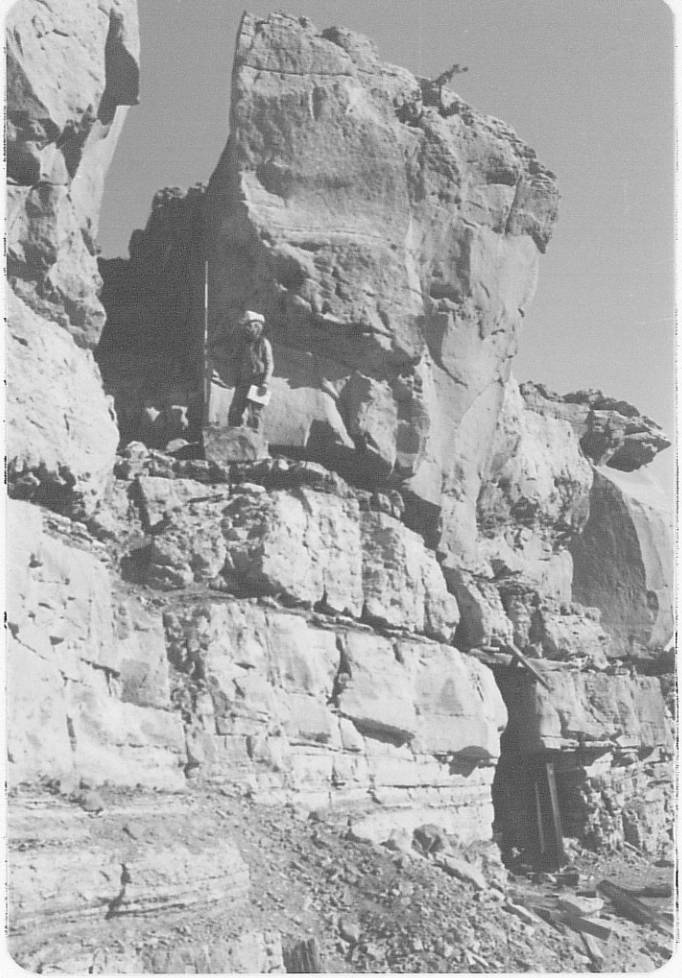
Photo (e) View northeastward at main adit showing portal at lower right and notched cliff for ore hoisting at upper left.

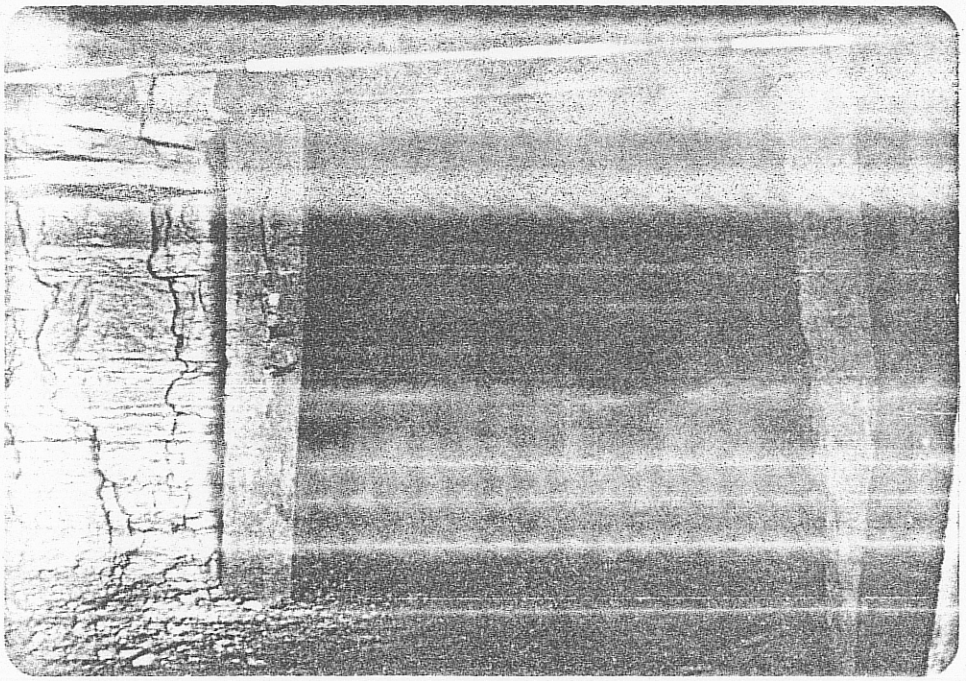
Photo (f) Interior view of main adit shown in (e) above; note range pole overhead for scale.

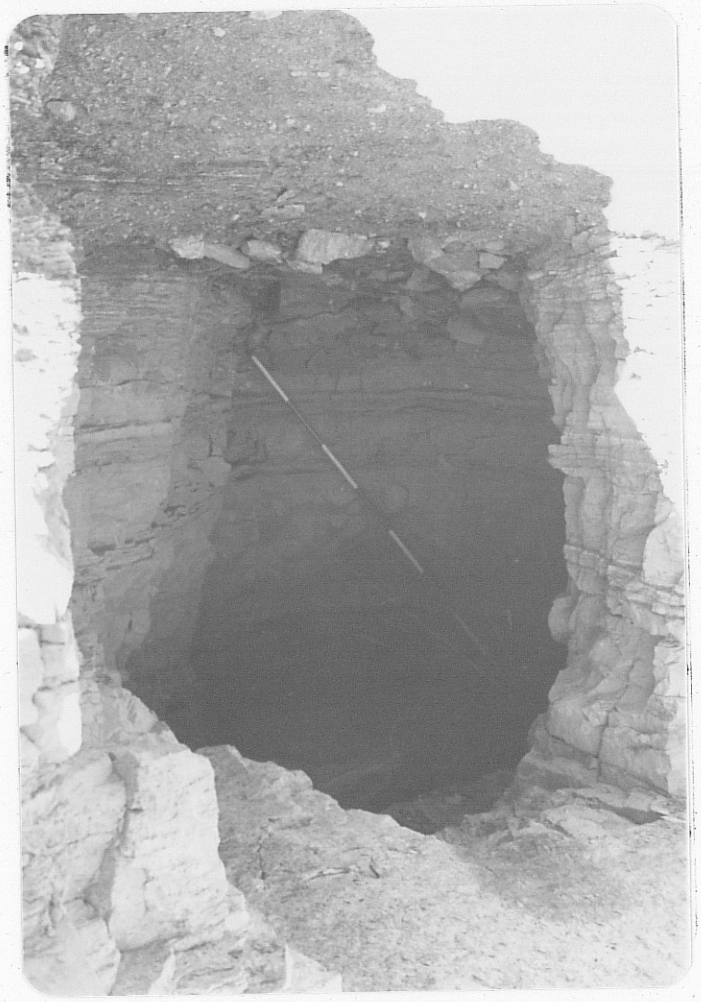
Photo (j) View northward into easternmost adit of the sec. 4 Rimrock workings.

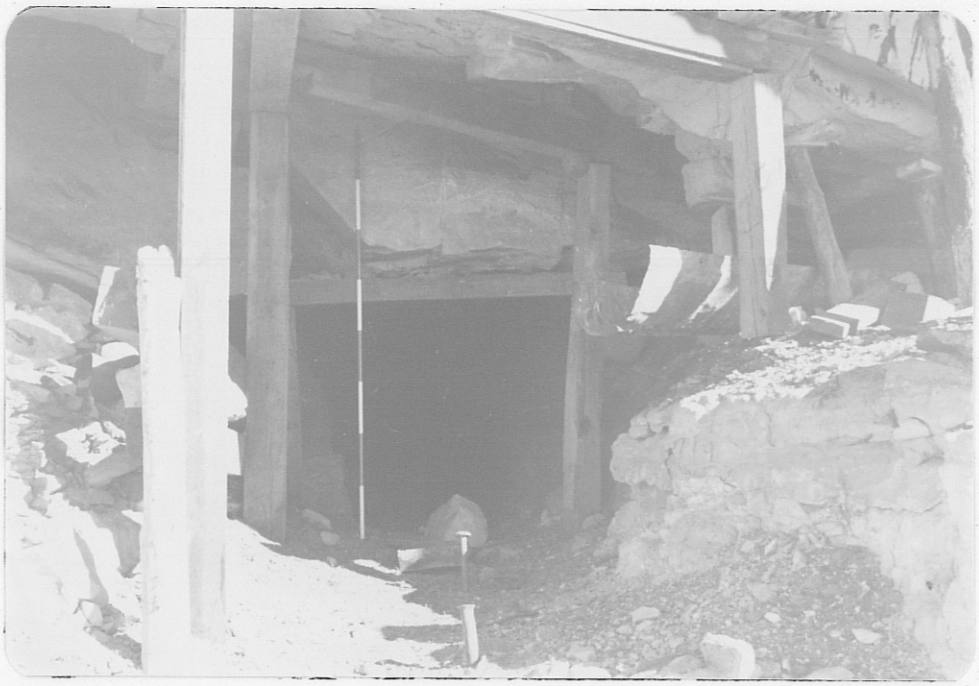
Photo (c) Looking NE at westernmost adit of the Santa Fe Christensen workings.

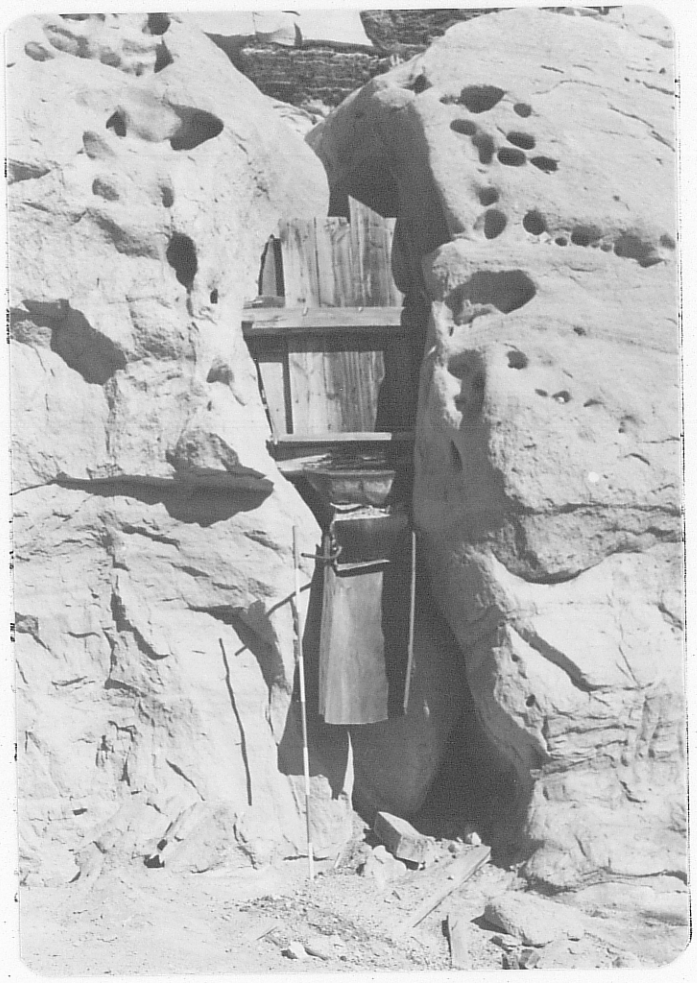
Photo (e) Looking north at the ore chute below the two Santa Fe Christensen adits.

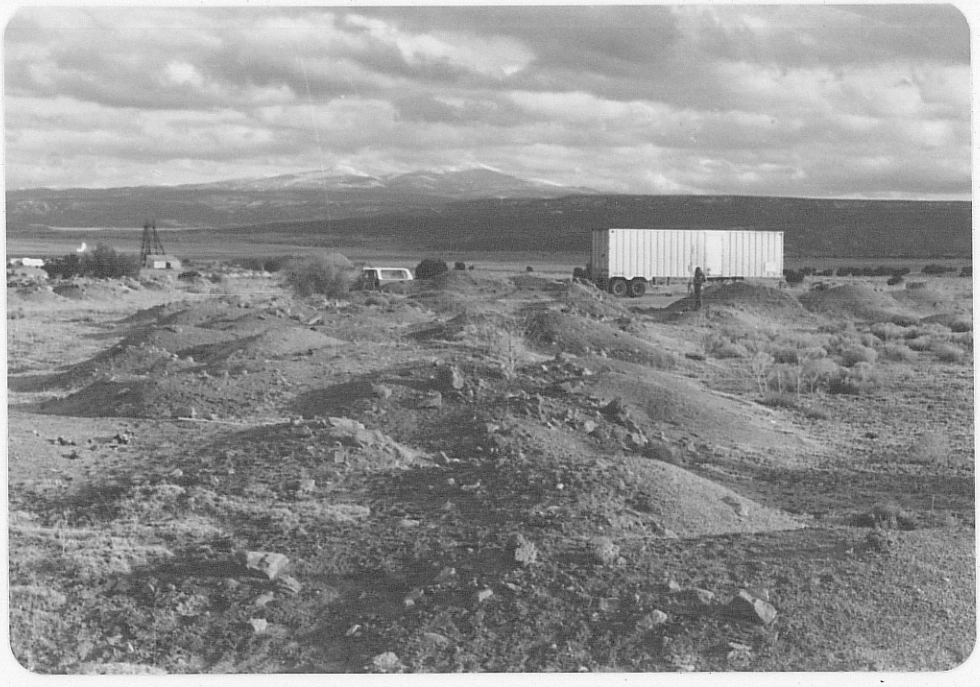
Photo (c) Looking northward at a dumping area just north of the mine shaft. Trailer rig is property of Koppen Mining Construction Co.; Mt. Taylor in background.

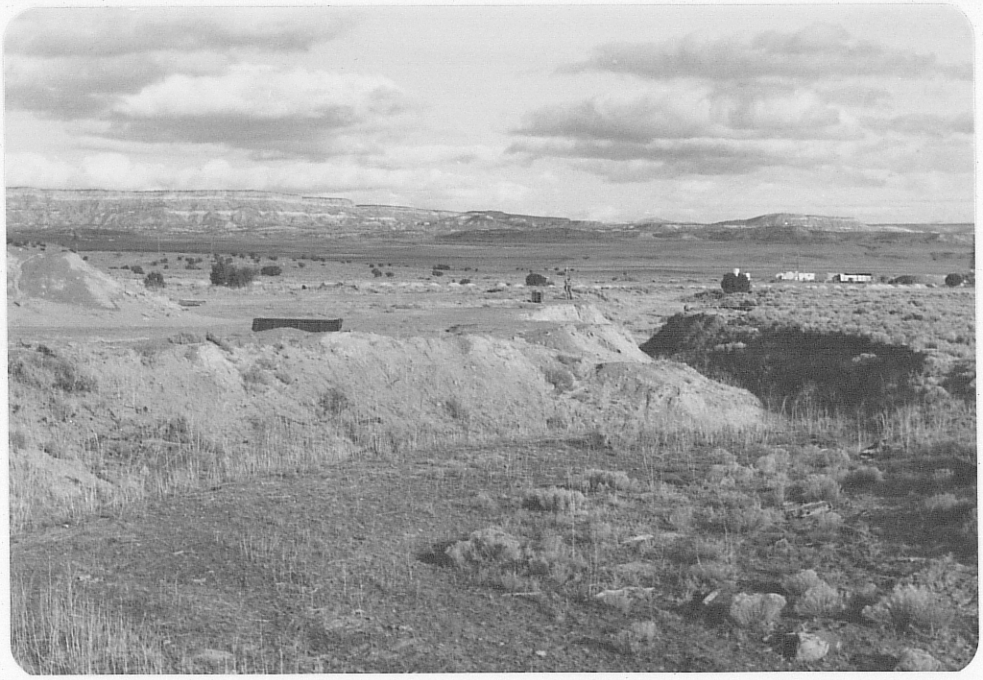
Photo (d) Looking eastward down small drainage that passes near southern edge of the dump area. Note person on left bank of drainage for scale.

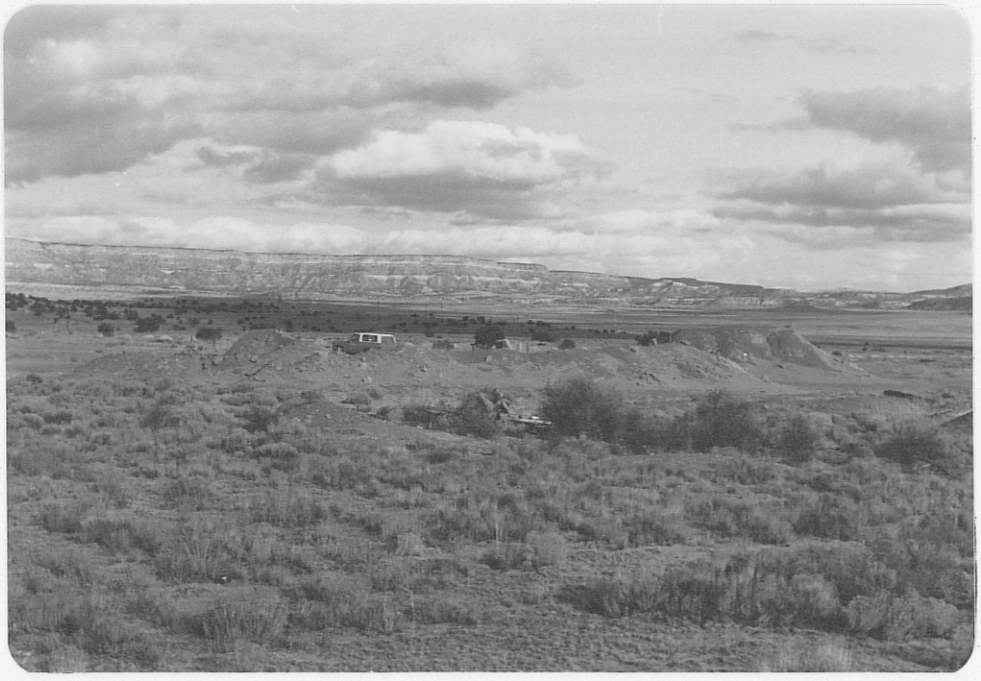
Photo (b) View northeastward of dump area on south and west sides of mine shaft; shaft location is to immediate right of vehicle in photo.

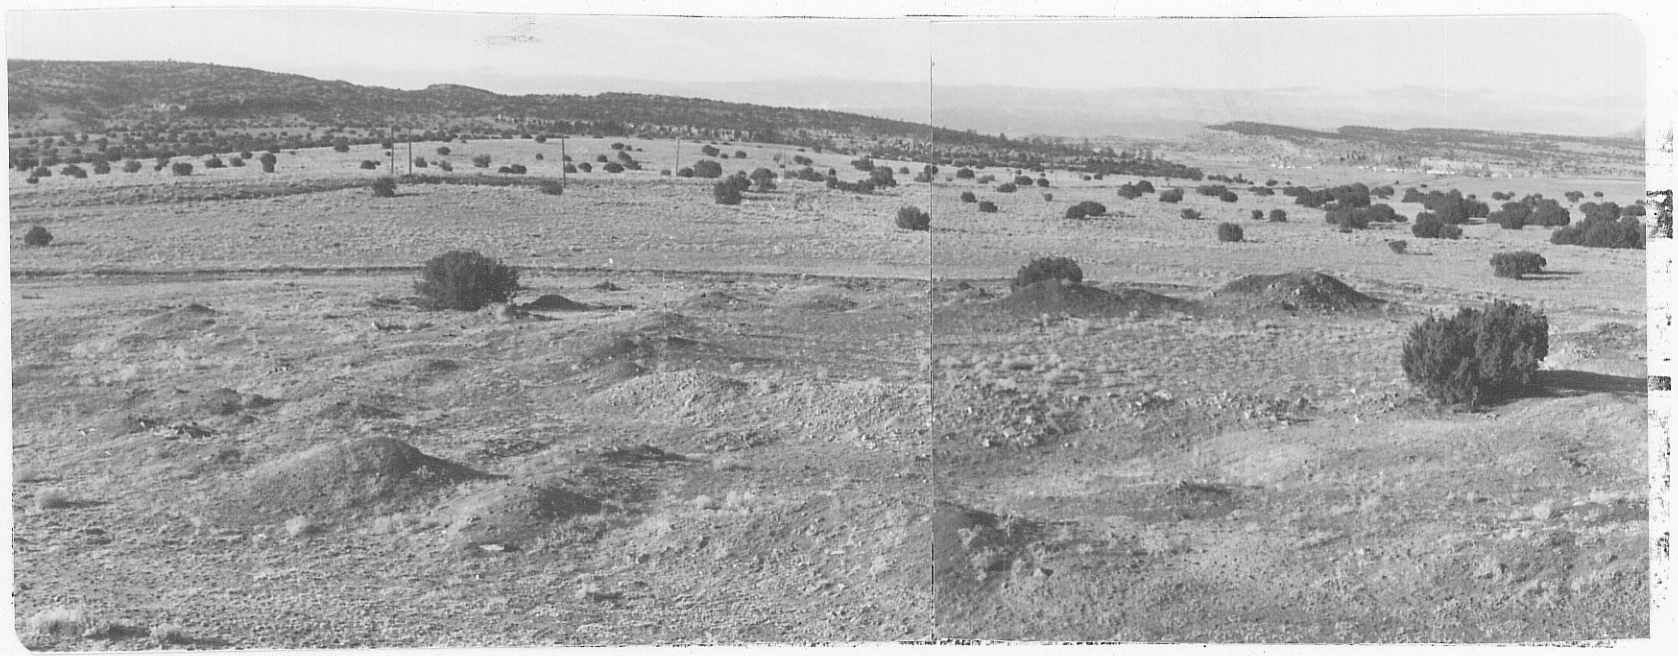
Photo (e) Looking westward showing dump area with small scattered 3'-4' high waste piles; area measures 220' N-S, but there are patches within that have no waste material. Ambrosia Lake junction (numerous light colored buildings) is visible at right in the distance 1¼ mi. away; note range pole at left of center for scale.

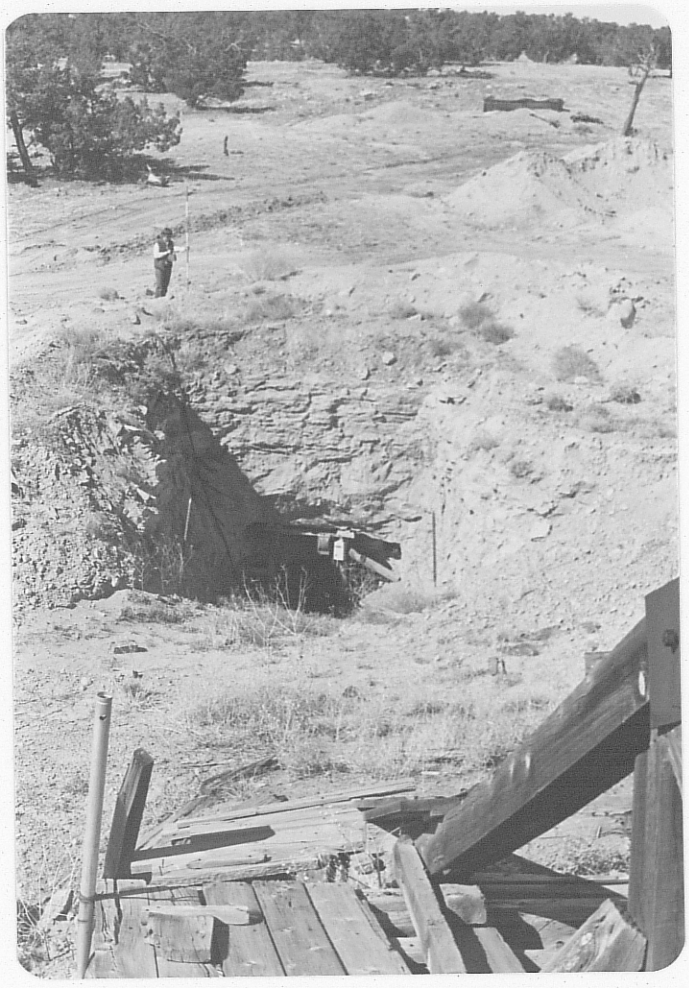
Photo (a) Looking westward into Gossett Incline from the headframe; it is presently in use as upcast air ventillation shaft for Poison Canyon Mine.

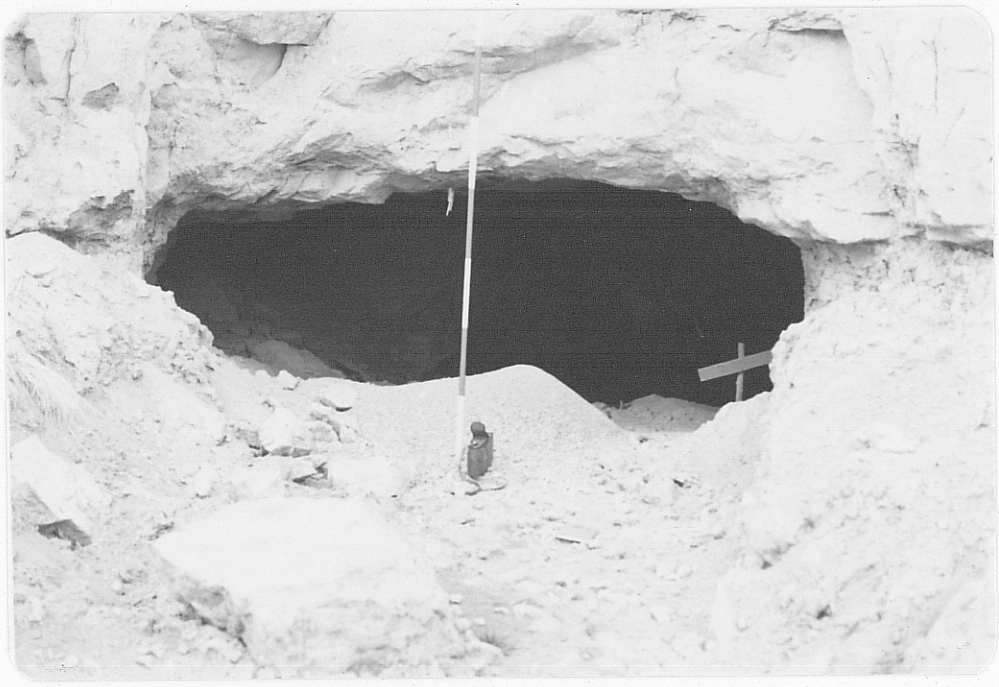
Photo B Looking northward at second adit 85' west of A; portal is 4' high, 9' wide and tunnel continues on a N 25° W trend for at least 100'.

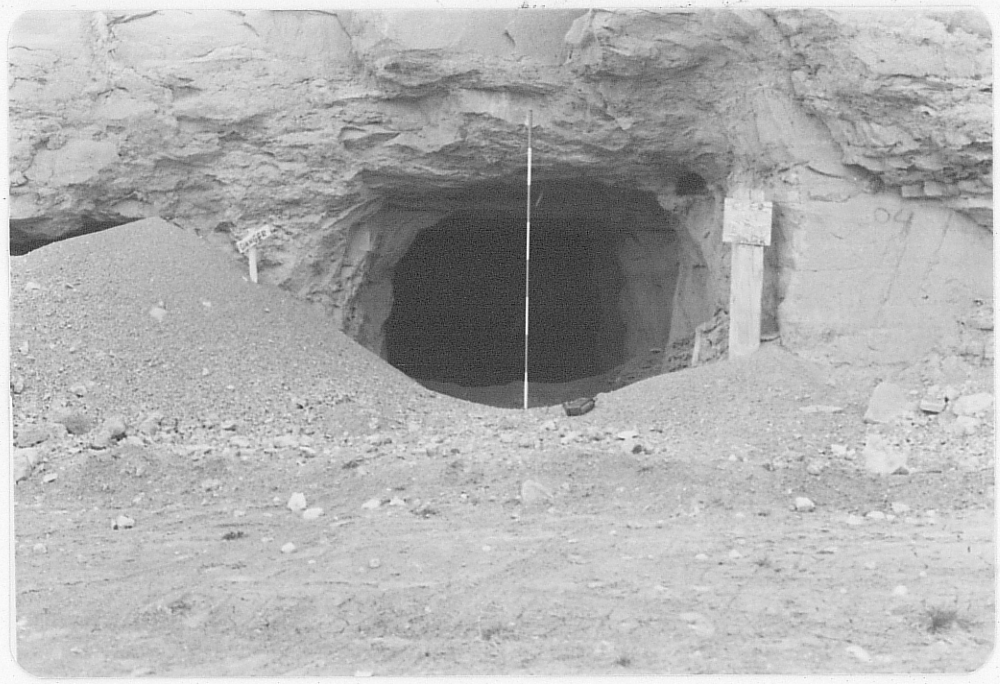
Photo C Looking northward at 3rd adit going west; portal is nearly 6' high, 7' wide, and continues on a N 15° W trend for as far as light goes (at least 75').

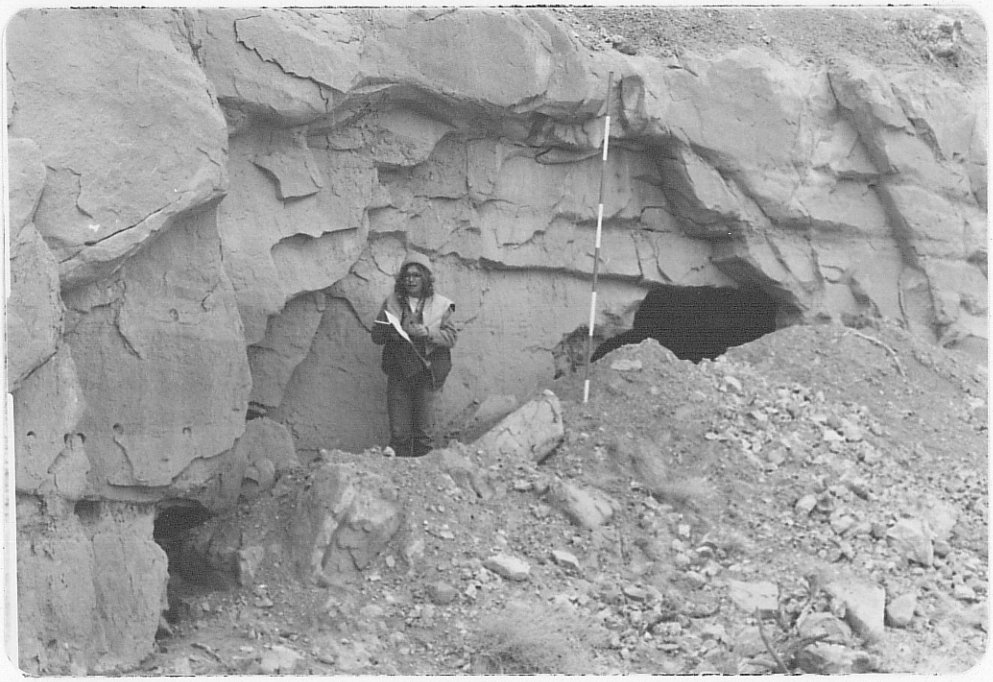
Photo D Looking northward at 4th workings in series, 200' west along outcrop from No. 3 in C; probably consists of a pair of gopher holes, each about 3' deep, but left one has caved or has been blasted.

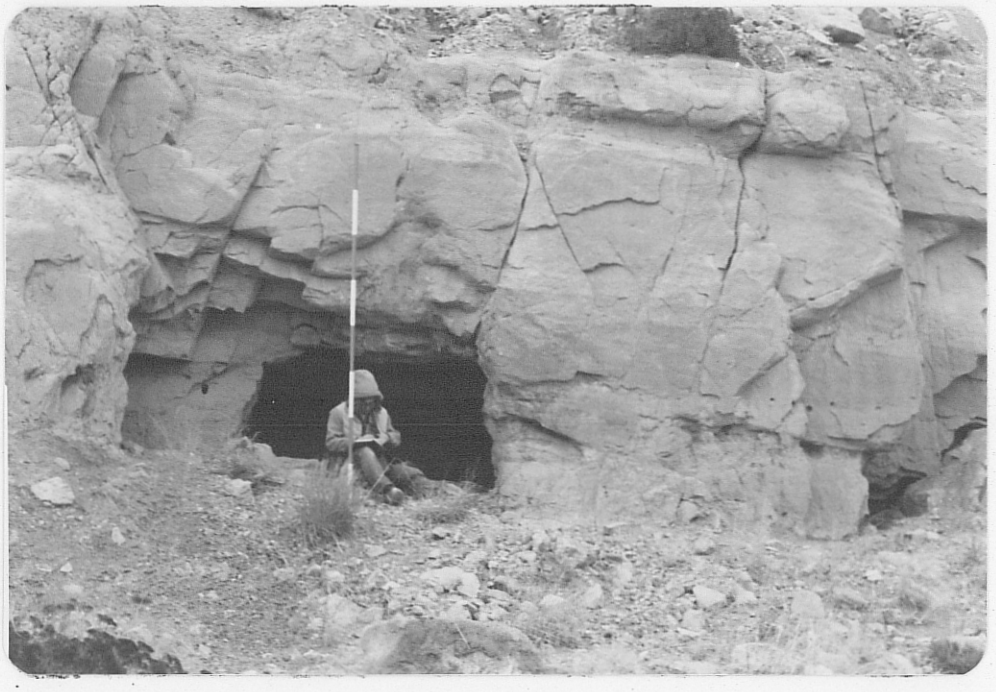
Photo E Looking northward at 5th workings, 15'-20' west of No. 4 shown in D; portal is 4' high, 6' wide, but adit is a stub going in only 4'.

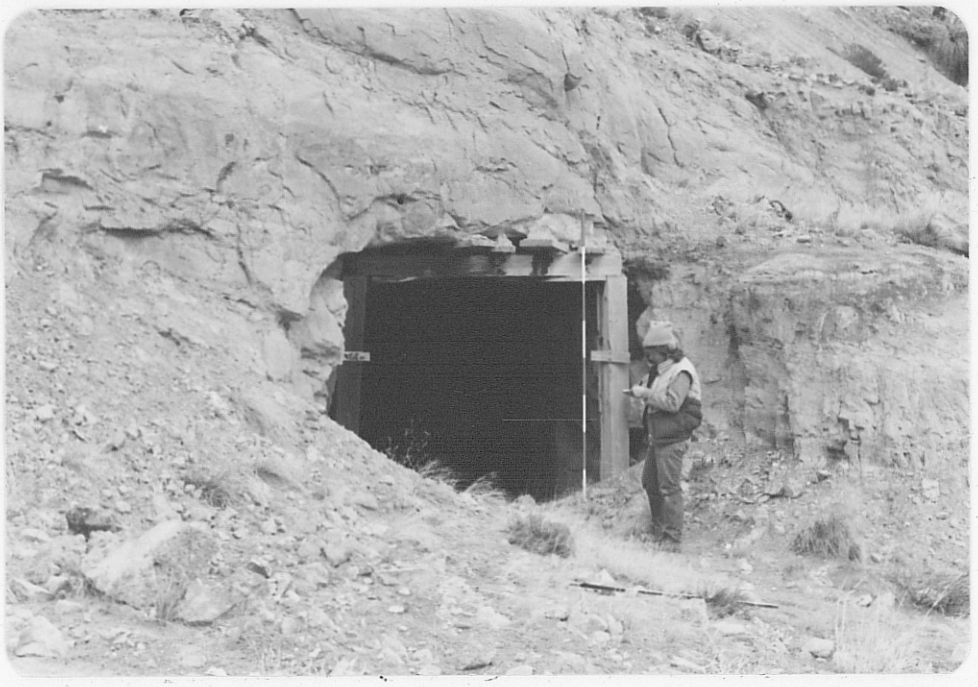
Photo F Looking northward at last or westernmost adit on Blue Peak workings, 85'west of stub shown in E. Portal is 7' high, 8' wide, and adit continues on a N 15° E trend for at least 75' at which point there may be some room and pillar structures.

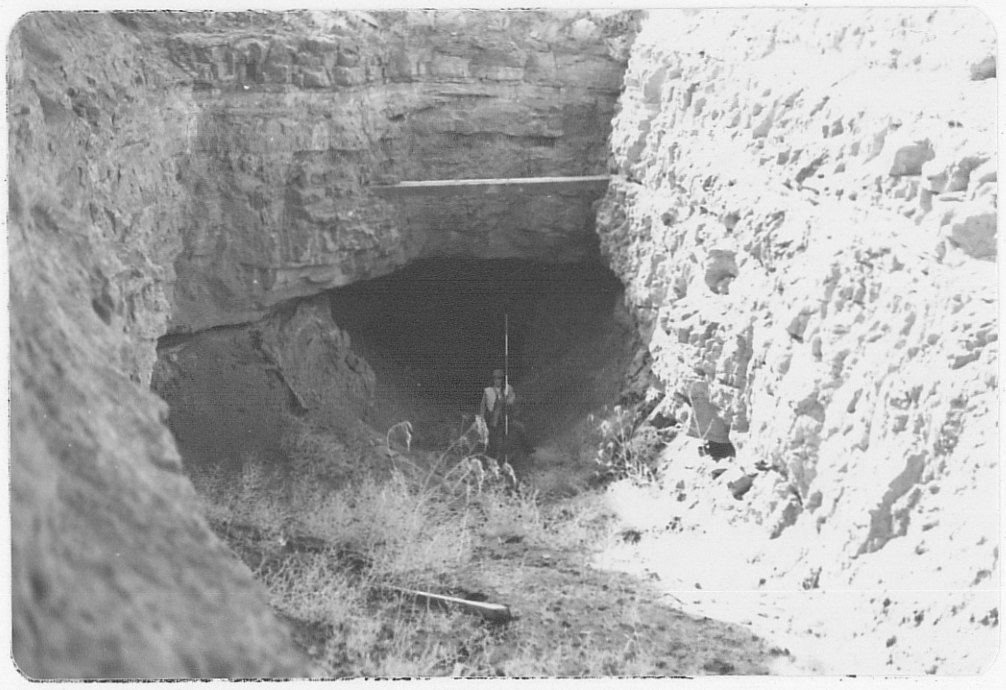
Photo (b) Close-up of decline shown in (a); portal is about 10' high, 14' wide.

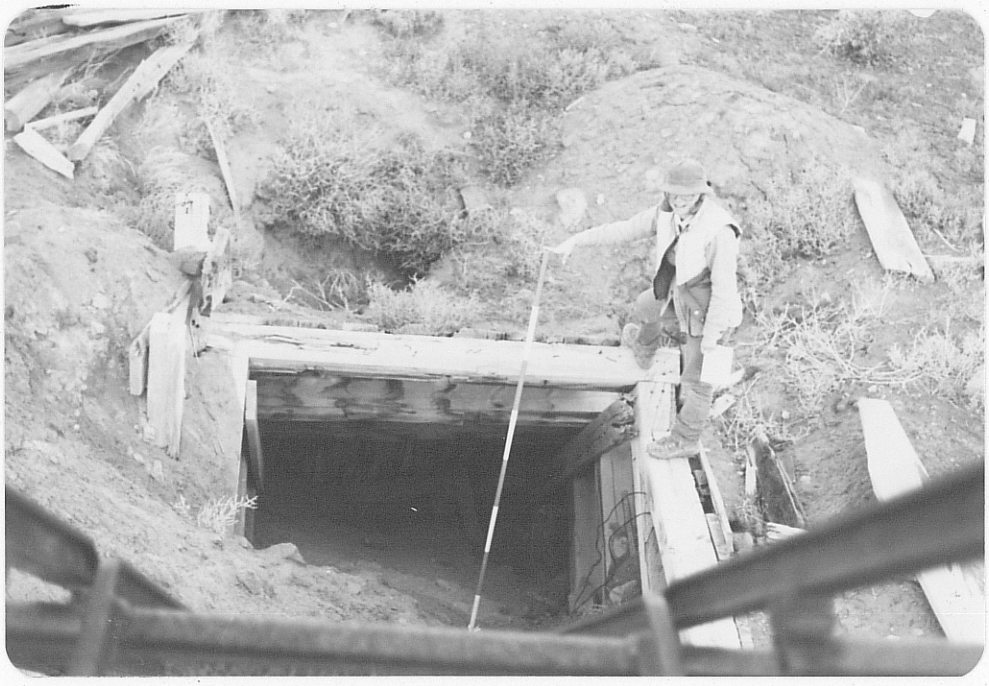
Photo (f) Close-up of inclined shaft shown in (e).

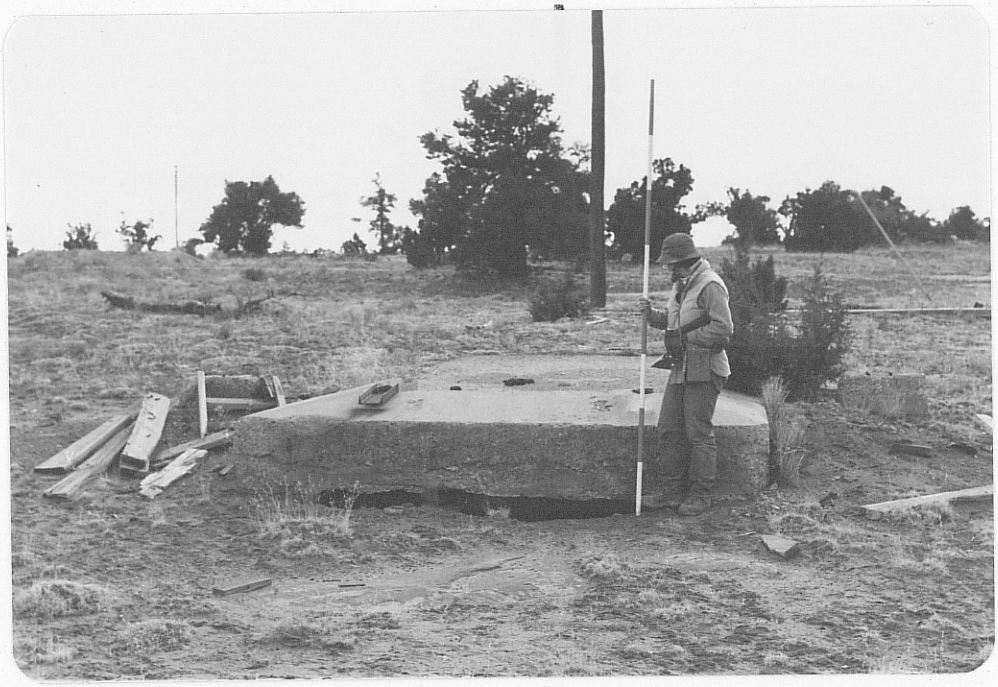
Photo (L) Close-up of raise shown in (k); some erosion around base of concrete covering is noticeable on north edge.

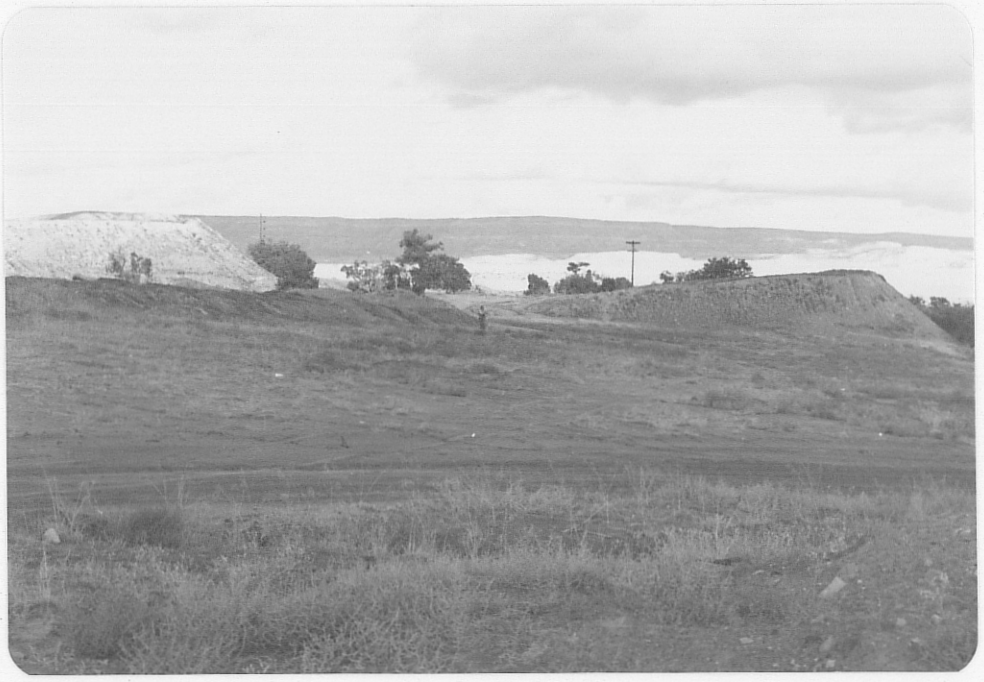
Photo E Looking northward at the two ramp shaped mine dumps; one on right (east) extends nearly to small drainage line. The one on the left (west) is about same size and is shown from other direction in F below; note person at center for scale.

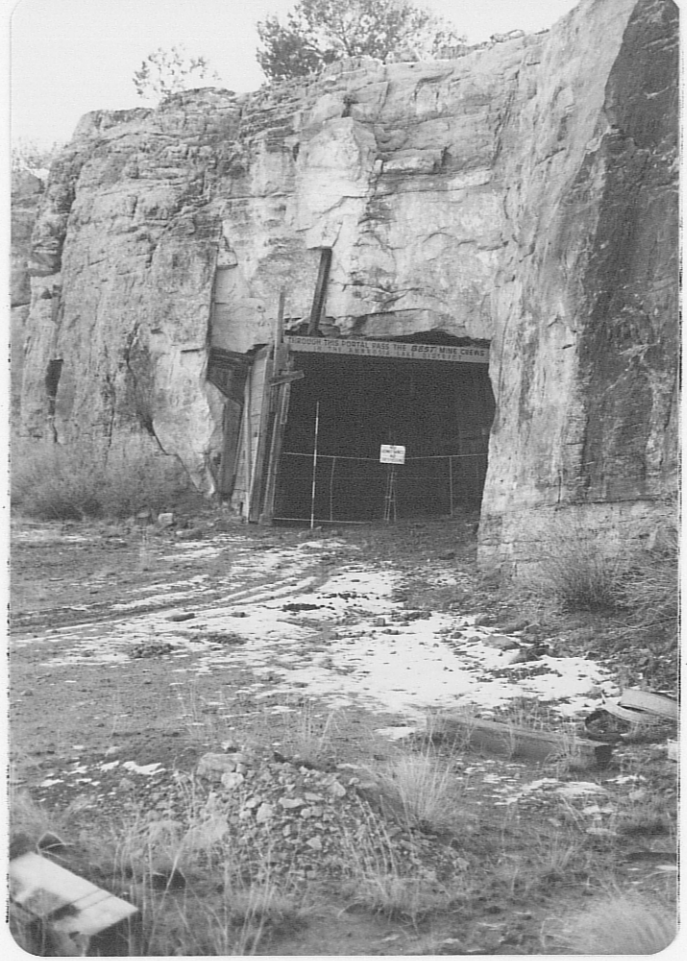
Photo (a) Portal of Marquez Mine in vertical cliff of Dakota Sandstone.

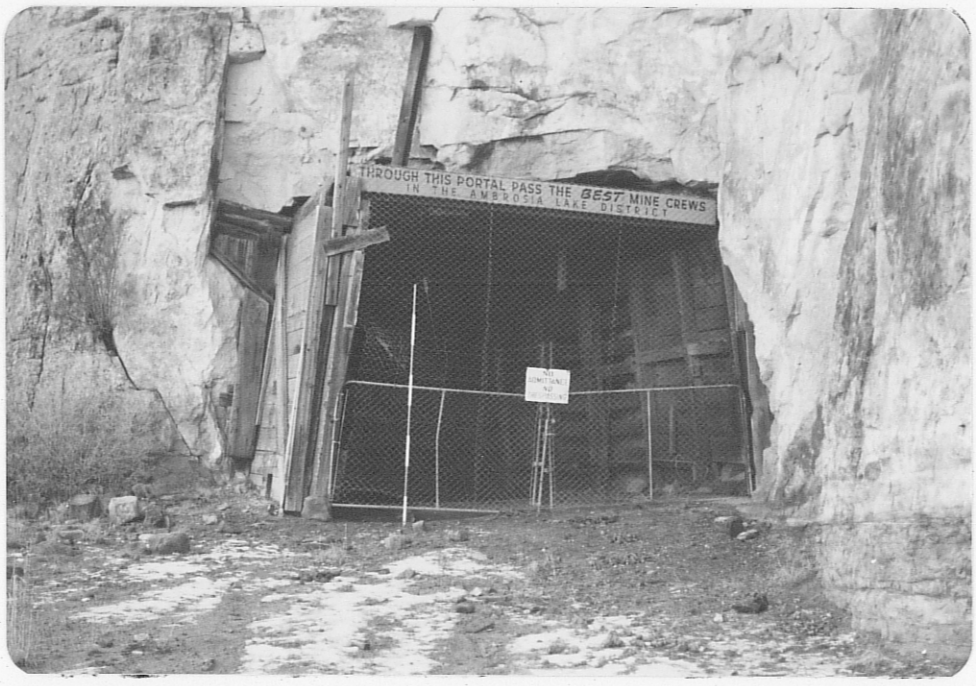
Photo (b) Close-up showing 11' by 15' portal secured by wire mesh gates; vertical timbers are 4" x 6", back is metal I beams crosswise with timbering lengthwise overlying. Note range pole for scale.

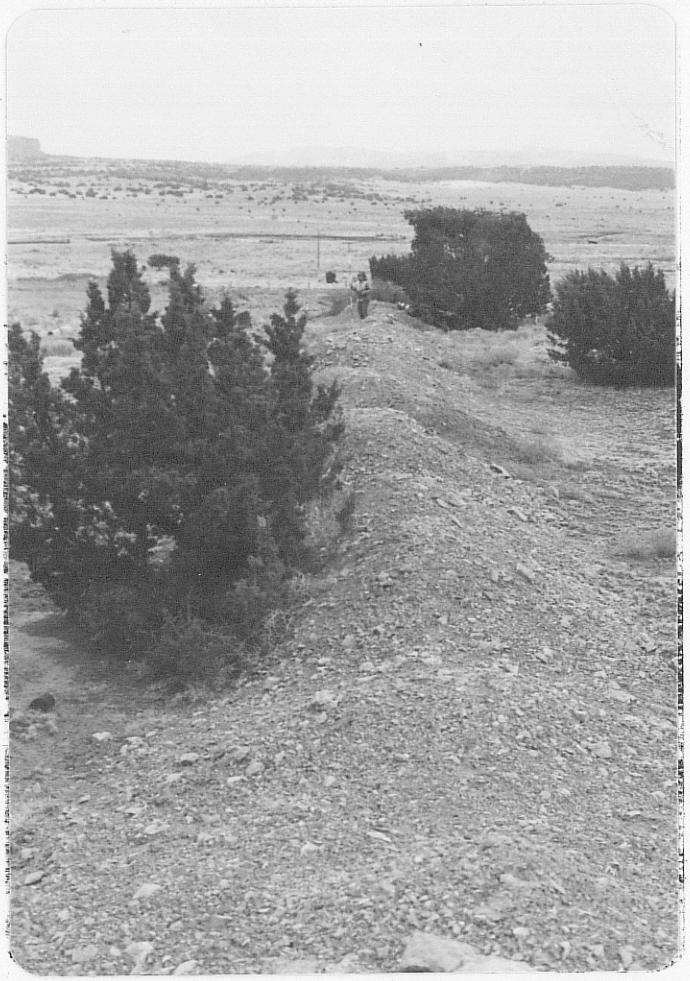
Photo E Looking SE at 4' high 200' long mine dump or low grade ore; dump extends NW of hoisting shaft.

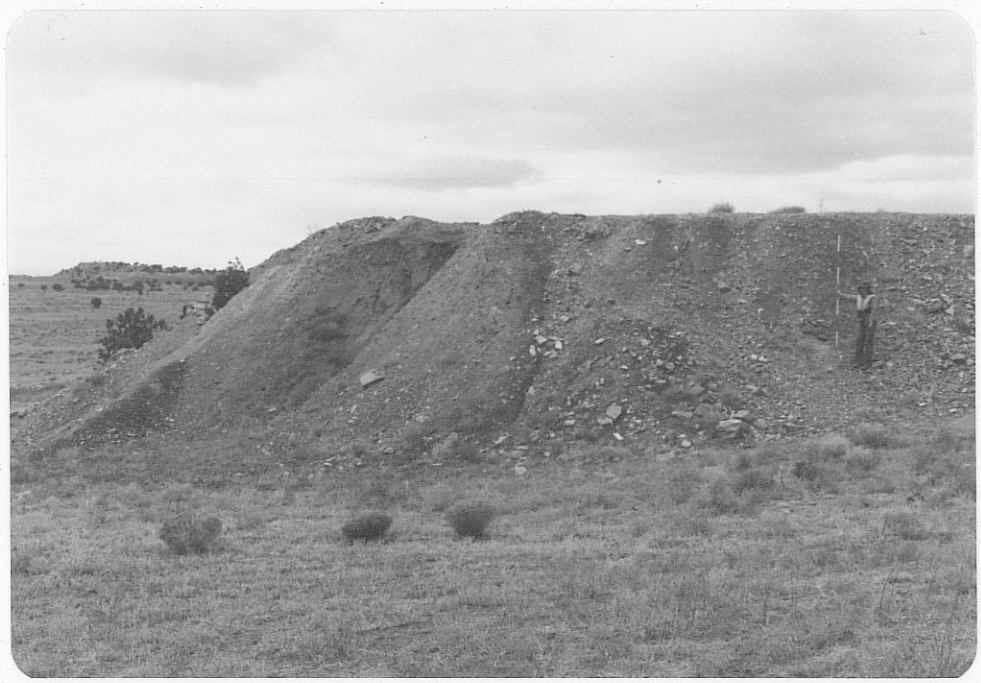
Photo F Main dumping area for hoisting shaft; waste forms only veneer on rock cored natural feature.

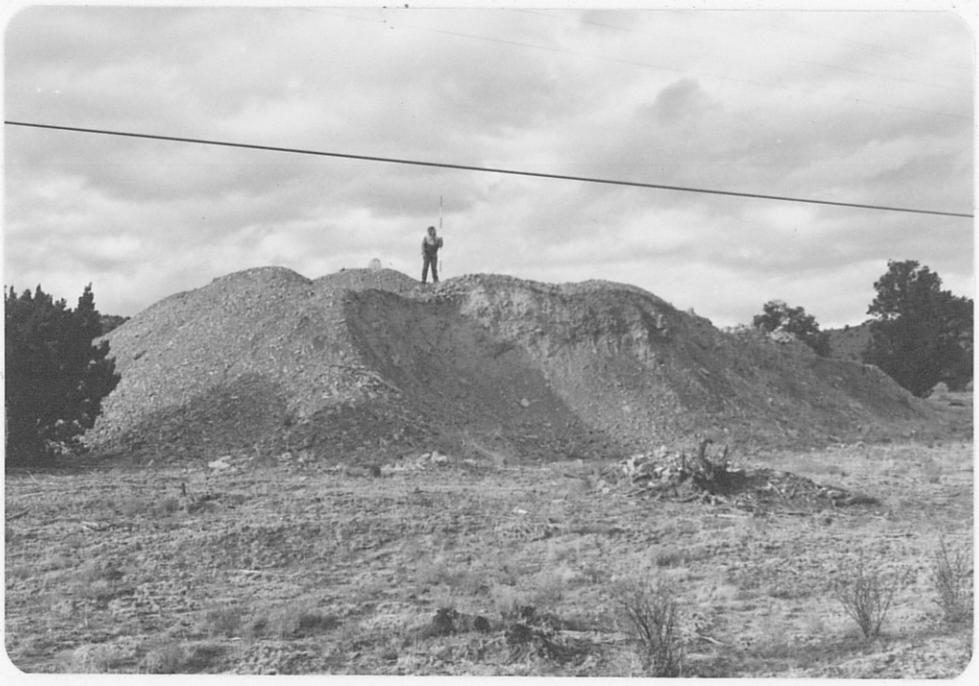
Photo B Looking northward at mine dump, here nearly 20' high; upper surface slopes gently to north.

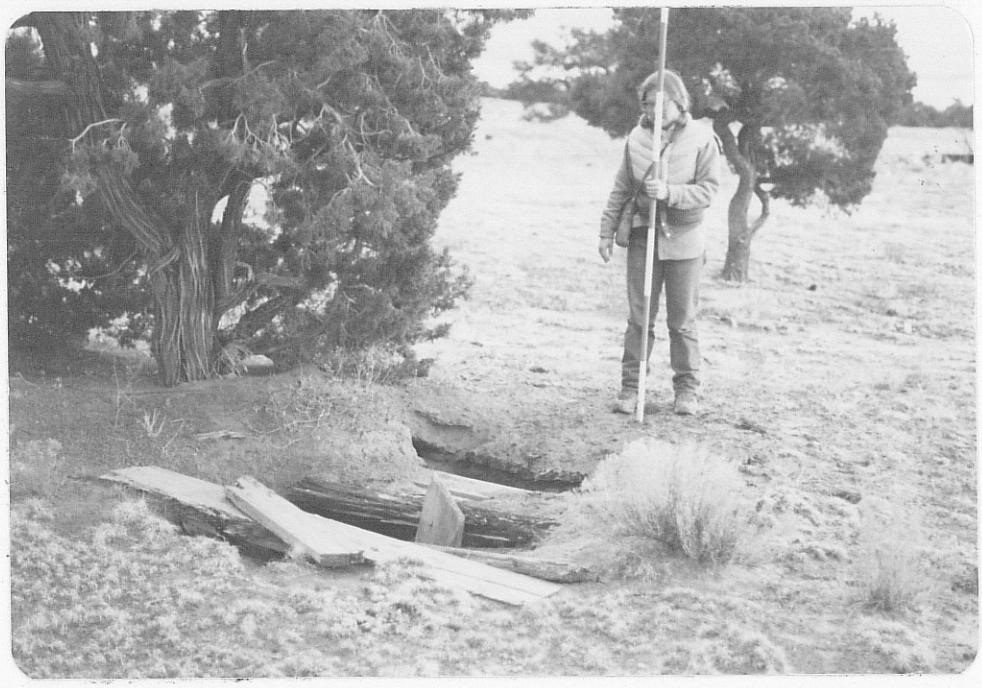
Photo C Small 4' x 4' backfilled shaft with wooden collar about 100' south of mine dump.

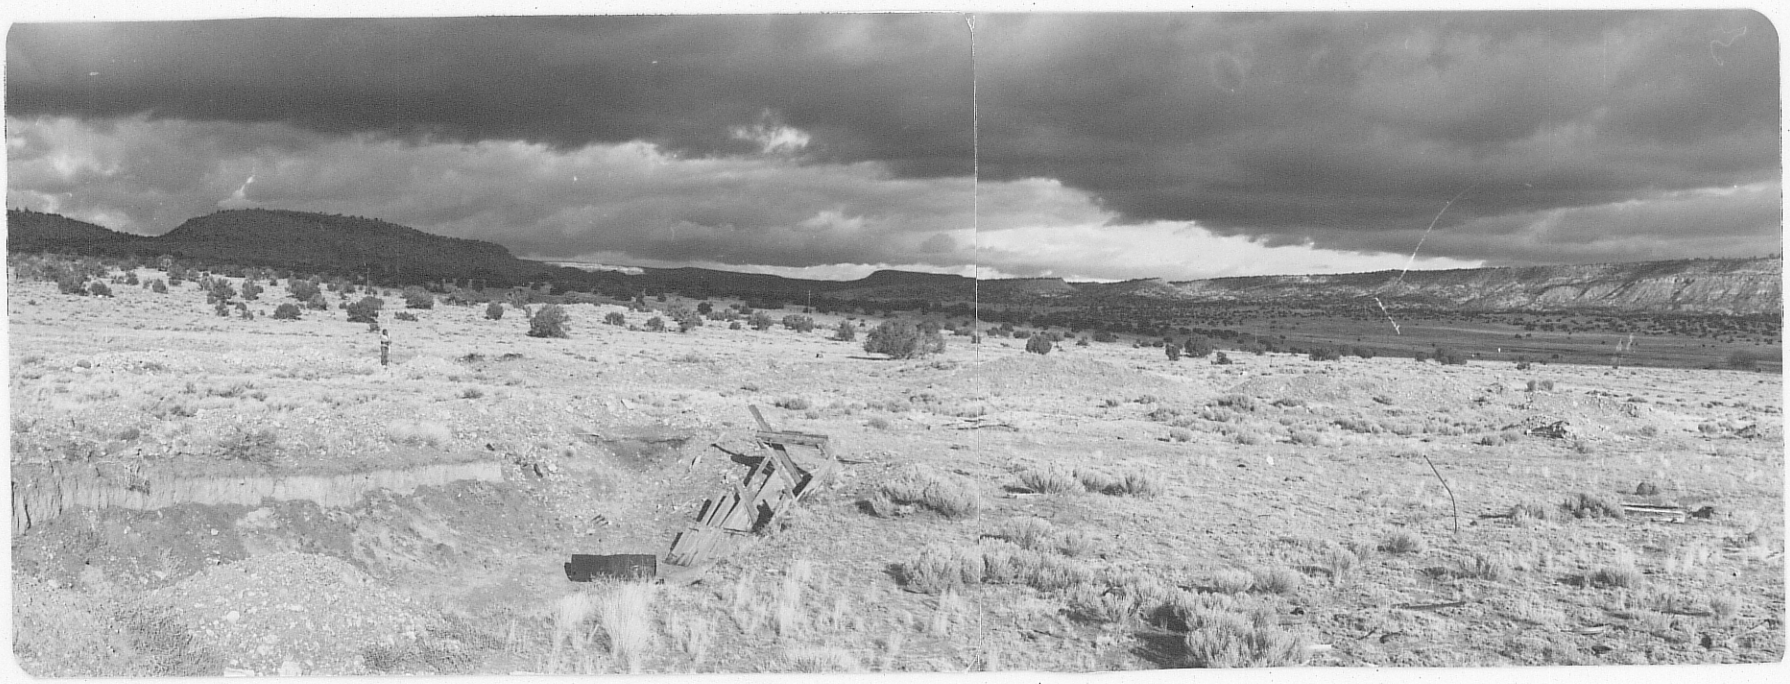
Photo (c) Looking northeastward at Flat Top Mine site showing (1) entrance to 30° incline (wooden framing) going off to left, (2) the small box cut just behind entrance to incline, and (3) scattered waste piles extending from left to right across picture in middle distance, note person at left for scale.

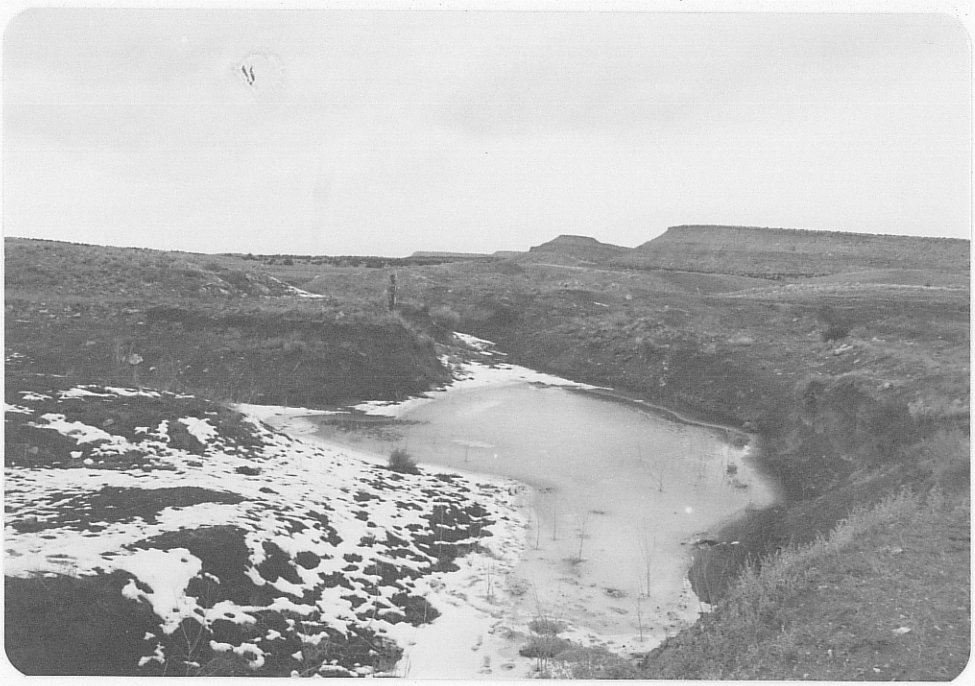
Photo (c) Shallow pit southeast of trench in (b), containing meltwater. Livestock tracks noted in area. Note person at left of center for scale.

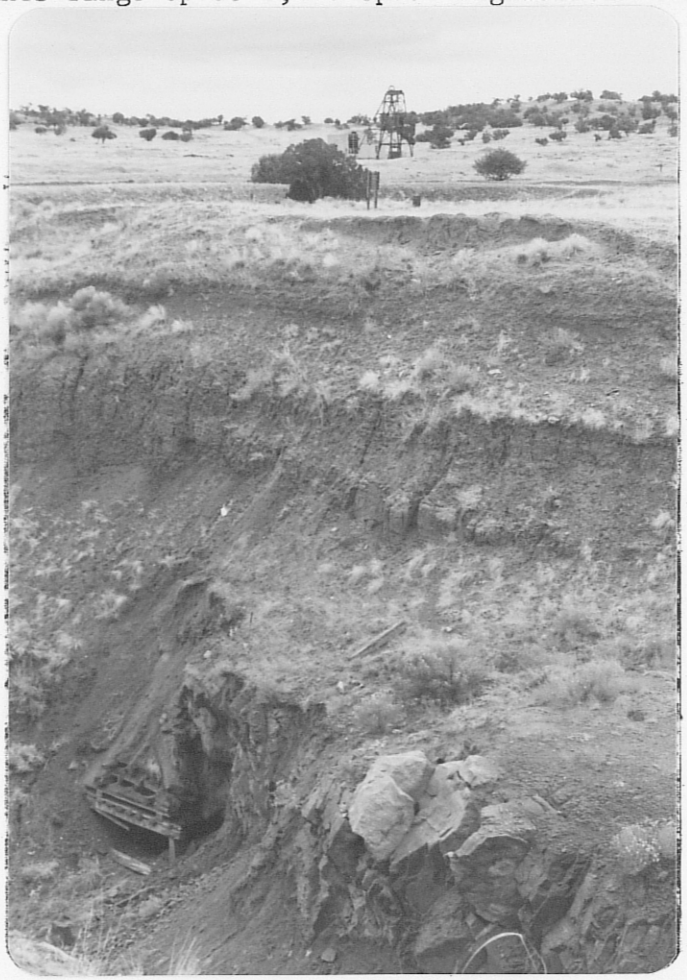
Photo (d) Looking northward into box cut with decline driven eastward at bottom. Close-up of decline is given on next page. Note section 25 head frame in background 1,000' away.

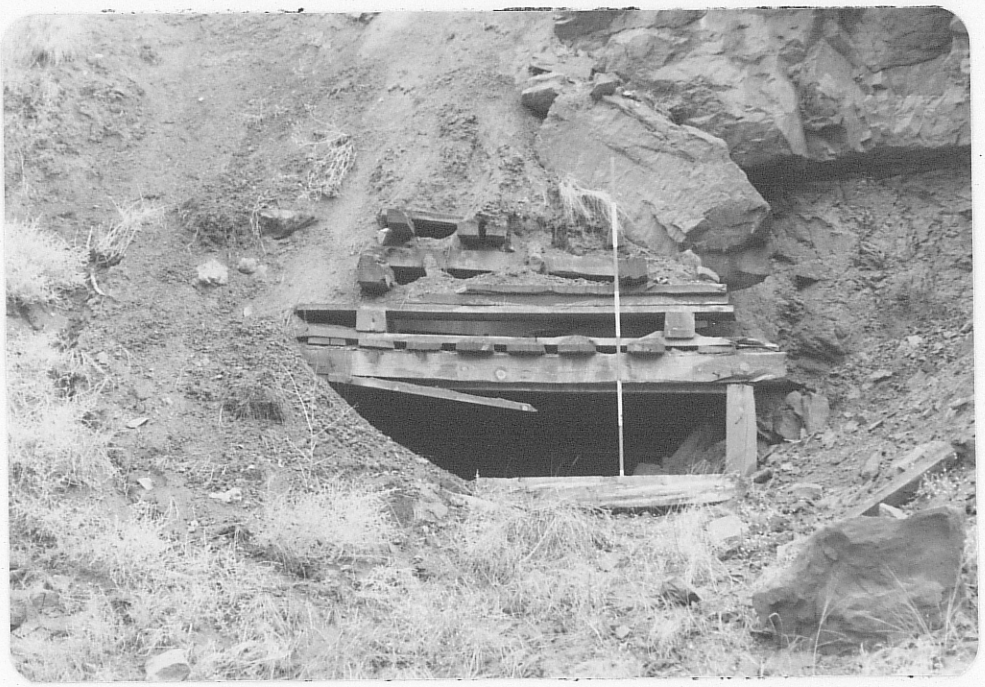
Photo (e) Close up of decline show in photo (d); present opening is less than 3' high. Note range pole for scale.

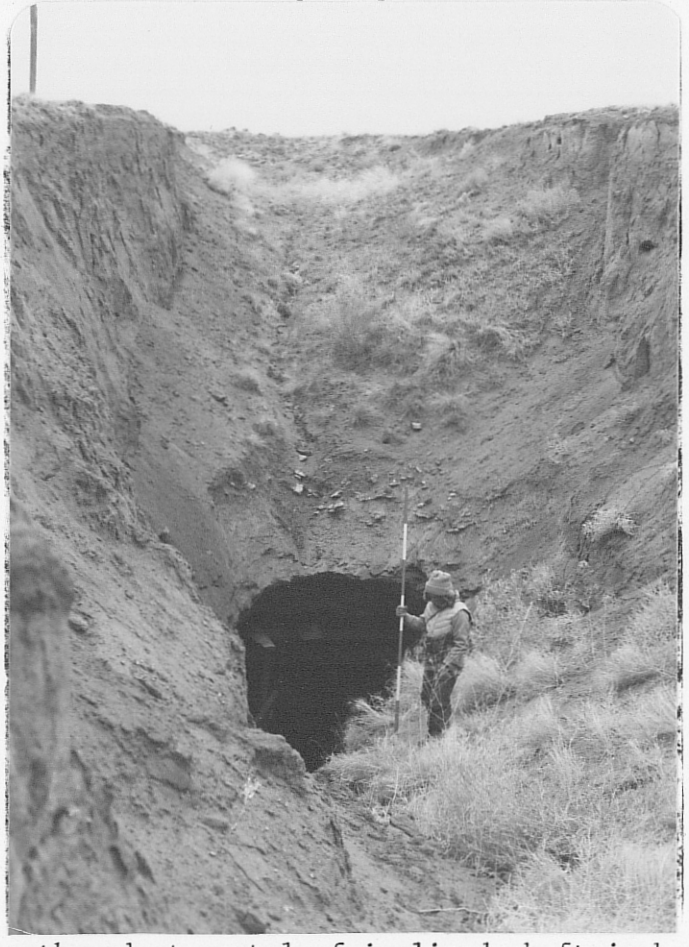
Photo (b) Looking southward at portal of inclined shaft in bottom of box cut.

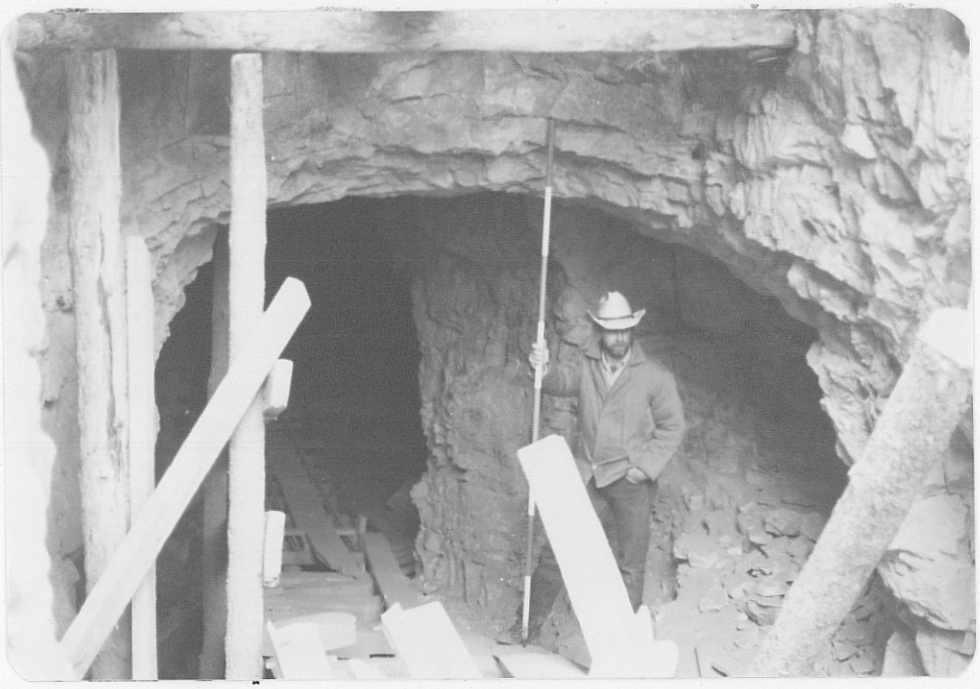
Photo (c) Inside portal of inclined shaft showing timbering and tracked haulage way.
