# ABANDONED OR INACTIVE URANIUM MINES IN NEW MEXICO

A report of investigation carried out between August 1979 and May 1980 under contract with the New Mexico Energy and Minerals Department.

New Mexico Bureau of Mines and
Mineral Resources
Open-File Report 148

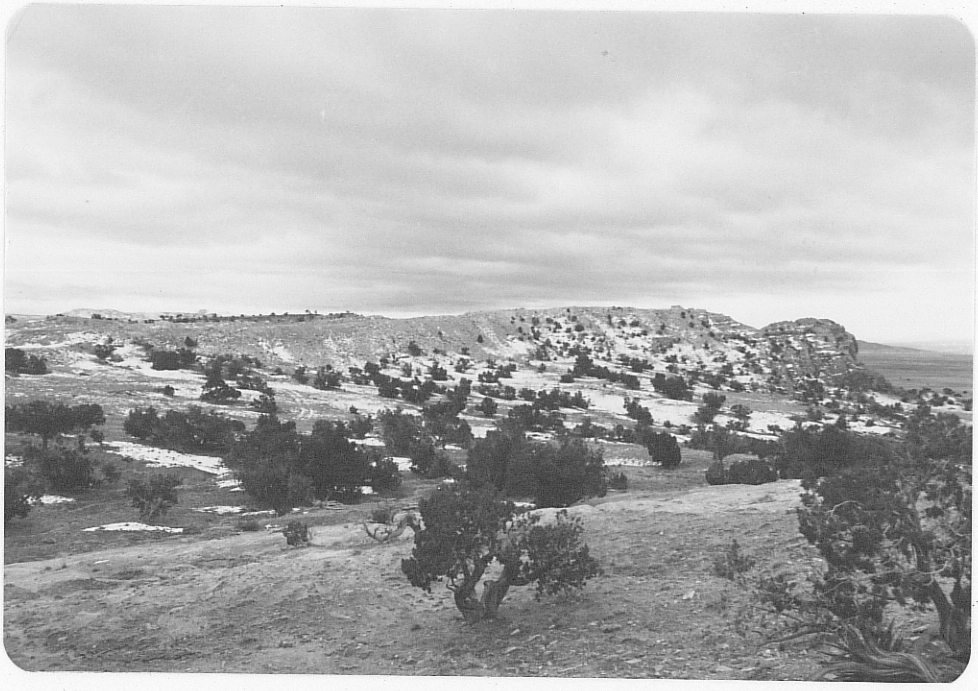
Photo (d) View eastward of sec. 36 mesa top shown in photos (a) and (b), and the waste dump extending down slope (arrow) along west side of mesa.

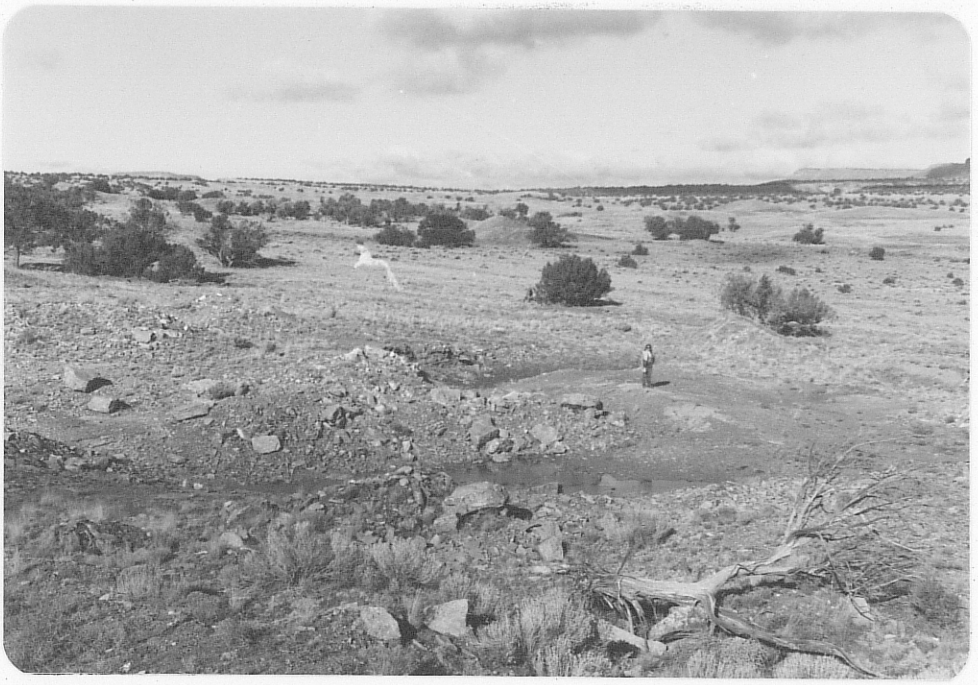
Photo (c) Looking west at a 175' long open pit just south of the north ¼ corner in sec. 31.

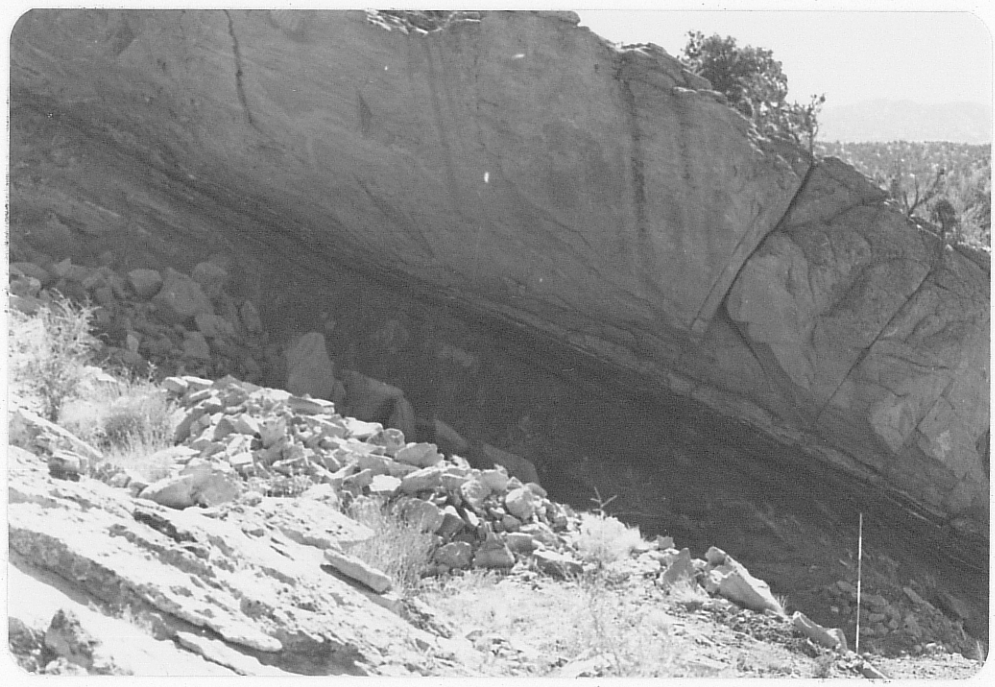
Photo (b) Looking south at south face of cut showing ore bearing sandstone at base with overlying carbonaceous shale in turn overlain by massive red sandstone; again note range pole.

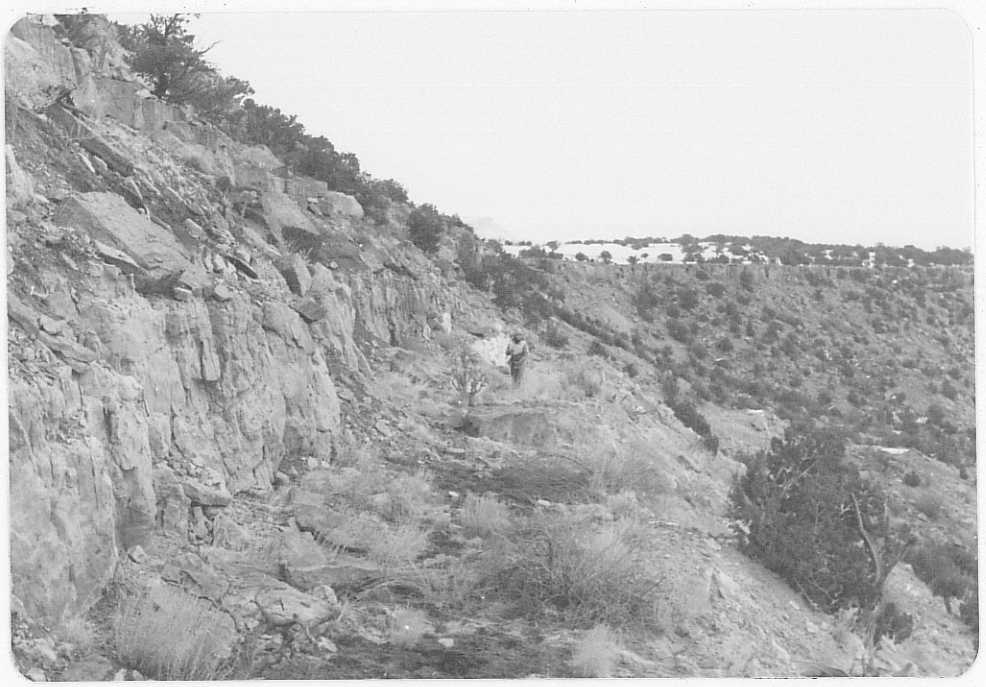
Photo (a) Looking eastward along bench cut in basal Dakota ss. at sec. 34 Mine. Note person at center for scale.

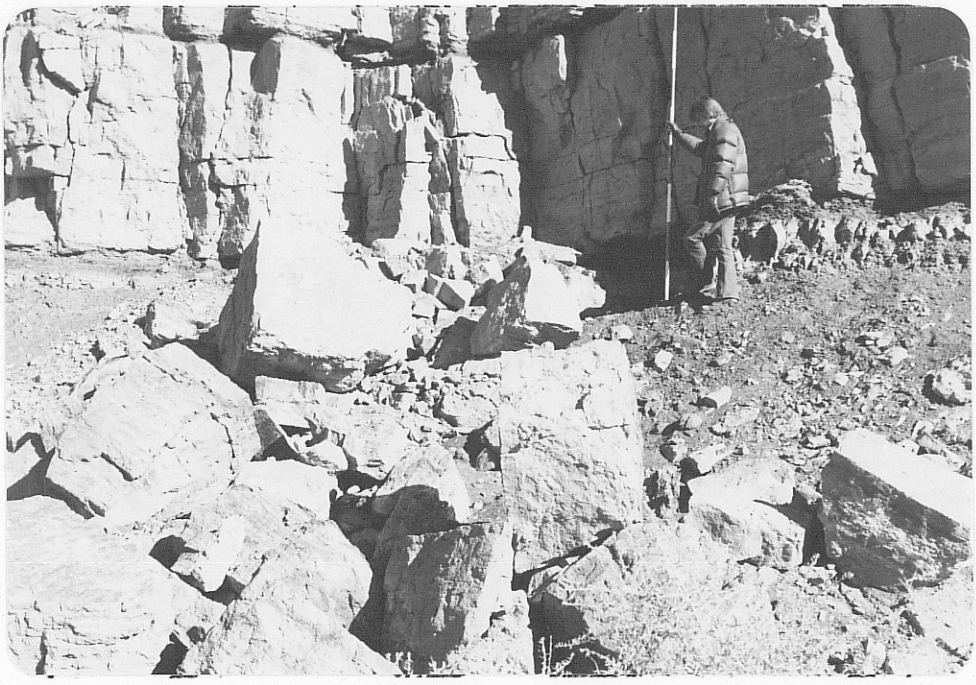
Photo (b) Looking northward at caved entrance to second adit (going eastward) in series of four.

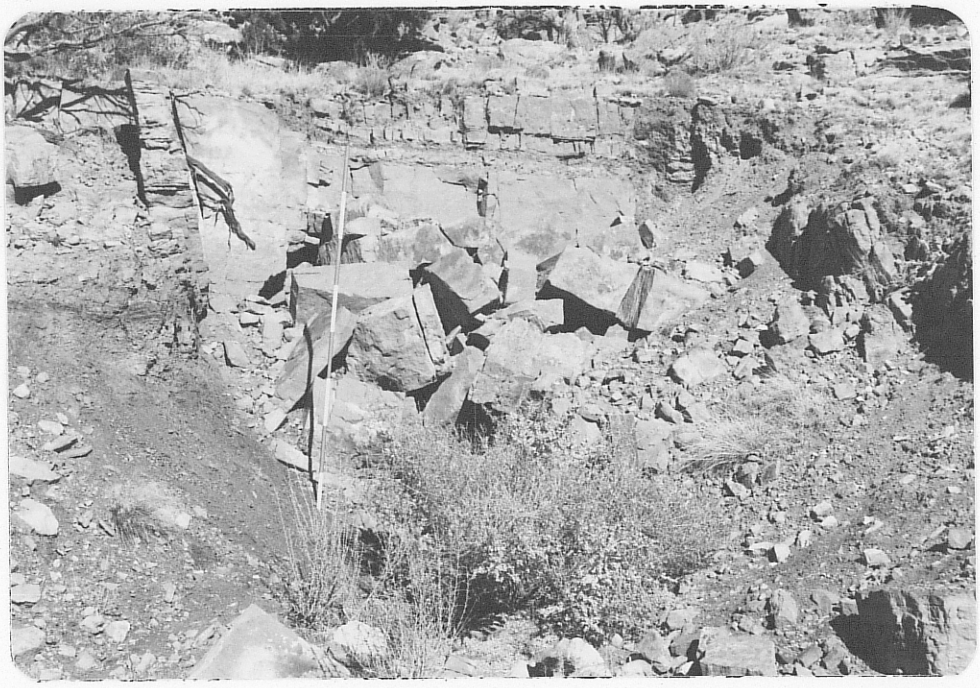
Photo (d) Looking northward at caved entrance to fourth adit (easternmost) in series of four.

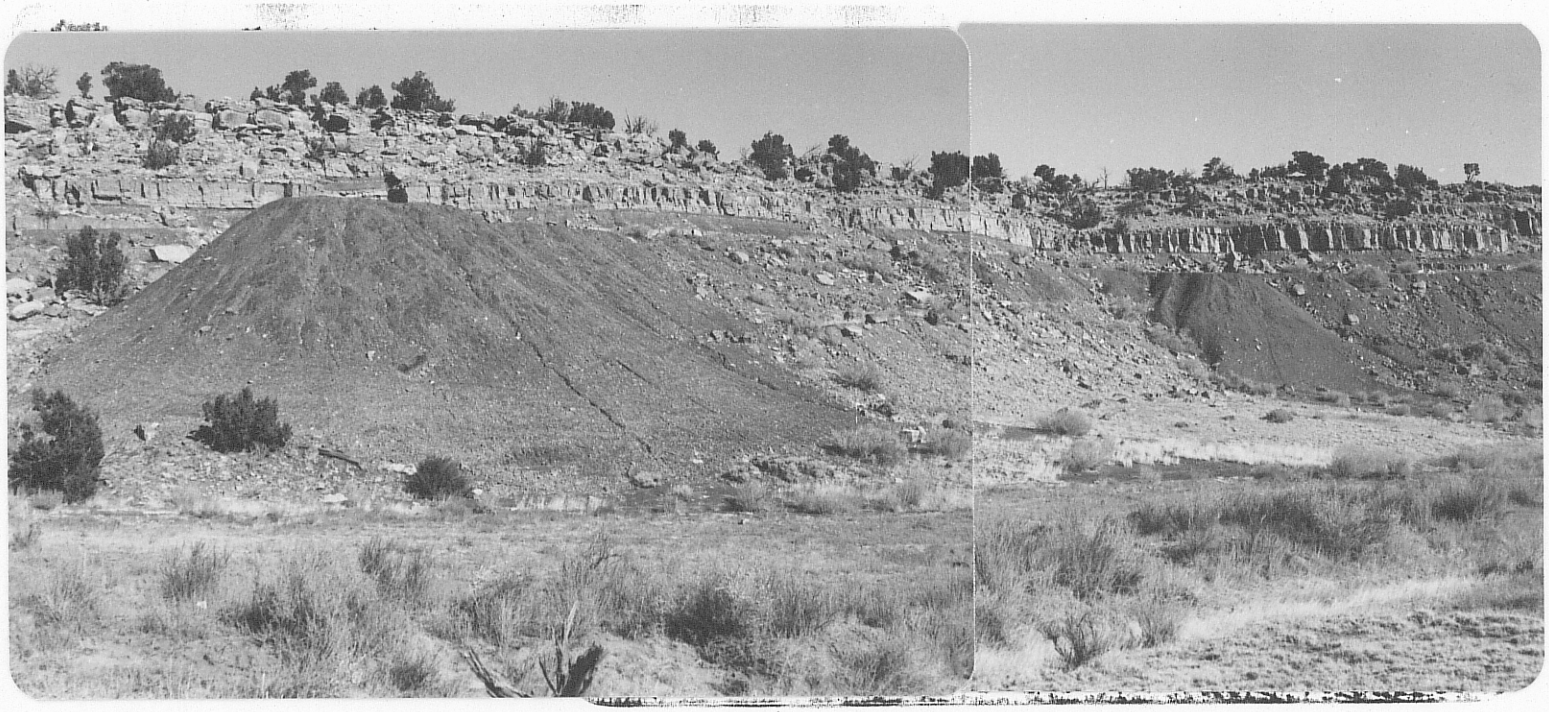
Photo (e) Looking north-northeastward at Febco Mines showing tailings dump from largest adit at left, and the coalesced tailings dumps from the other 3 adits at right. Dump at left is 60' high, but is spread thinly. (For close-up see photo (f)).

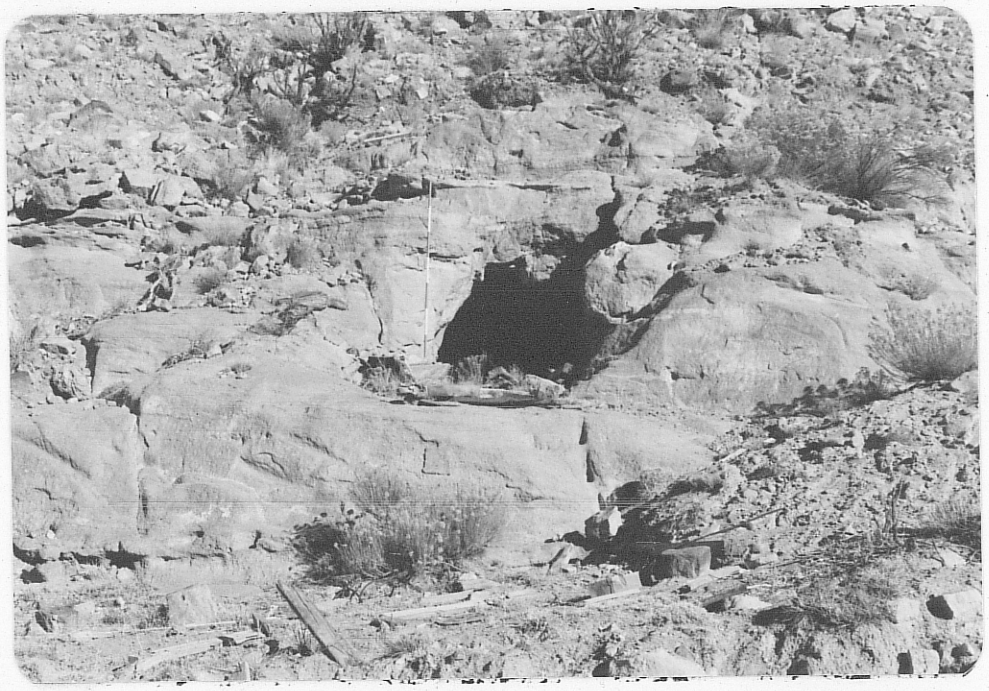
Photo (c) Looking northward into adit, about 5' high, 6' wide, and more than 65' long, located about 25' to the west (beyond) the collapse hole shown in photo (a).

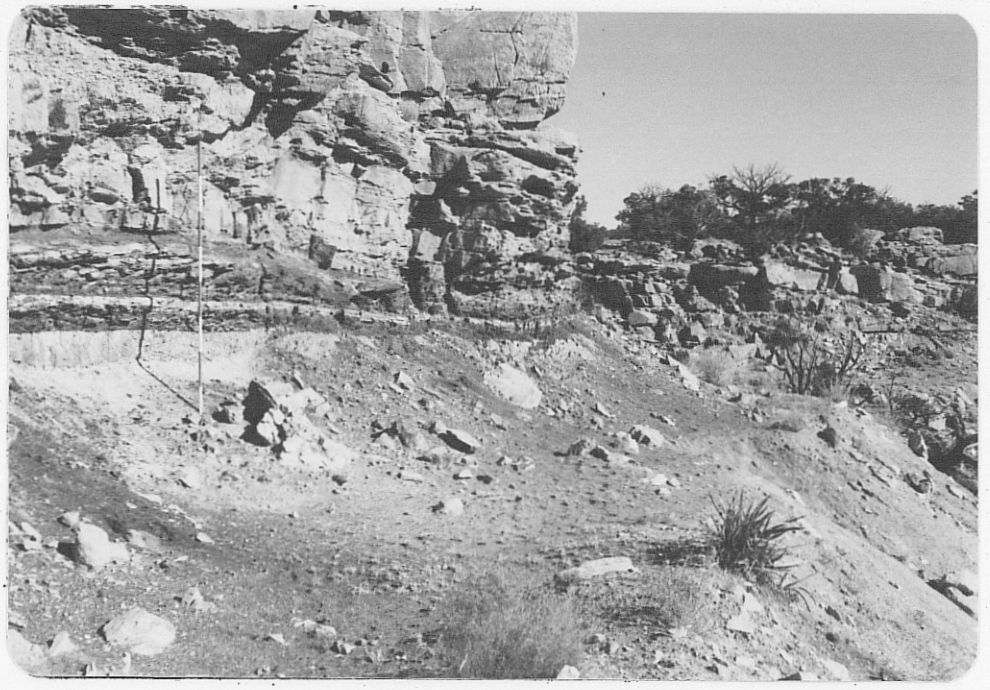
Photo (a) Looking northeastward at section 2 Strip Mine; note carbonaceous shale zones behind range pole.

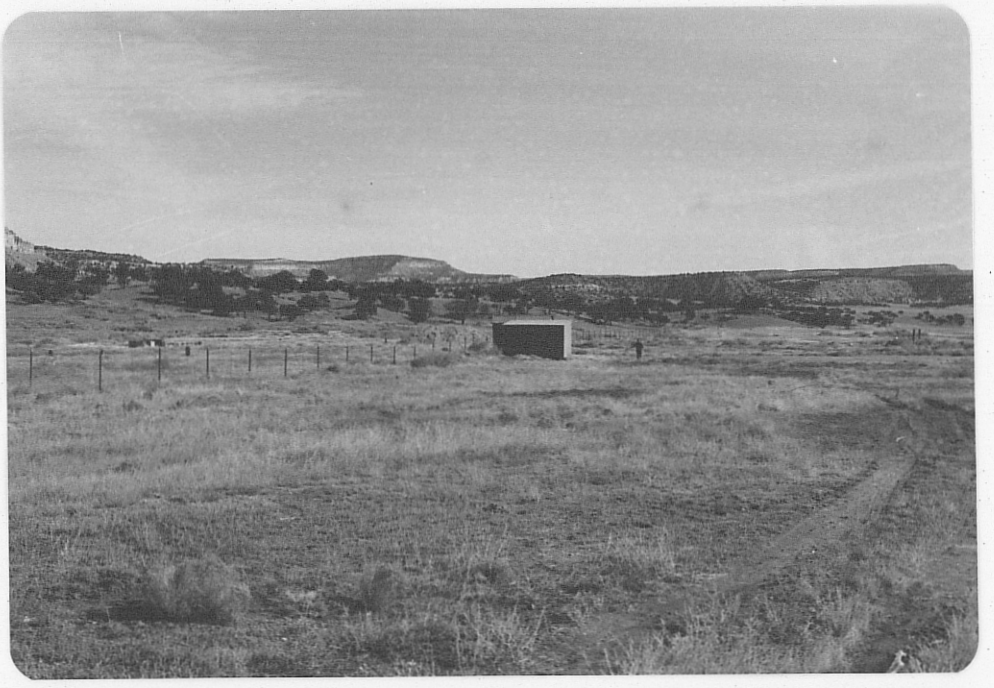
Photo (a) Looking eastward toward the Blackjack #1 site; headframe foundation at left indicated by arrow.

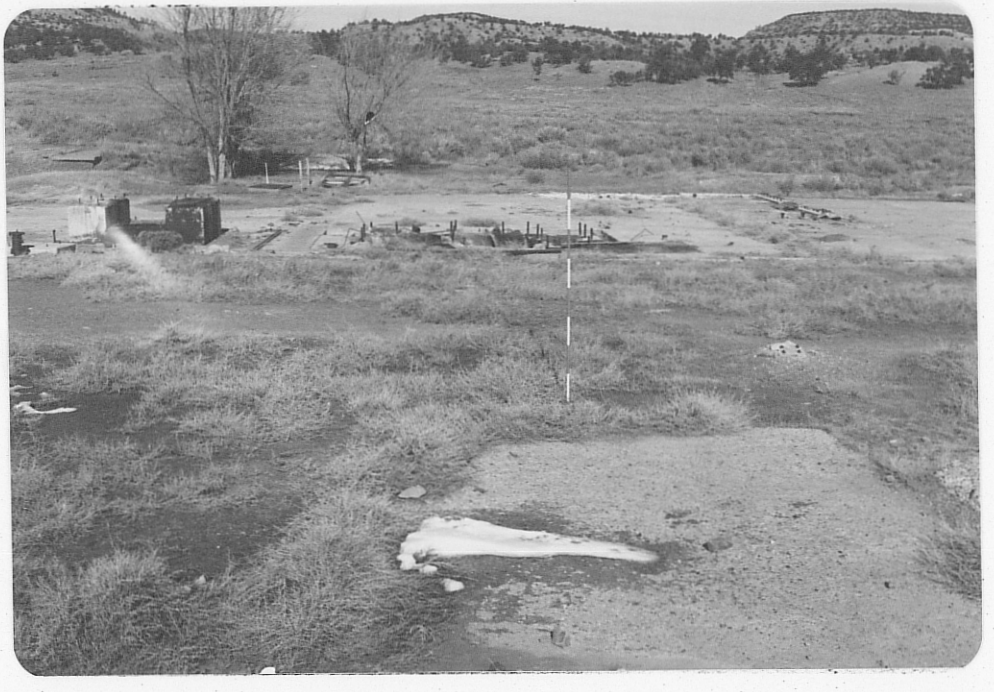
Photo (b) Looking north at shaft site immediately in front of range pole, and one corner of headframe foundation (arrow). Hoist foundation lies behind range pole.

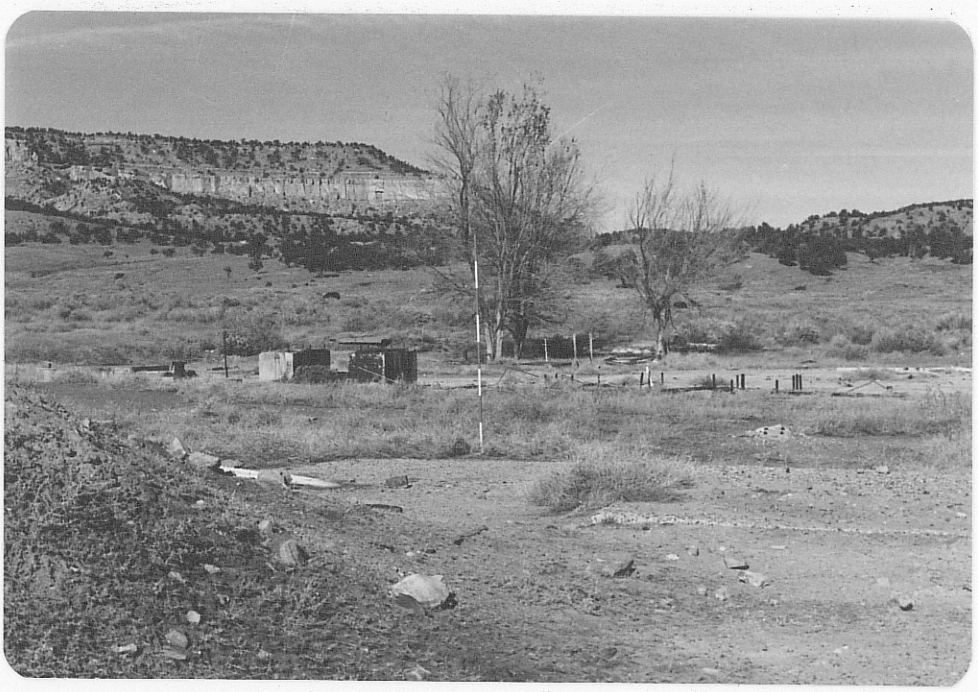
Photo (e) Looking northwestward at shaft site with 5' high tailings dump showing at lower left; dump produced scintillometer readings up to 1,200 cps.

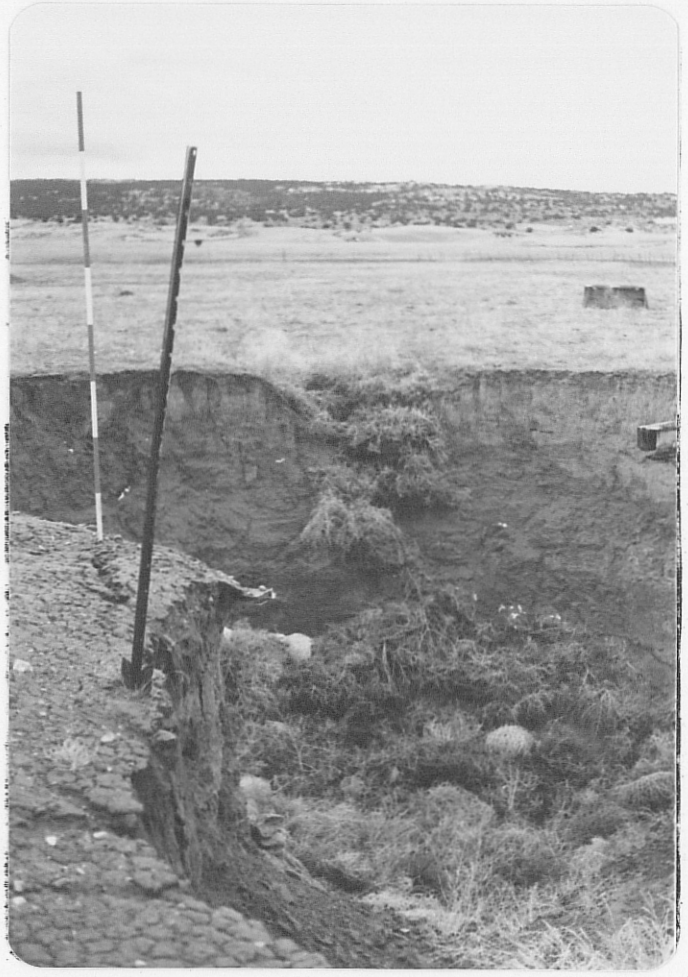
Photo (c) Close-up of caved shaft showing accumulation of tumbleweed at bottom.

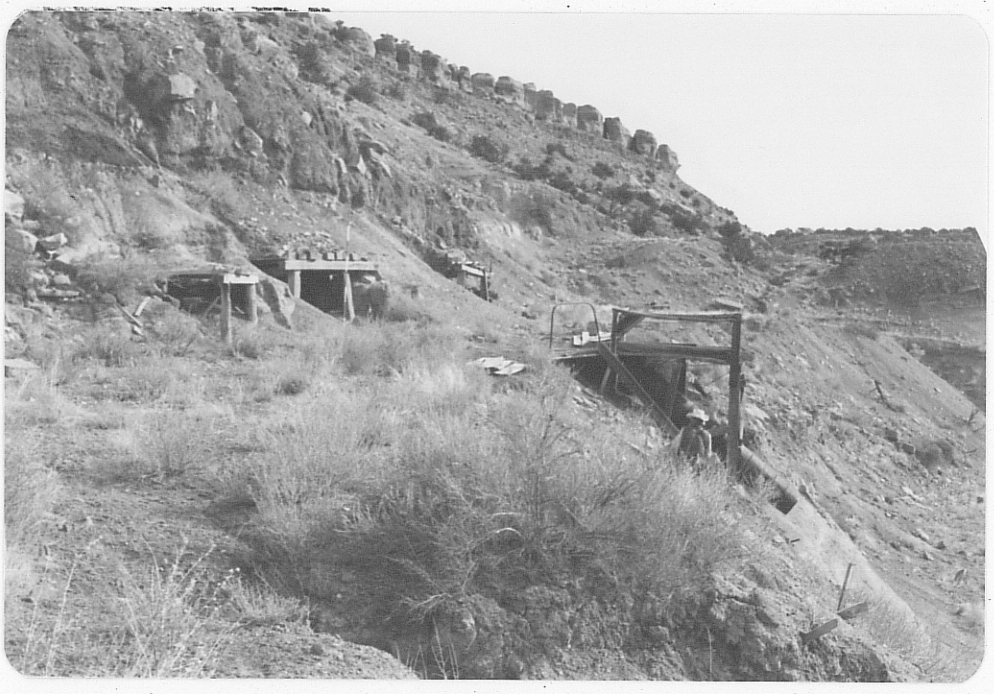
Photo (b) Looking eastward at the three adits driven in upper face and deteriorating wooden ore chute at right; note range pole at center adit for scale.

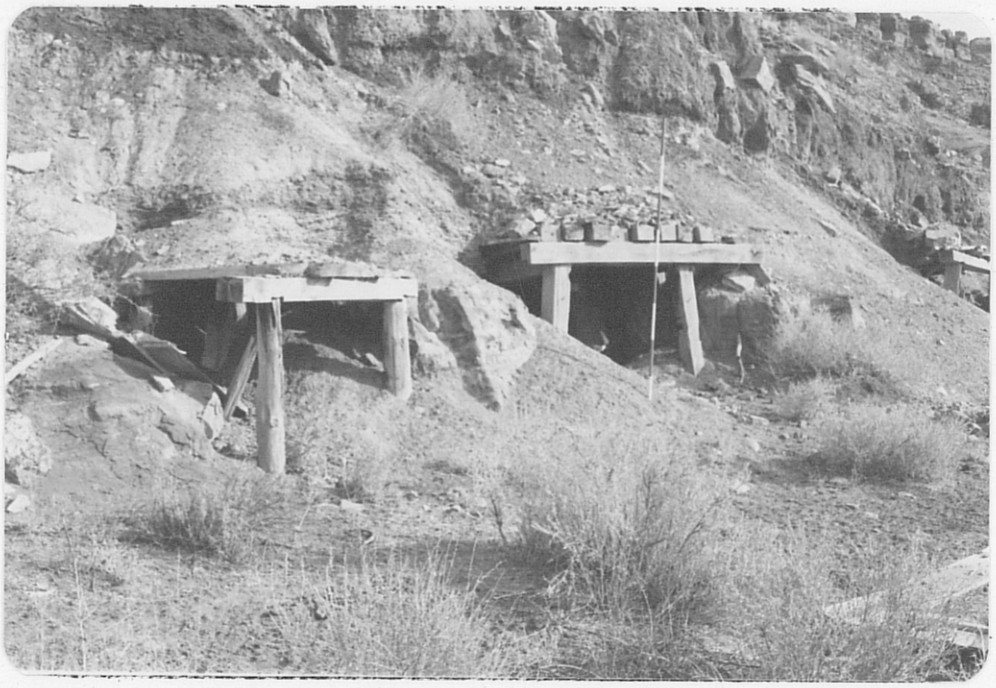
Photo (c) Looking northeastward at two adits at west edge of cut; adit at right behind range pole is main adit 50' or more in length.

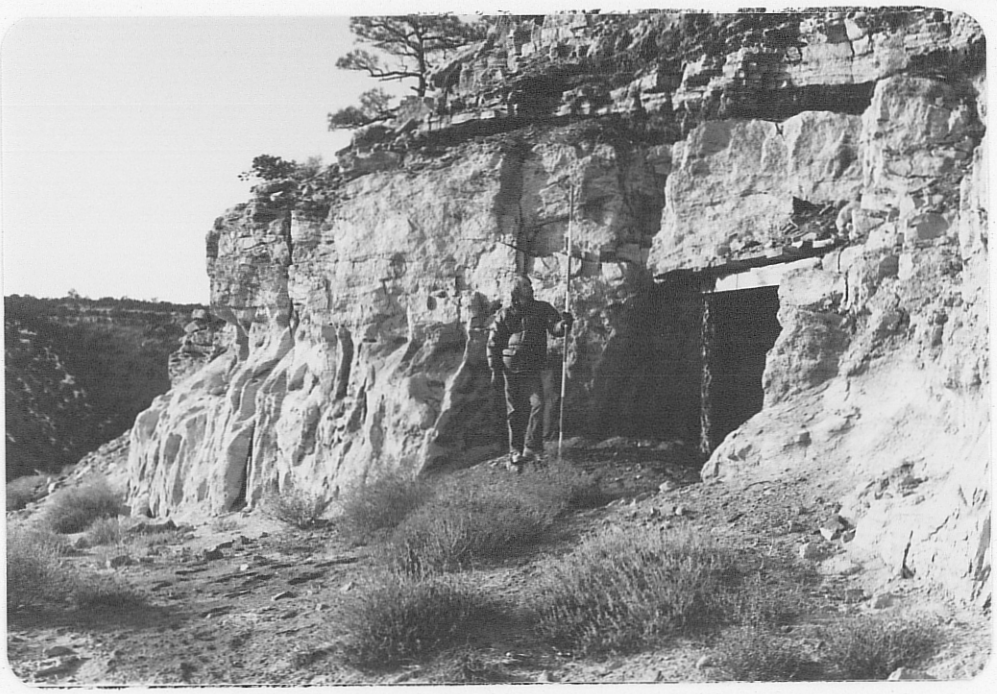
Photo (a) Looking northward at entrance to Silver Bit adit, driven at Dakota/Morrison contact.

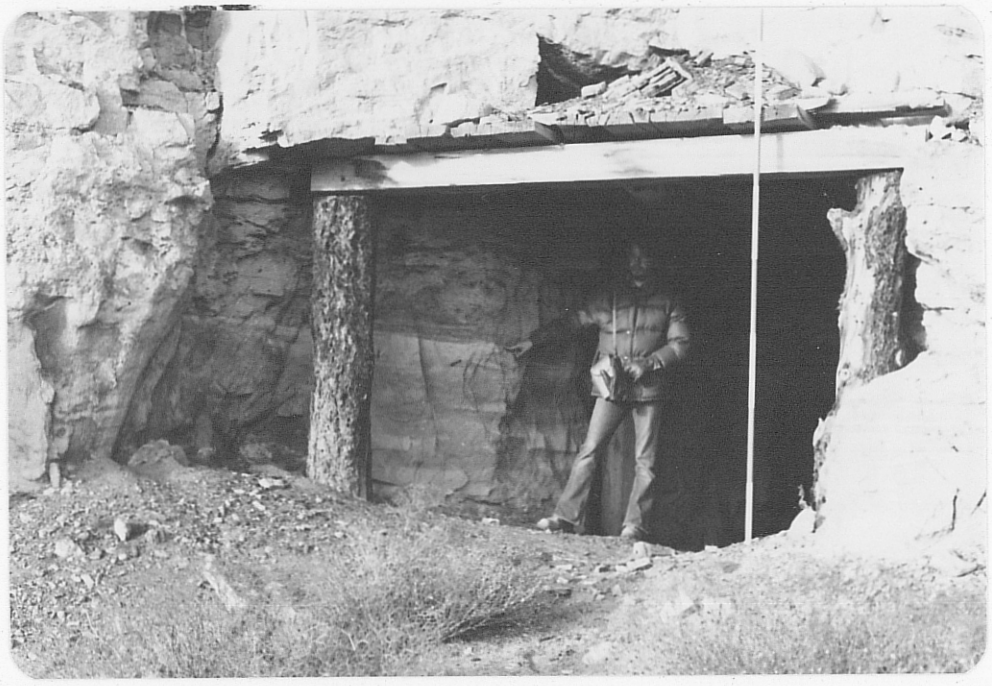
Photo (b) Looking northeastward at portal of Silver Bit adit, 6' high, 8' wide. Person in adit is pointing to color and lithology change probably at Dakota/ Morrison contact.

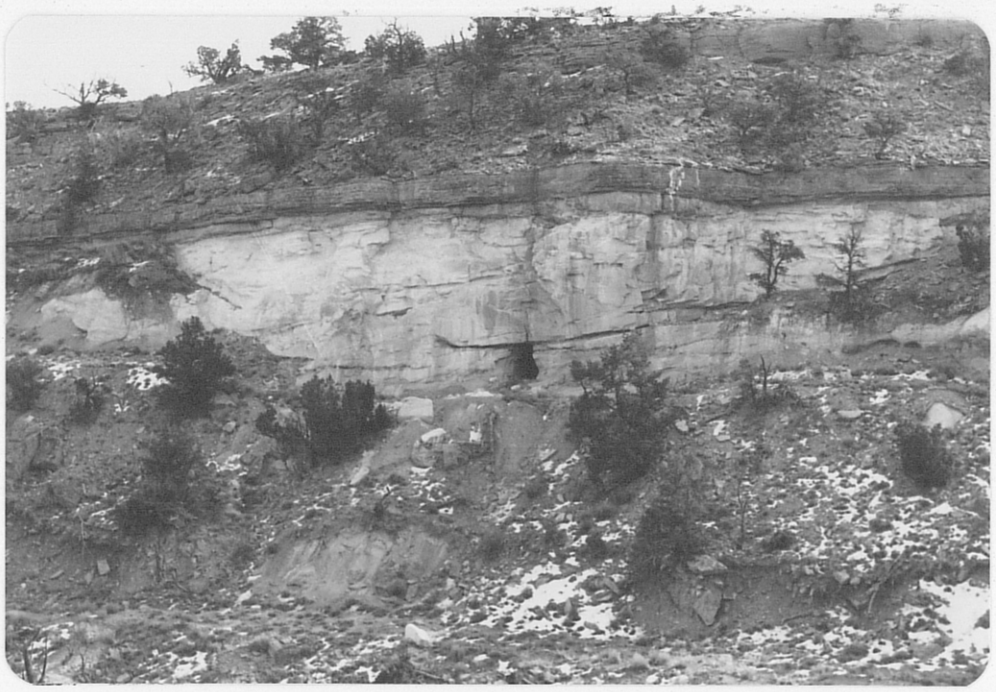
Photo (a) Looking eastward at adit driven into bleached sandstone of upper Brushy Basin member of Morrison fm.; at Francis Mine.

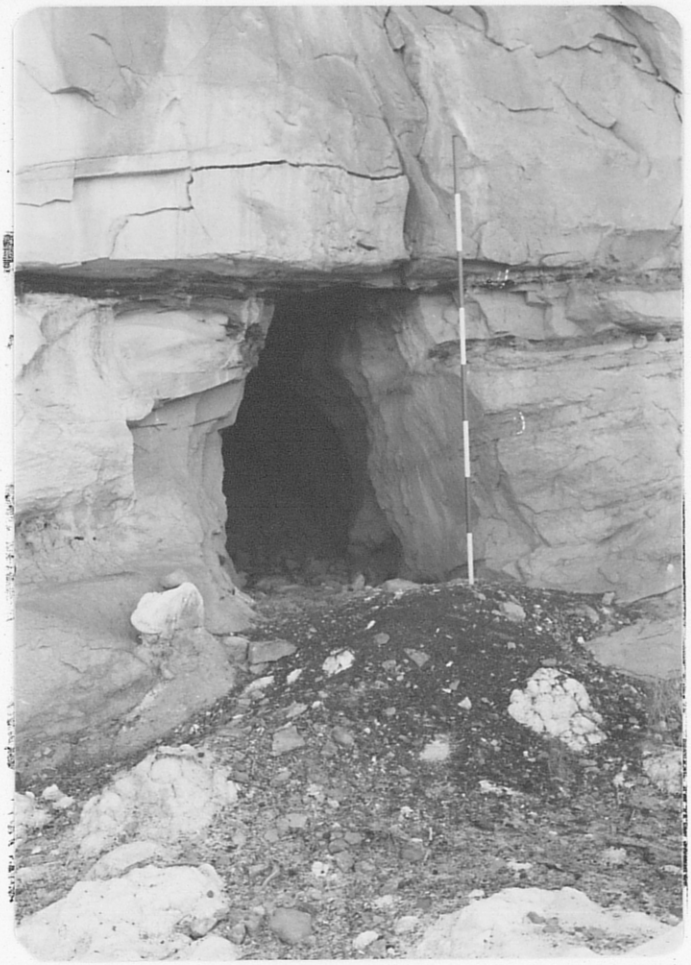
Photo (b) Close-up of adit shown above in (a).

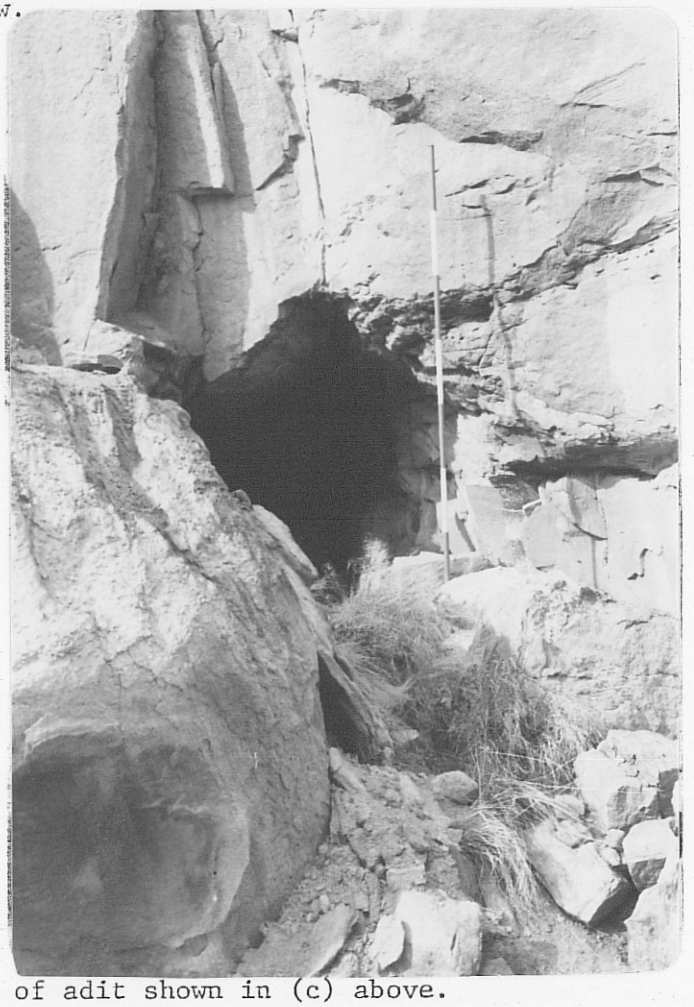
Photo (d) Close-up of adit shown in (c) above.

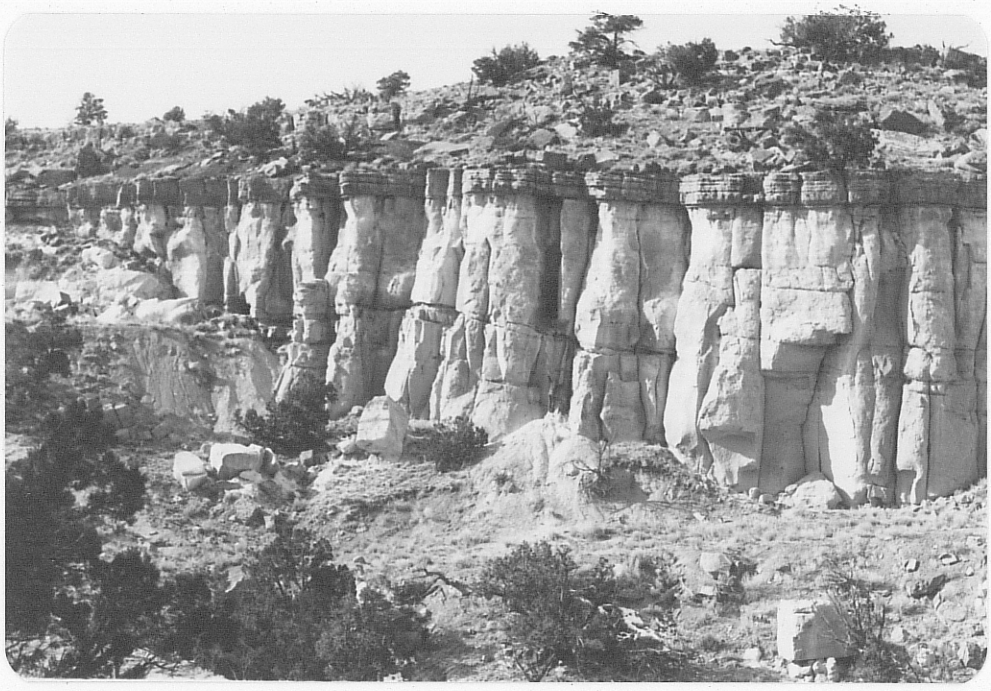
Photo (e) Looking westward at west wall of canyon showing the area where third adit is driven (upper circle) and person below (lower circle) at a crude ladder leading from dump level to adit 20' above.

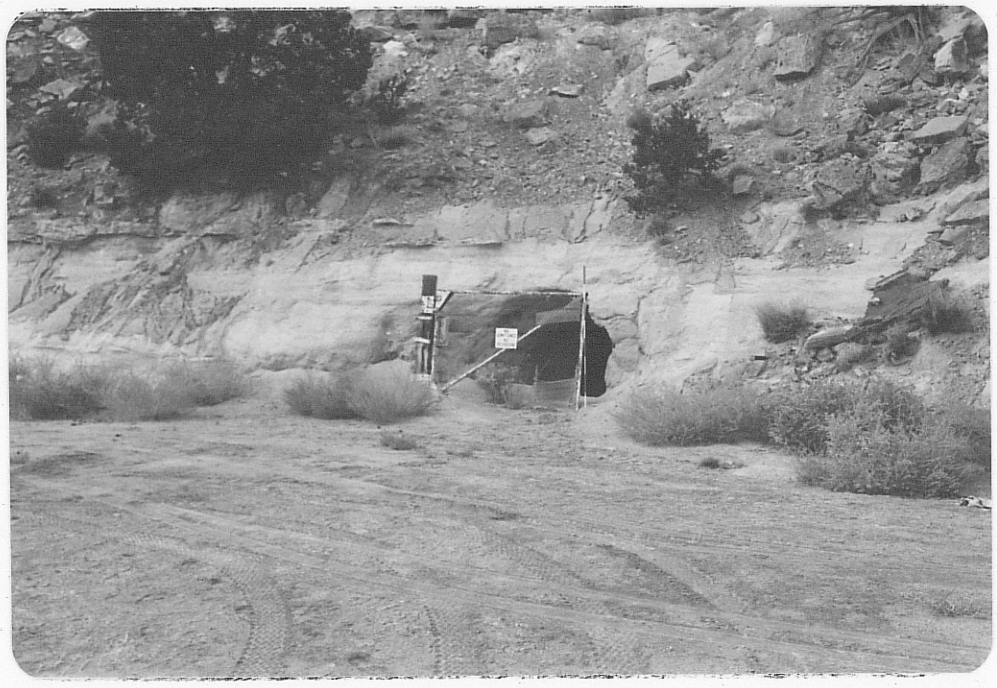
Photo (b) Looking westward at "screened" portal of main adit shown in foreground in photo (a).

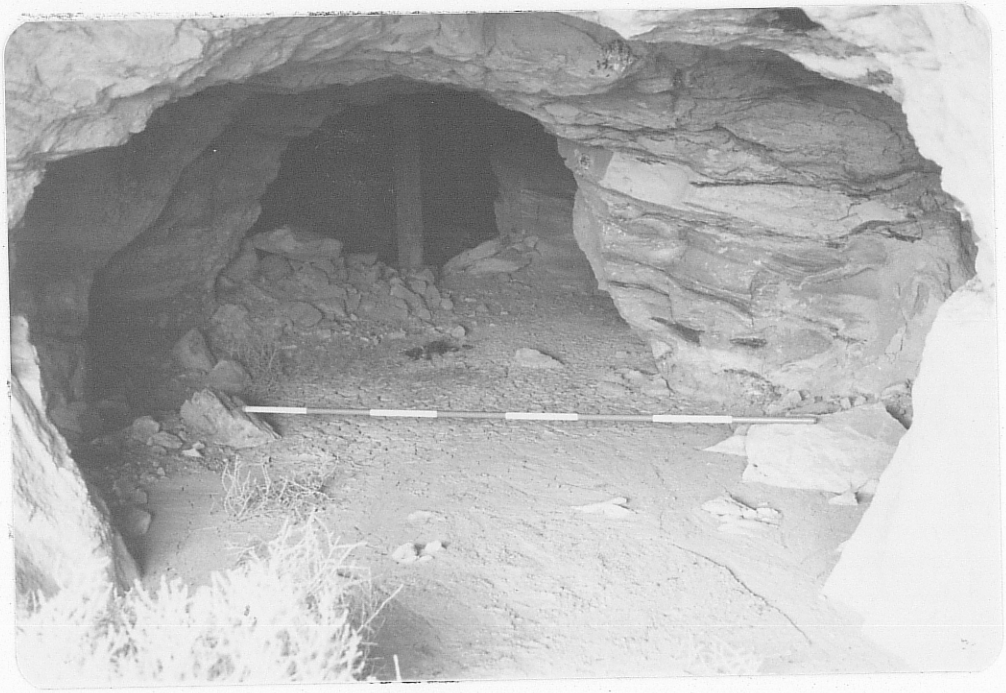
Photo (d) View inside adit at left in photo (c), showing vertical timber; note range pole (crosswise) for scale.

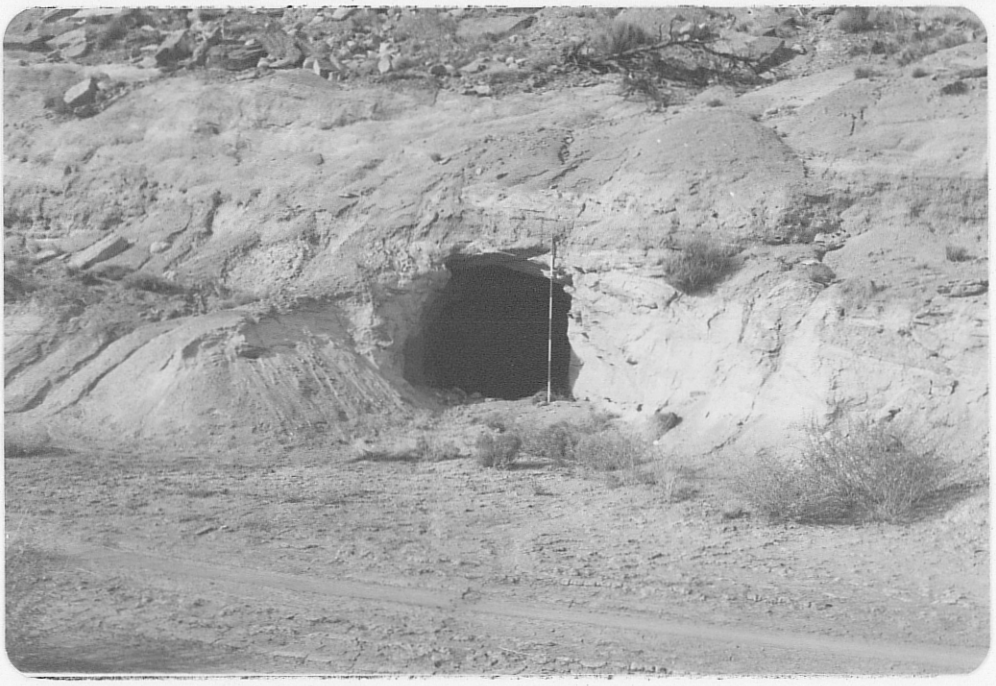
Photo (e) Looking west at northernmost group of adits at Evelyn Mine; note range pole for scale.

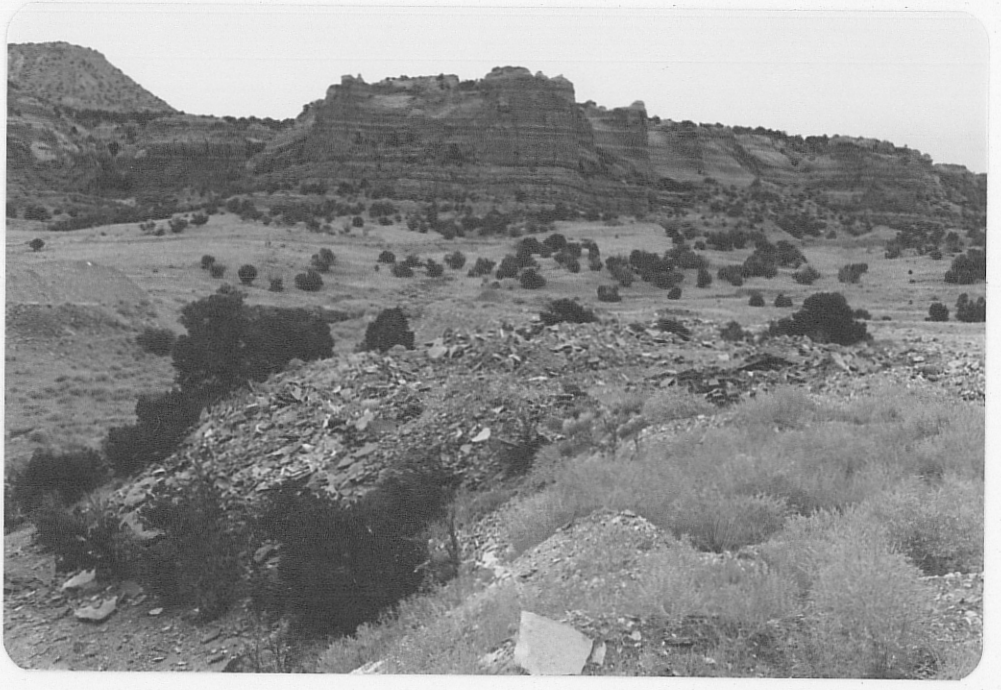
Photo (e) Looking northeastward at north edge of workings showing waste dump on bank of small drainage line.

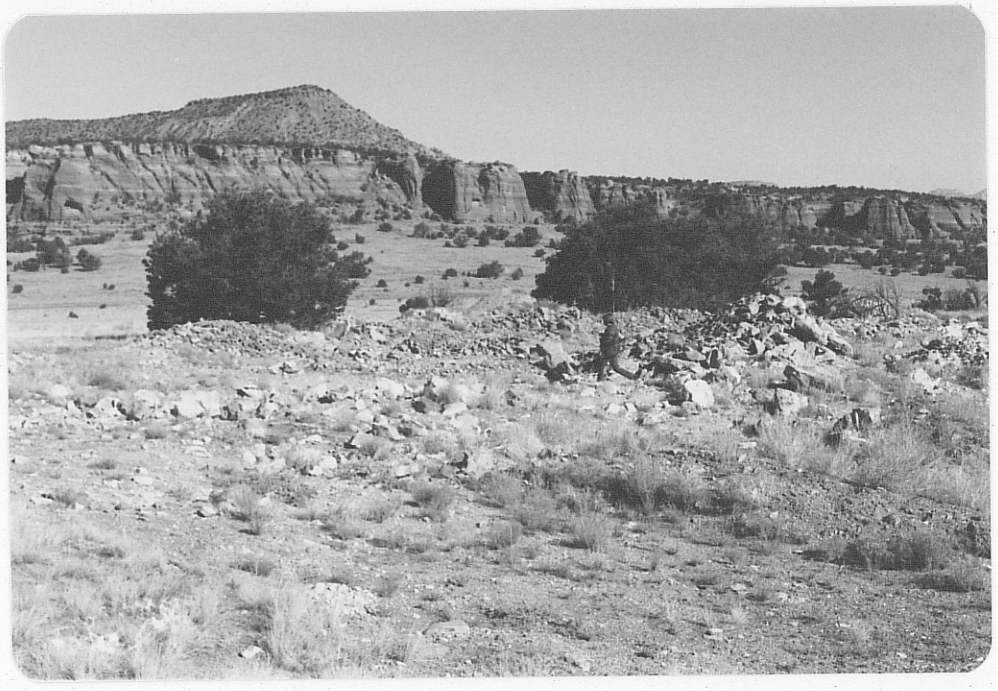
Photo (b) Looking north at west edge of prospect area shown in photo (a); note person just right of center for scale.

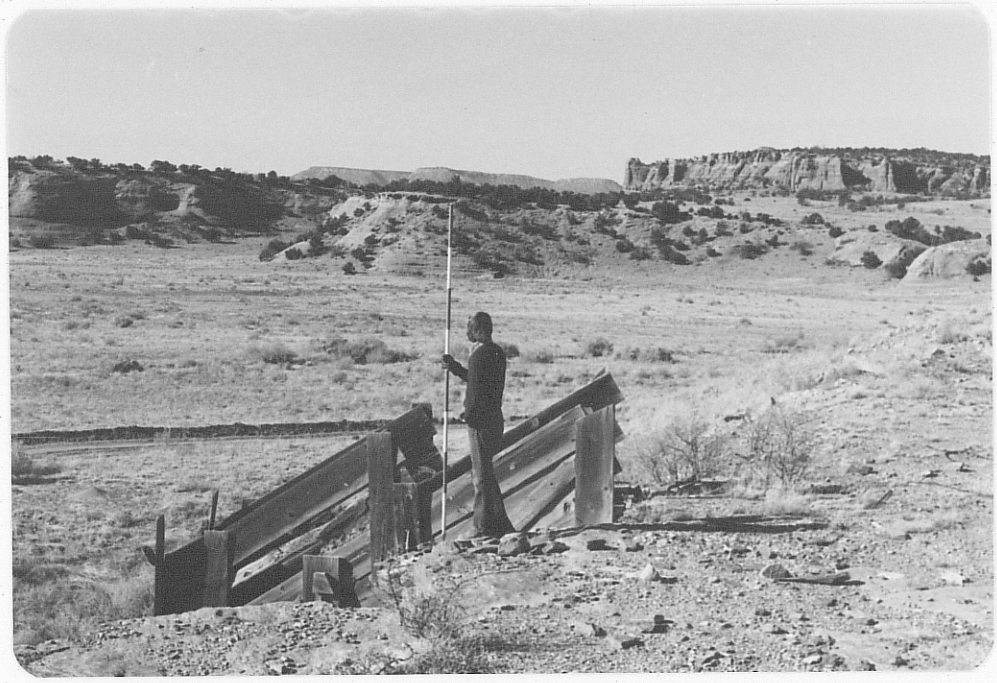
Photo (c) Looking west at ore chute from top of dump.

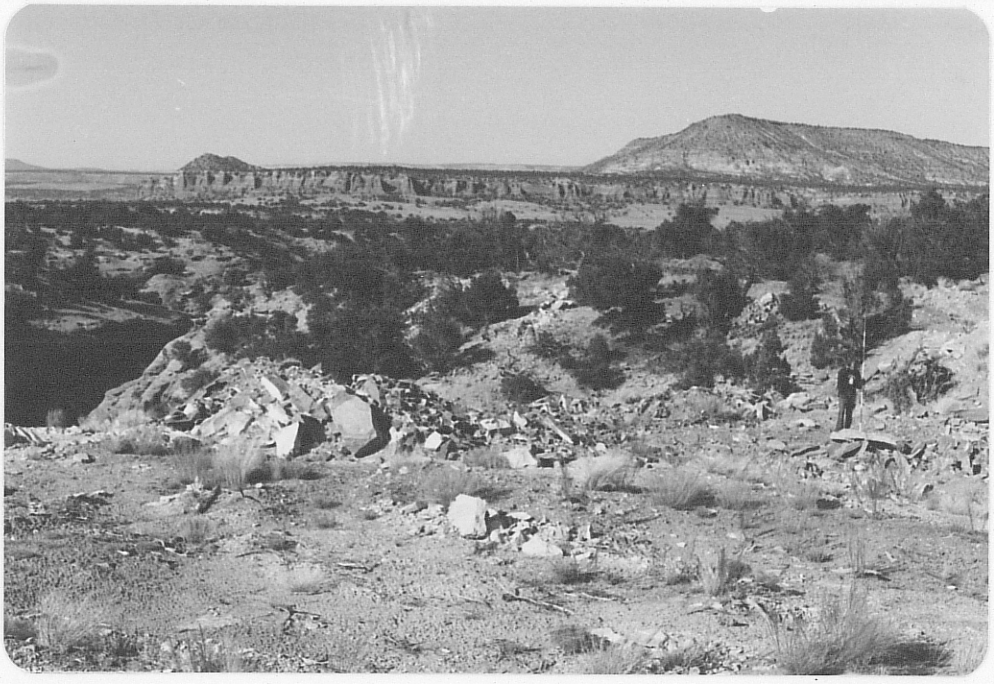
Photo (a) Looking north at small open pit and waste piles of Todilto limestone at Yucca #2 Mine.

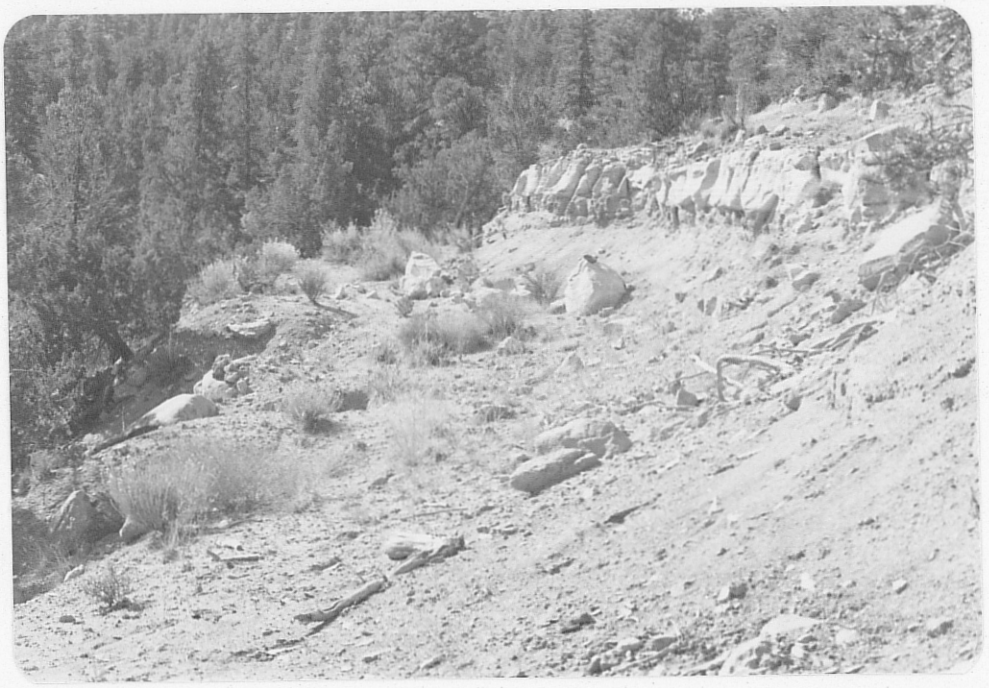
Photo (c) Prospecting above the bench cut in photo (b) on the southern Lucky Strike workings.

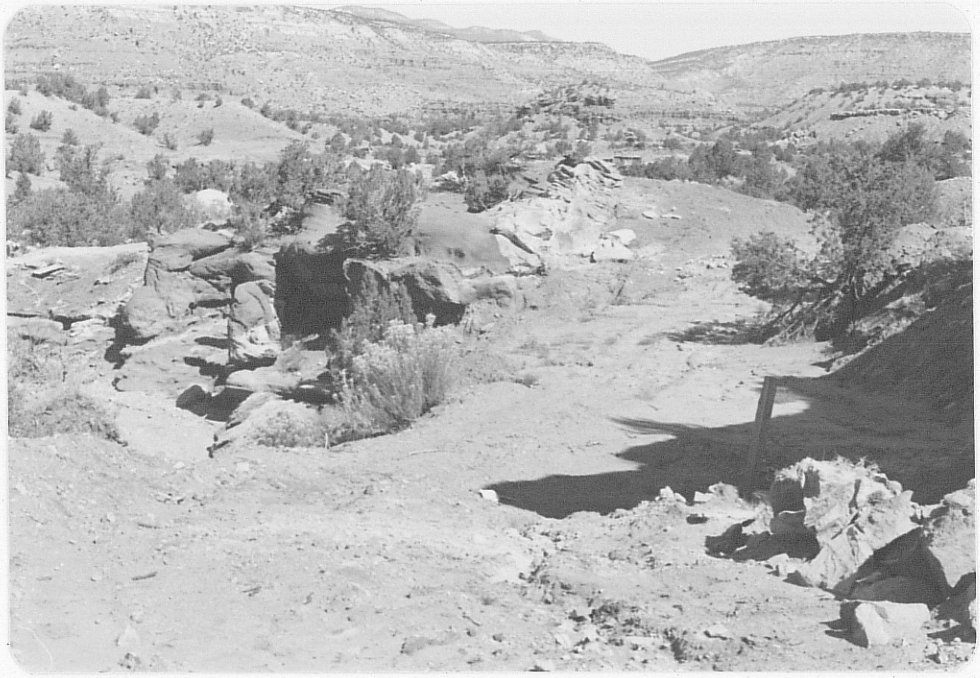
Photo (a) Red Head Claims with local dwellings in center of photo.

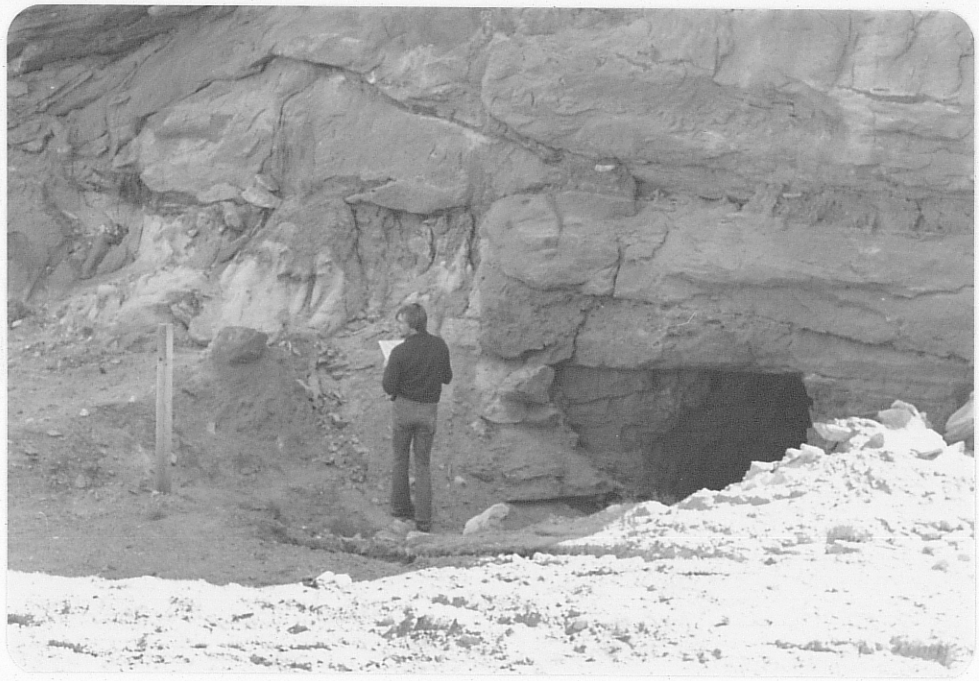
Photo (b) Red Bird adit on the Red Head Claims.

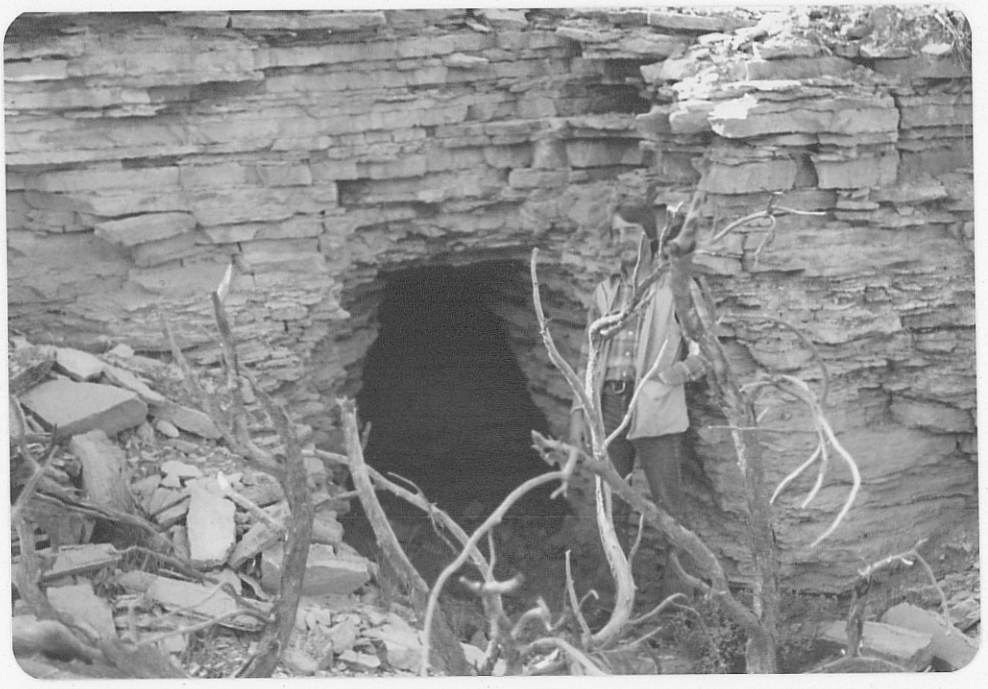
Photo (a) Lucky Dog/Horny Toad Adit.
