# ABANDONED OR INACTIVE URANIUM MINES IN NEW MEXICO

A report of investigation carried out between August 1979 and May 1980 under contract with the New Mexico Energy and Minerals Department.

New Mexico Bureau of Mines and
Mineral Resources
Open-File Report 148

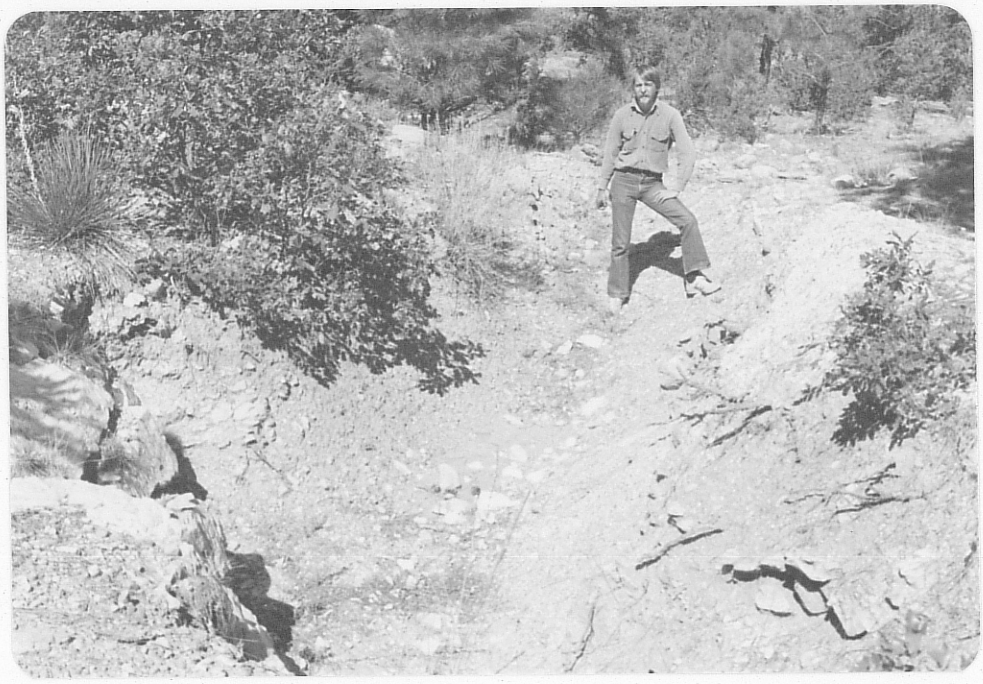
Photo (d) Shallow pit northeast of water filled shaft. Maximum scintillometer readings at this pit were 100 cps.

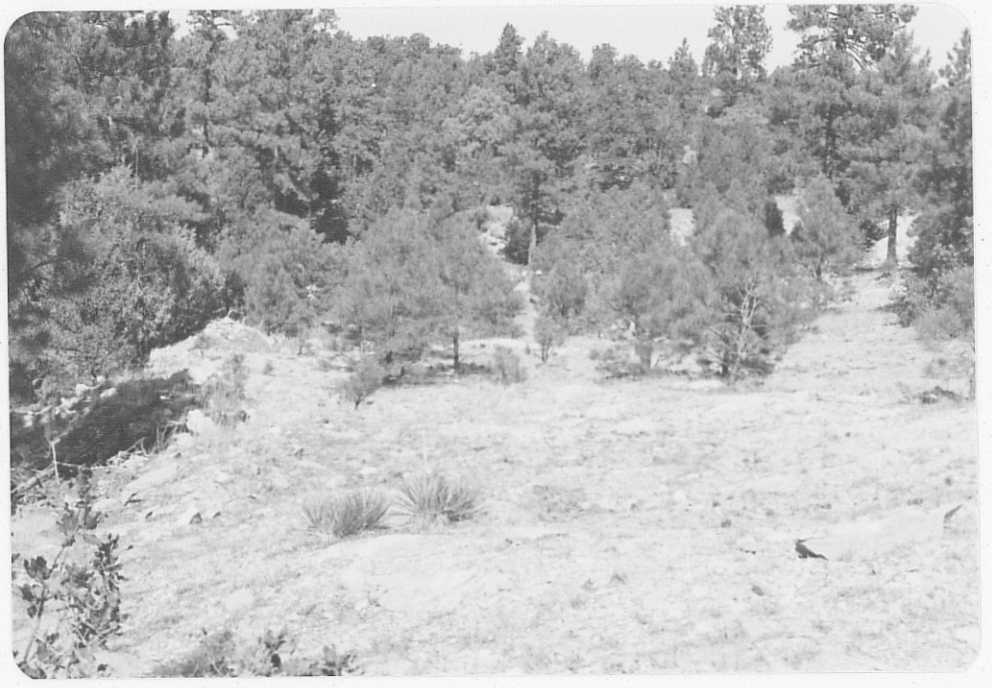
Photo (e) Bulldozed area on the La Paloma workings. Note rejuvination of area by pines and grasses.

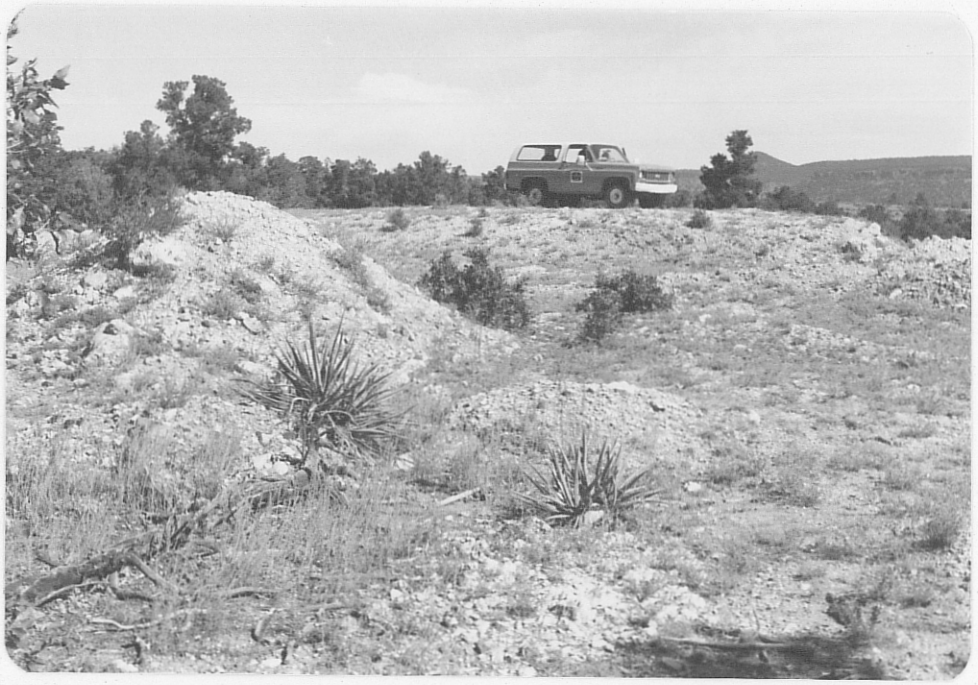
Photo (a) Looking NE at small bulldozer cuts and the dump on the Pineapple property.

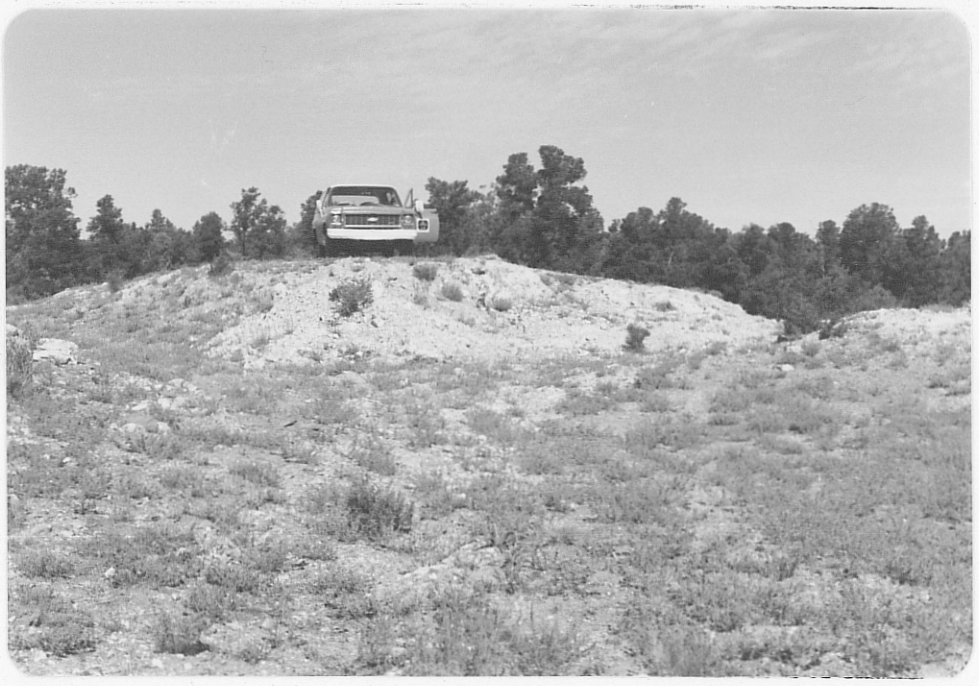
Photo (b) Looking north at the Pineapple dump.

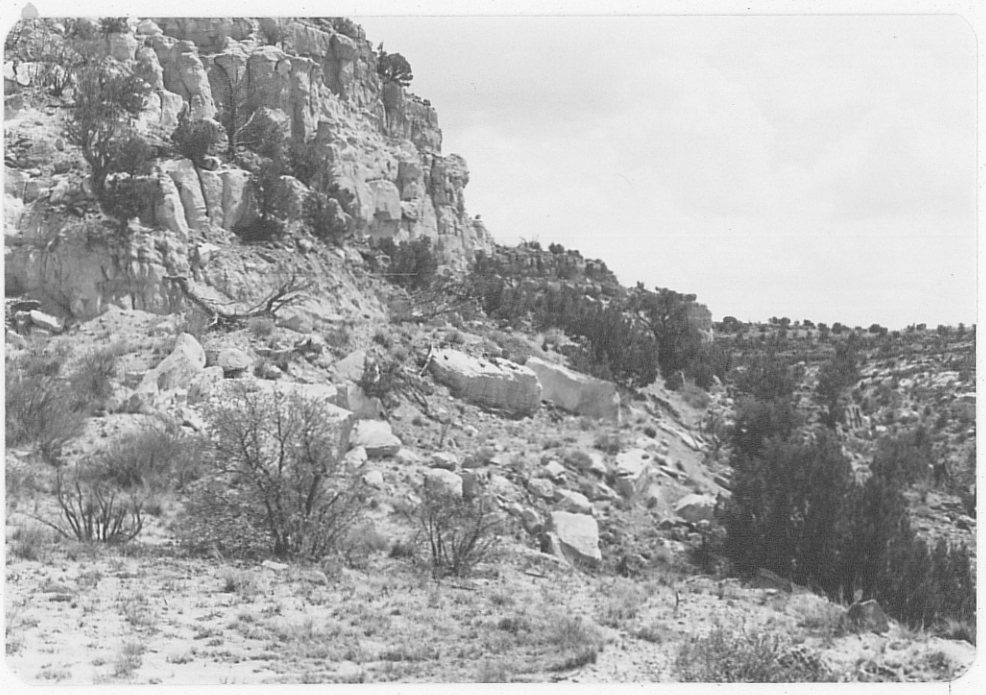
Photo (b) Looking southeastward from cut shown in (a); prospecting road continued for 100' south of cut but is now obliterated due to slumping. Cliffs on skyline are 100' above cut, capped by Dakota Sandstone.
