Ground subsidence near Espanola, New Mexico

Deborah Shaw and Gary Johnpeer

New Mexico Geology, v. 7, n. 2 pp. 32-34, Print ISSN: 0196-948X, Online ISSN: 2837-6420.

Ground subsidence near Española, New Mexico

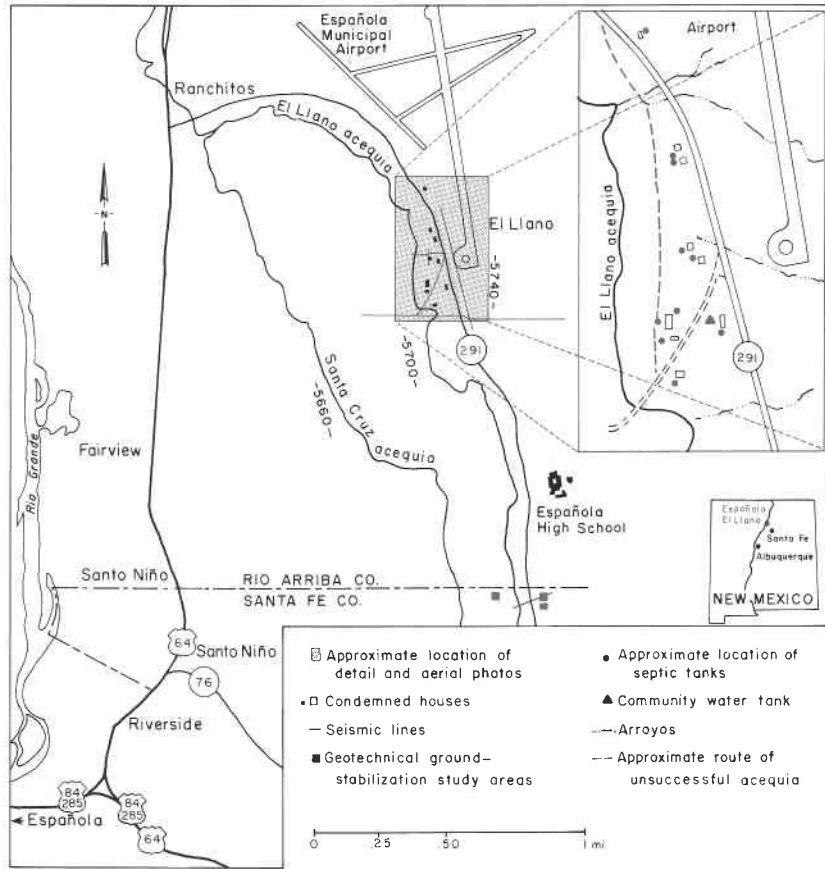
FIGURE 1—Location map of study area in and around El Llano, near Española, Rio Arriba and Santa Fe Counties, New Mexico.

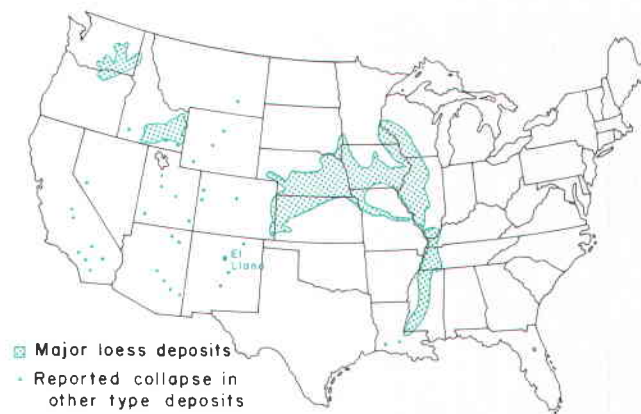
NMBMMR was designated the lead state agency to conduct a detailed geotechnical study of the site in cooperation with other state agencies and consultants knowledgeable in soil and structural stability. It is hoped that this study will provide the information necessary to enable repair of damaged houses and to prevent further damage in El Llano and in other areas where similar problems exist (Fig. 6).

FIGURE 6—Map of the U.S. showing extent of loess deposits, soils known to be collapsible, and other areas where soil collapse has been reported; modified from Arman and Thornton, 1972.

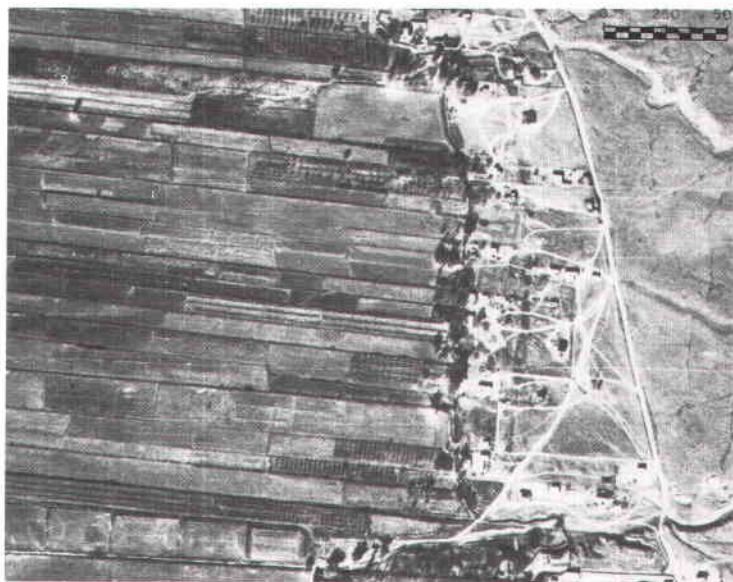
FIGURE 7—Aerial photograph of part of El Llano taken in 1949. Area shown includes, but extends farther west than, detail shown in Fig. 1. The scale is in feet.

Although El Llano is not a newly settled area, only within the last 25 yrs has the area been subdivided and built up significantly. Aerial photographs (Fig. 7, 8) reveal very long, narrow land subdivisions, which represent typical Spanish land grants. Originally, properties were divided so that each owner had a portion of land that bordered on a dependable water source such as an acequia or a river. An unsuccessful attempt was made in the early 1900's to build an acequia that would have flowed close to some of the now-settling houses (Fig. 1, detail). According to available information, El Llano lands east of the existing acequia have never been irrigated or wetted significantly. Newer houses generally have been built at the eastern edge of the original land grants, uphill from the irrigated lands (Figs. 1, 8). Indoor plumbing and septic tanks have been used increasingly since the mid 1940's, and, because most El Llano houses are not connected to the Española sewage system, septic tanks are utilized. Other sources of increased moisture include leaky water lines, surface runoff (unusually high rainfall was recorded in October 1984), disruption of natural runoff, and outdoor watering.

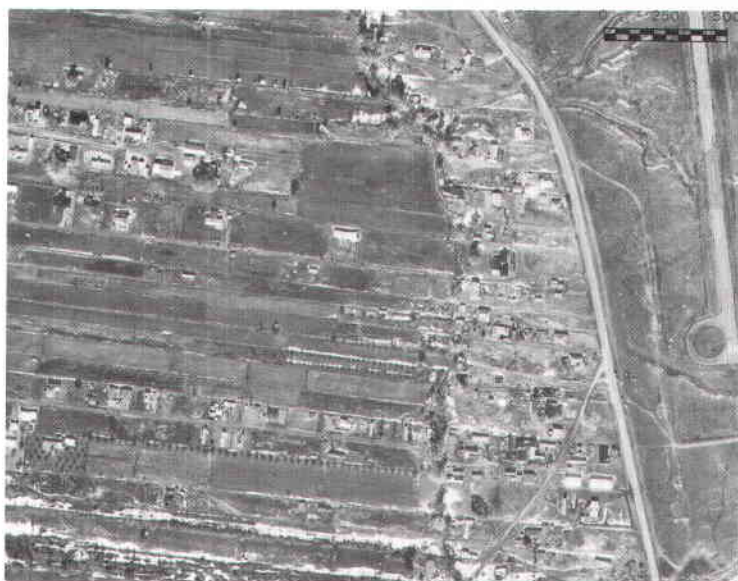
FIGURE 8—Aerial photograph of part of El Llano taken January 15, 1985. Note the concentration of structures east of the acequia near the highway. Area shown includes, but extends farther west than, the detail shown in Fig. 1. The scale is in feet.
