EL LLANO AND VICINITY  
GEOTECHNICAL STUDY

INTERIM REPORT

VOLUME I

15 April 1985

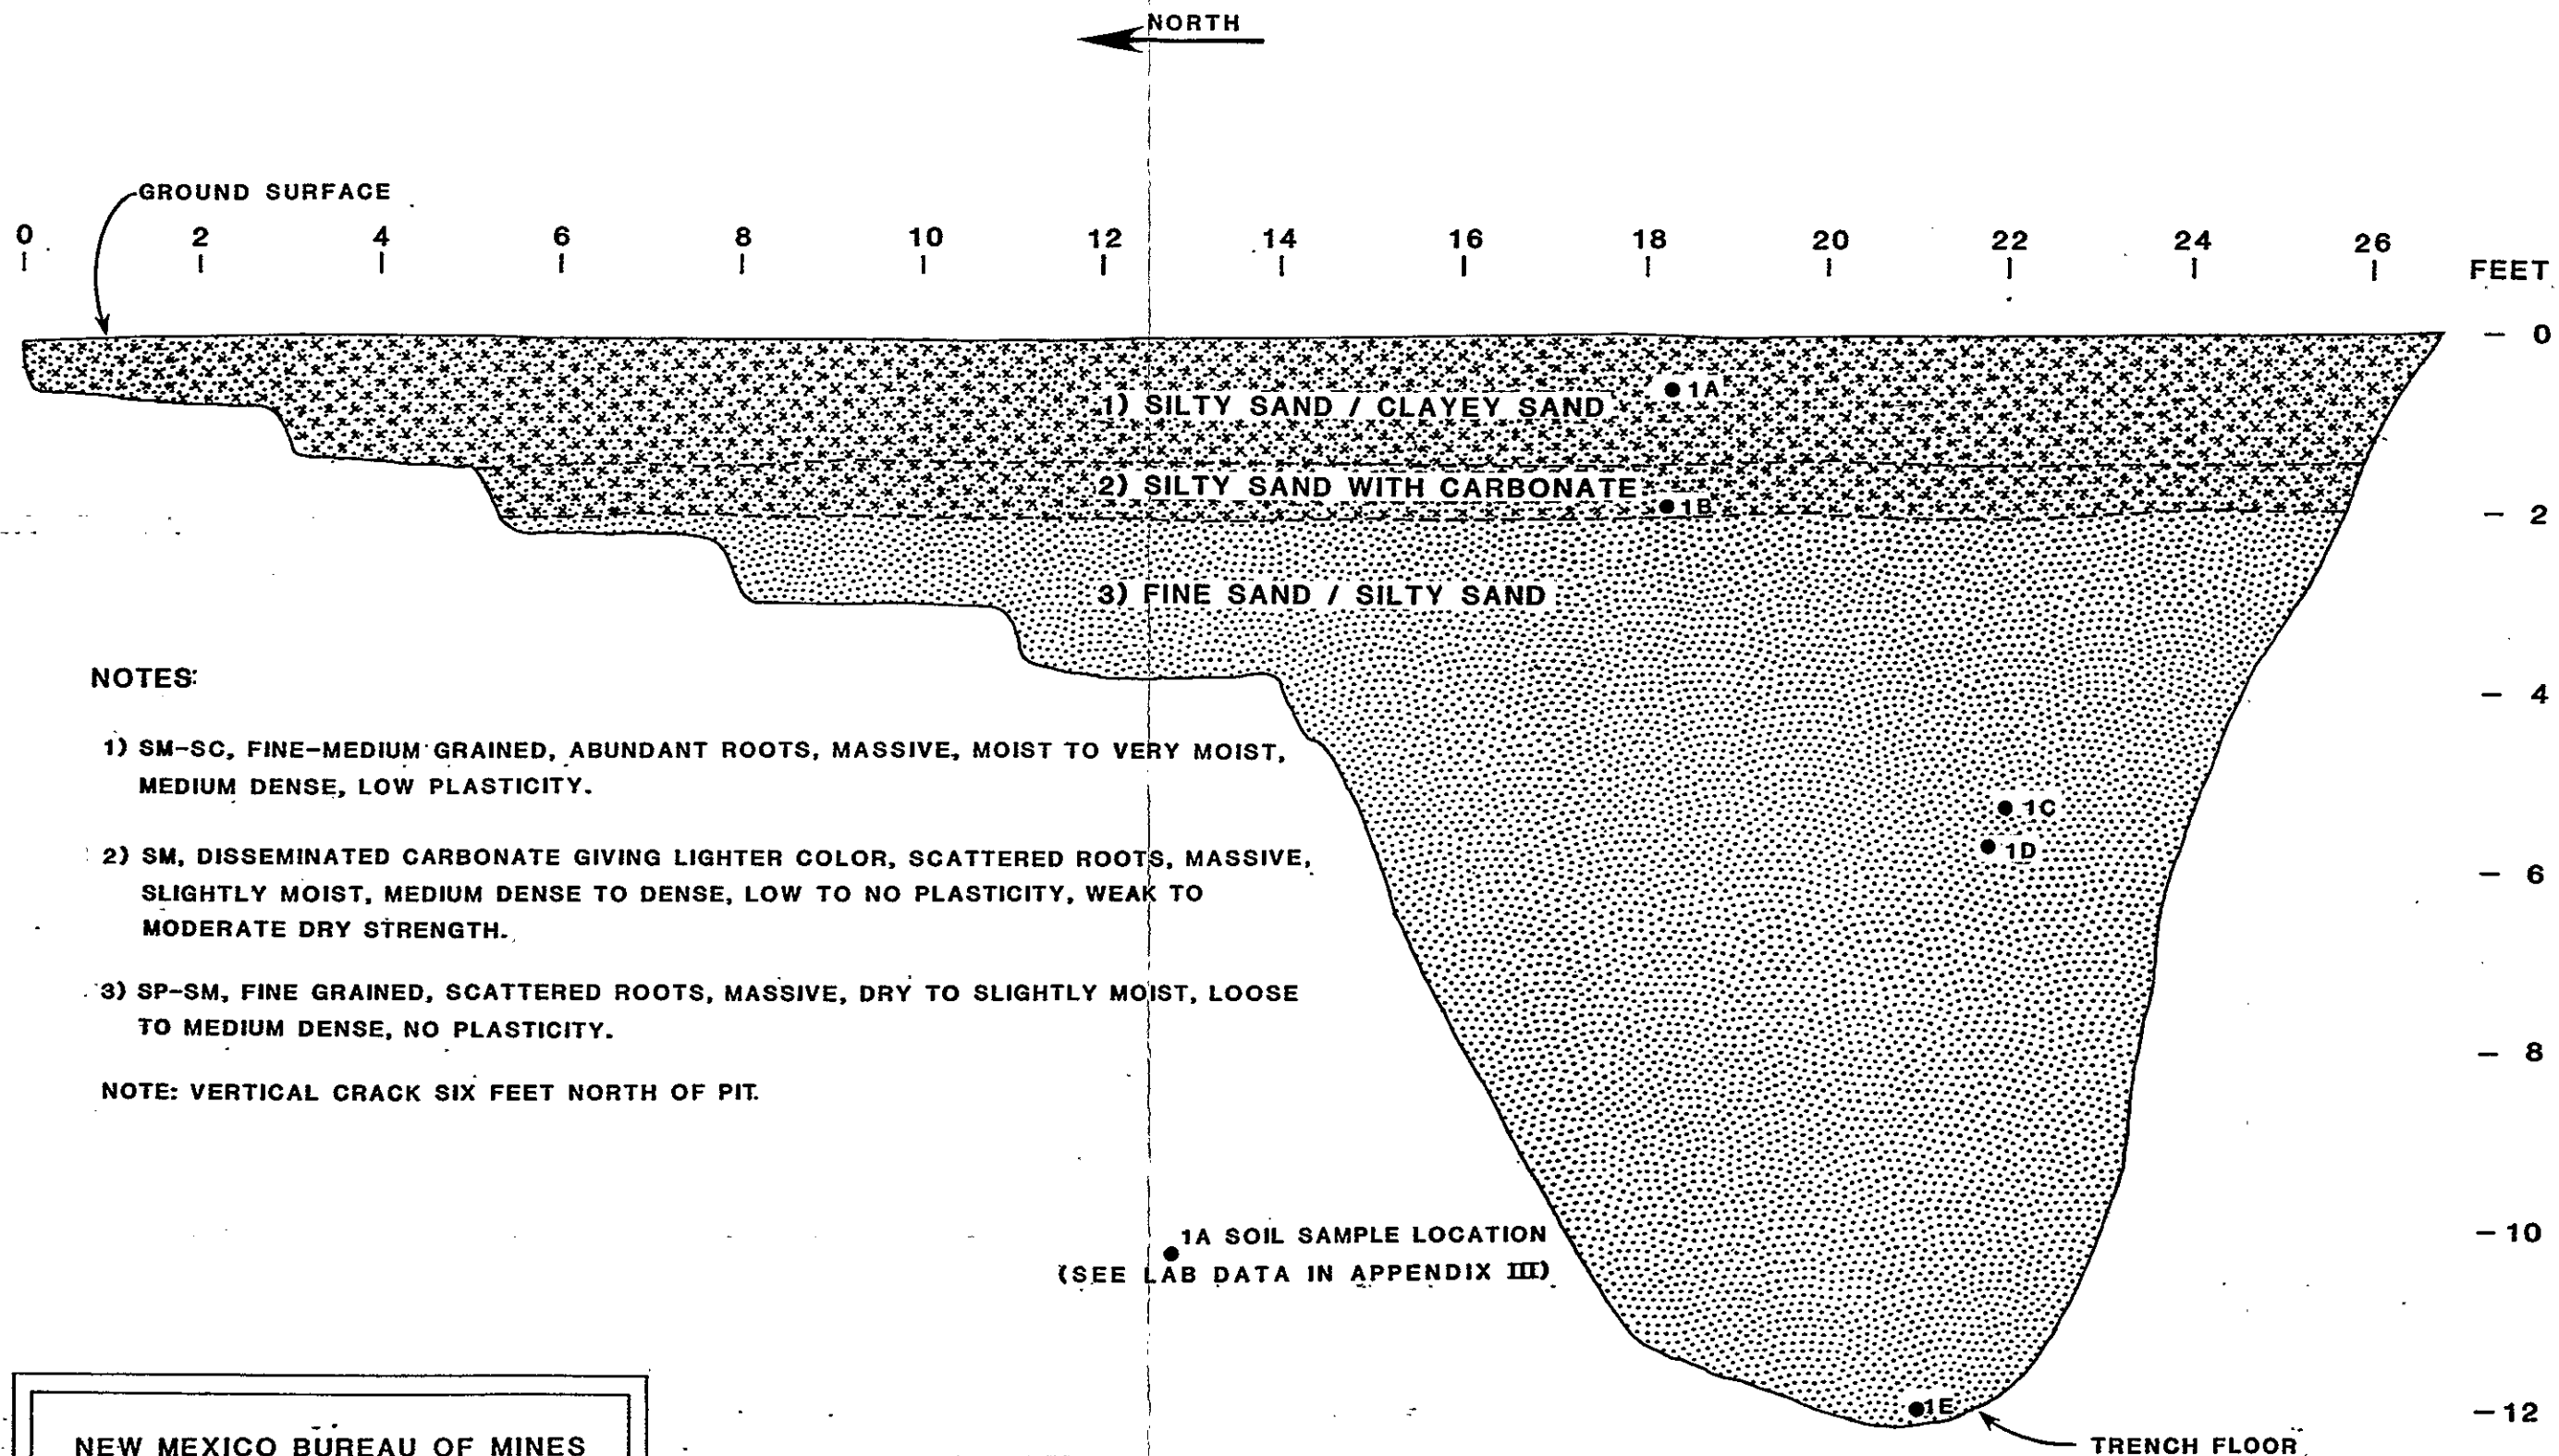
- 1) SM-SC, FINE-MEDIUM GRAINED, ABUNDANT ROOTS, MASSIVE, MOIST TO VERY MOIST, MEDIUM DENSE, LOW PLASTICITY.
- 2) SM, DISSEMINATED CARBONATE GIVING LIGHTER COLOR, SCATTERED ROOTS, MASSIVE, SLIGHTLY MOIST, MEDIUM DENSE TO DENSE, LOW TO NO PLASTICITY, WEAK TO MODERATE DRY STRENGTH.
- 3) SP-SM, FINE GRAINED, SCATTERED ROOTS, MASSIVE, DRY TO SLIGHTLY MOIST, LOOSE TO MEDIUM DENSE, NO PLASTICITY.

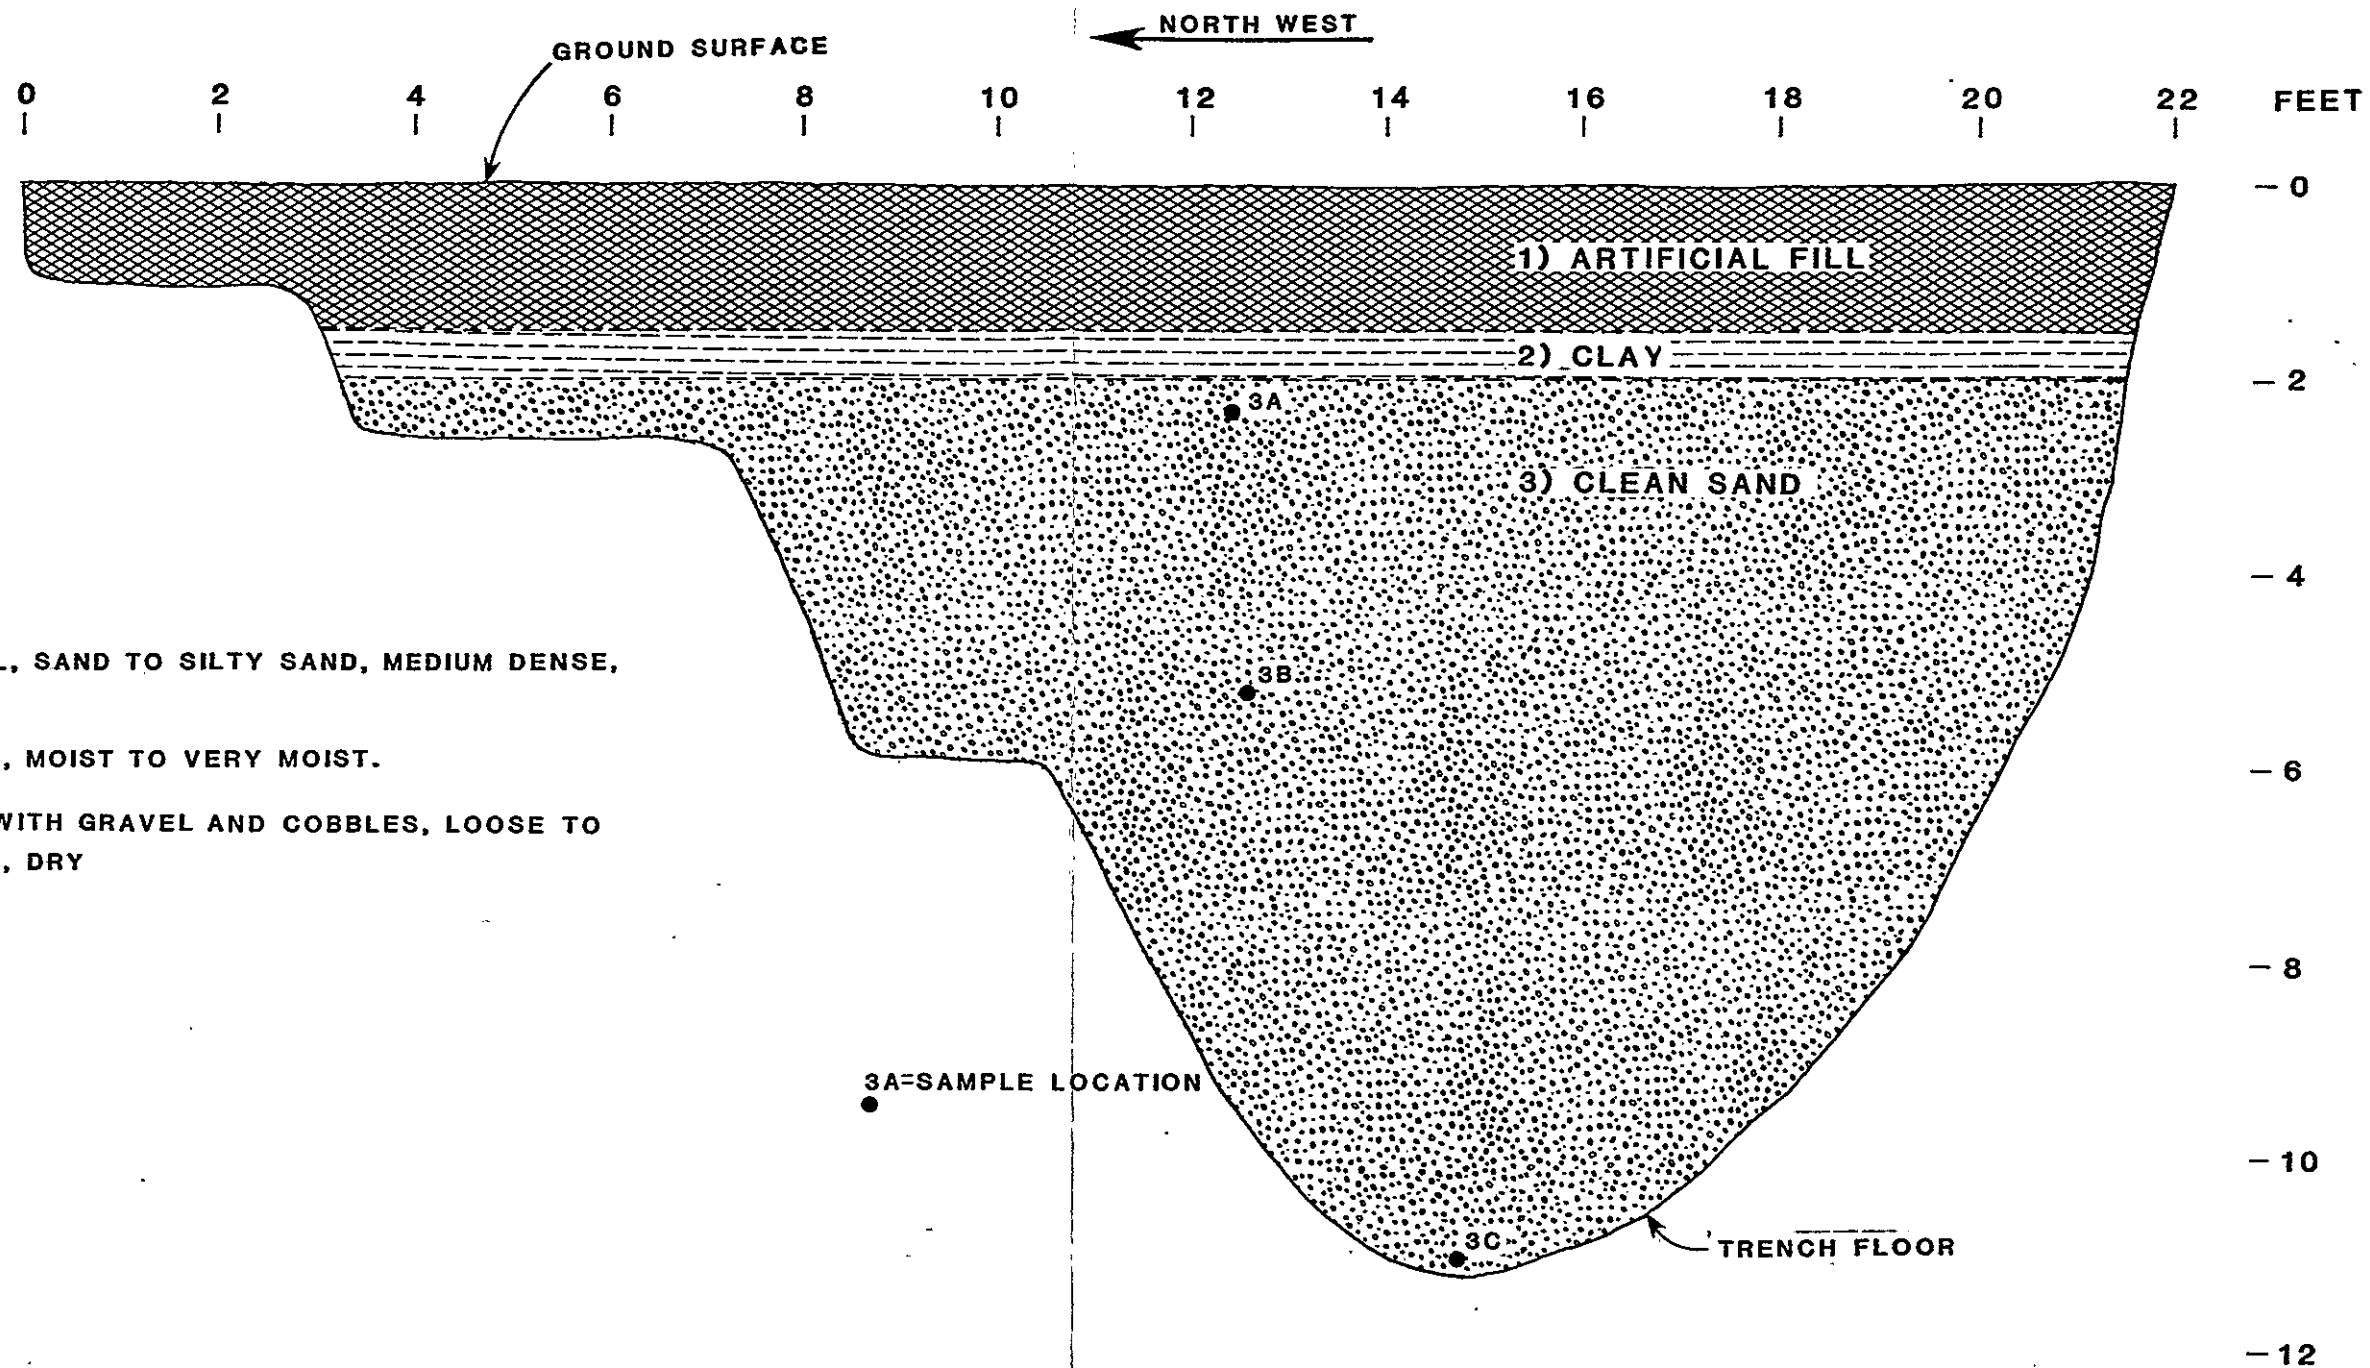
- 1) ARTIFICIAL FILL, SAND TO SILTY SAND, MEDIUM DENSE, VERY MOIST.
- 2) CL, CLAY, FIRM, MOIST TO VERY MOIST.
- 3) SW-SP, SAND WITH GRAVEL AND COBBLES, LOOSE TO MEDIUM DENSE, DRY

NOTE: TRENCH IS IN CENTER OF A SECOND, APPARENTLY OLDER, SUBSIDENCE FEATURE.

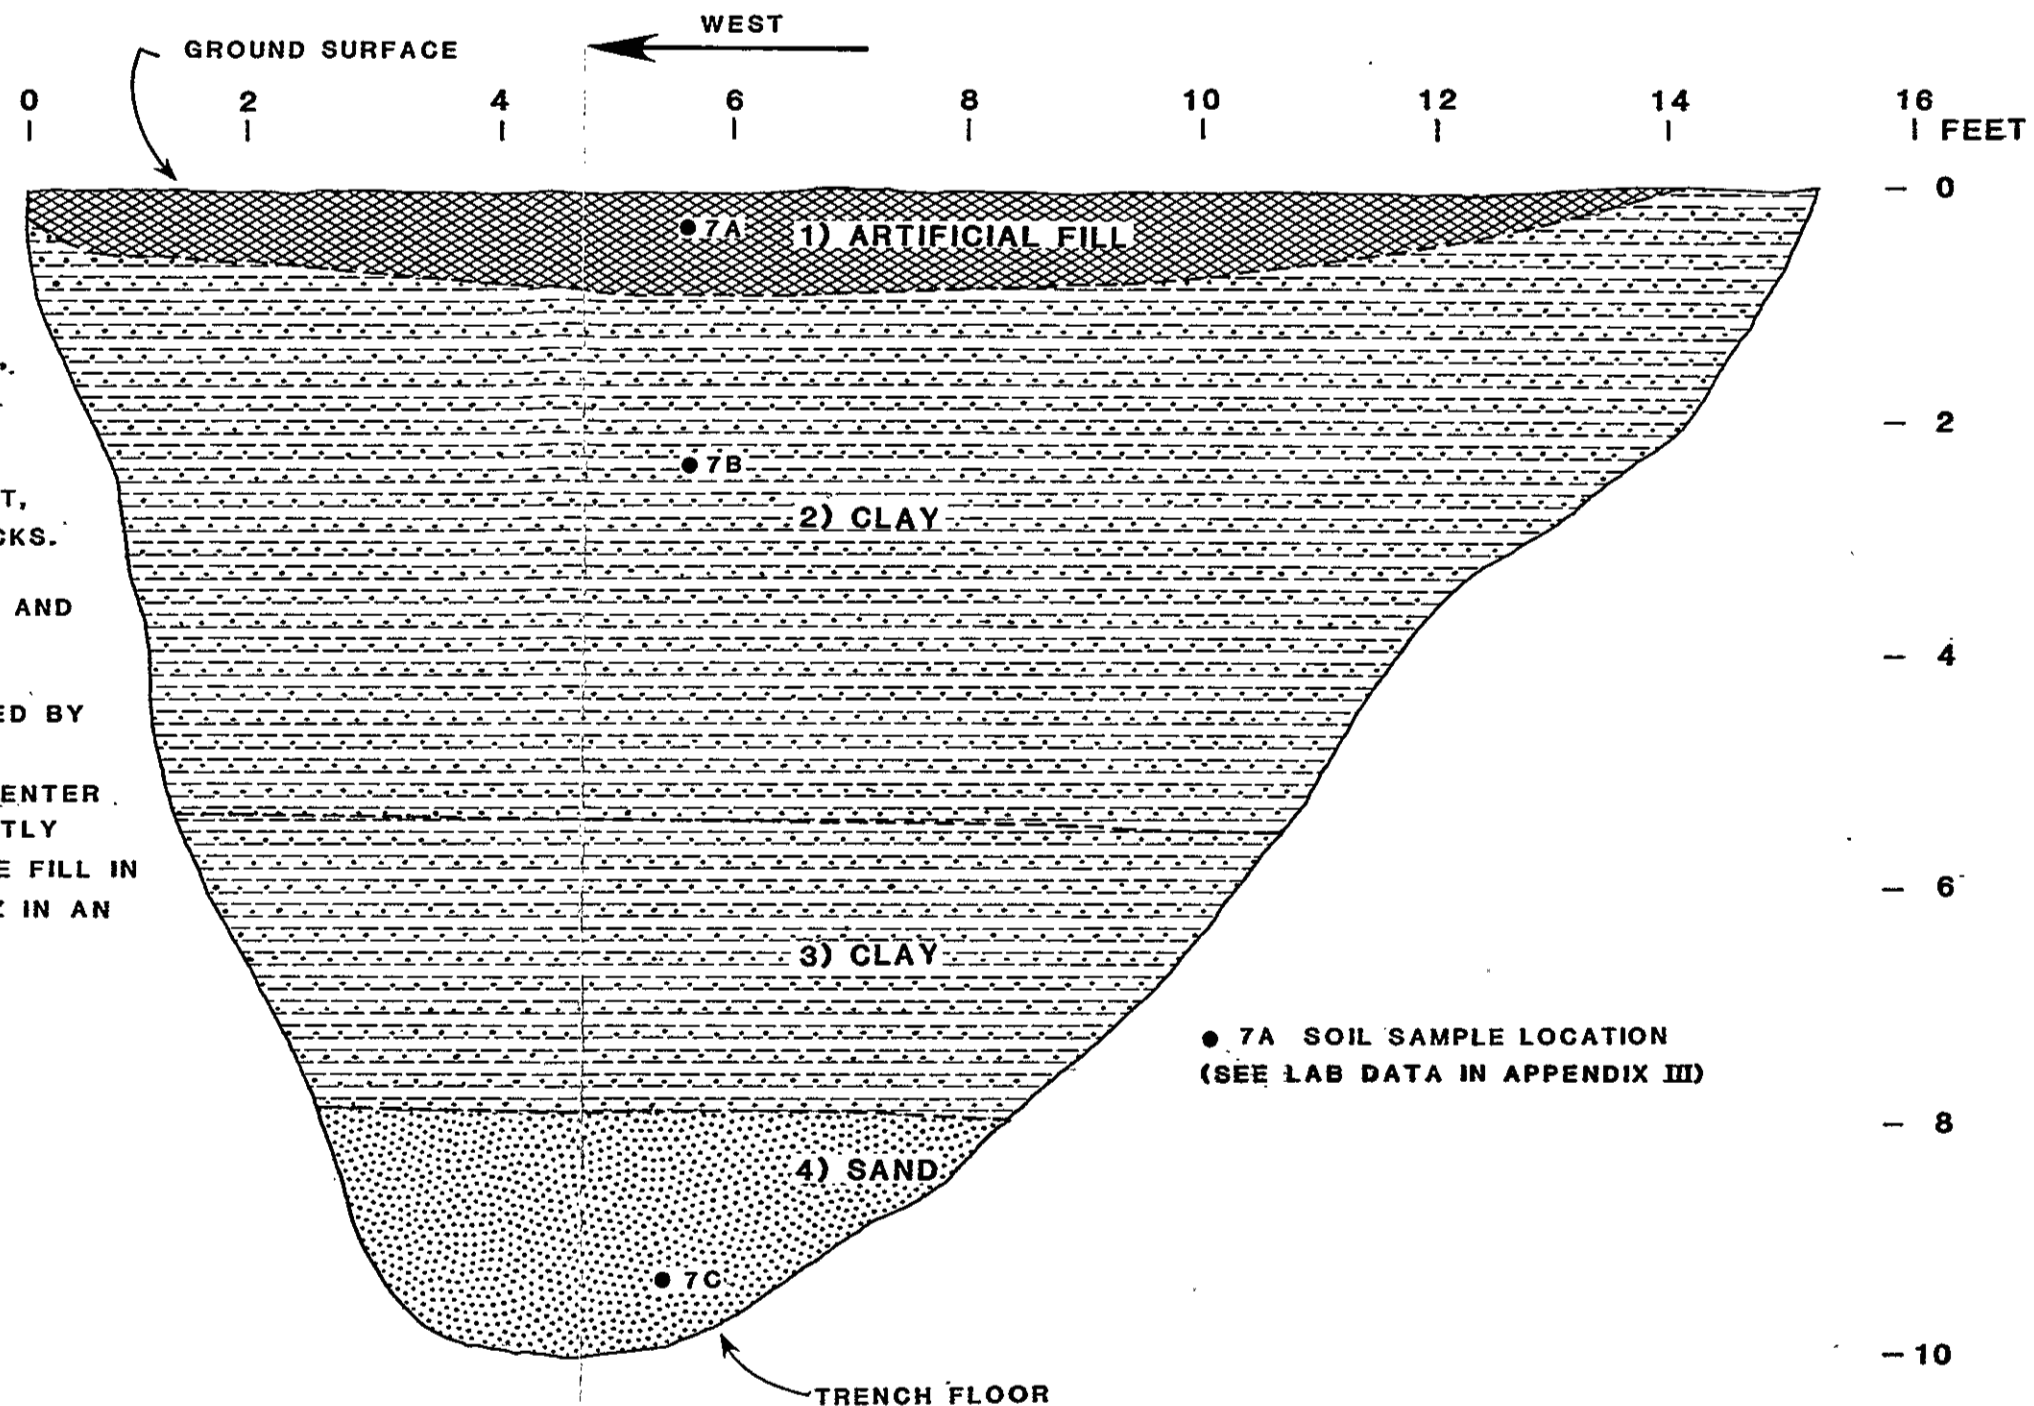
NEW MEXICO BUREAU OF MINES  
AND MINERAL RESOURCES  
EL LLANO SUBSIDENCE PROJECT  
LOG OF TRENCH ESBH-7

- 1) ARTIFICIAL FILL, WET TO VERY MOIST, MEDIUM DENSE, SCATTERED METAL FRAGMENTS.
- 2) CL-CH, CLAY, SATURATED TO VERY MOIST, SOFT, LOW TO MODERATE PLASTICITY, SCATTERED LIVE ROOTS.
- 3) CL-ML, CLAY TO SILT, MEDIUM TO SLIGHTLY MOIST, FIRM TO HARD, LOW PLASTICITY, ABUNDANT CRACKS.
- 4) SP, CLEAN MEDIUM-GRAINED SAND WITH GRAVEL AND COBBLES, DRY, LOOSE TO MEDIUM DENSE.

NOTE: TRENCH DUG OVER "SOTANO" REPORTED BY F. VALDEZ AT WESTERN END OF HIS PROPERTY. IRRIGATION WATER WOULD ENTER THE SOTANO AND DRAIN OFF, APPARENTLY THROUGH THE CRACKS IN LAYER 3. THE FILL IN LAYER 1 WAS EMPLACED BY F. VALDEZ IN AN ATTEMPT TO PLUG THE SOTANO.

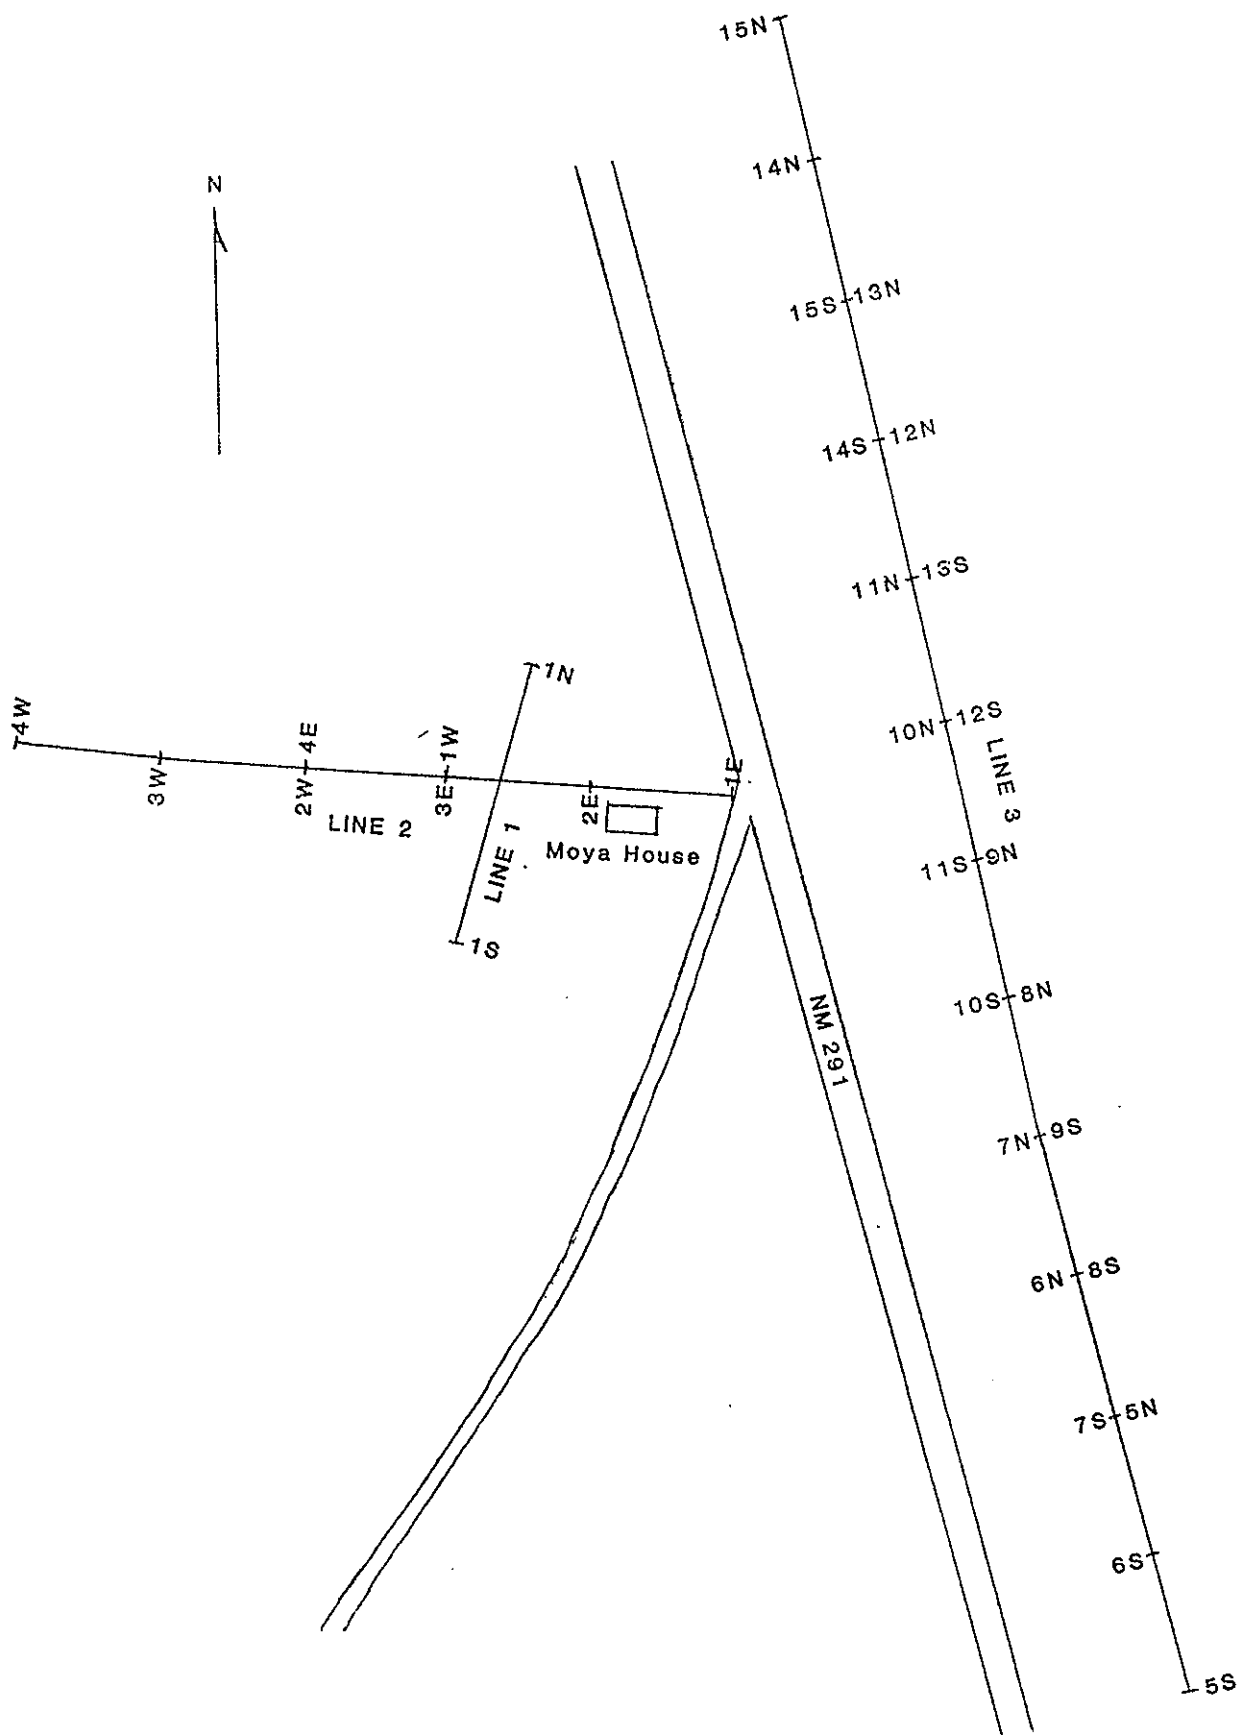
FIGURE 2 Location of Shallow Refraction Lines 1, 2 and 3, Espanola, New Mexico.

Line 2 was recorded from east to west along the lane north of the Moya house (Figure 2). Here the surface layer of about 900 ft/sec velocity thickens from about 6 ft at the east end to about 23 ft at the west end (Enclosure No. 3). The layer underlying it has a mean velocity of about 1198 ft/sec except near the area of the depression, where its mean velocity increases to about 1402 ft/sec. Overall, except for the increased velocity near the depression, this layer's velocity appears to decrease westward. The next deeper velocity layer, with a mean velocity of about 1800 ft/sec, appears to exist only from the area of the depression westward. It also increases in depth westward. Below this layer is another with a mean velocity in excess of 2000 ft/sec which deepens abruptly westward at about position 2W/4E; west of this point its velocity increases to more than 3000 ft/sec, or else the two are not correlative. Below this layer

C. Anomalous and somewhat similar shallow velocity conditions are present near the depression behind the Moya house (Line 2) and in the northern half of Line 3.

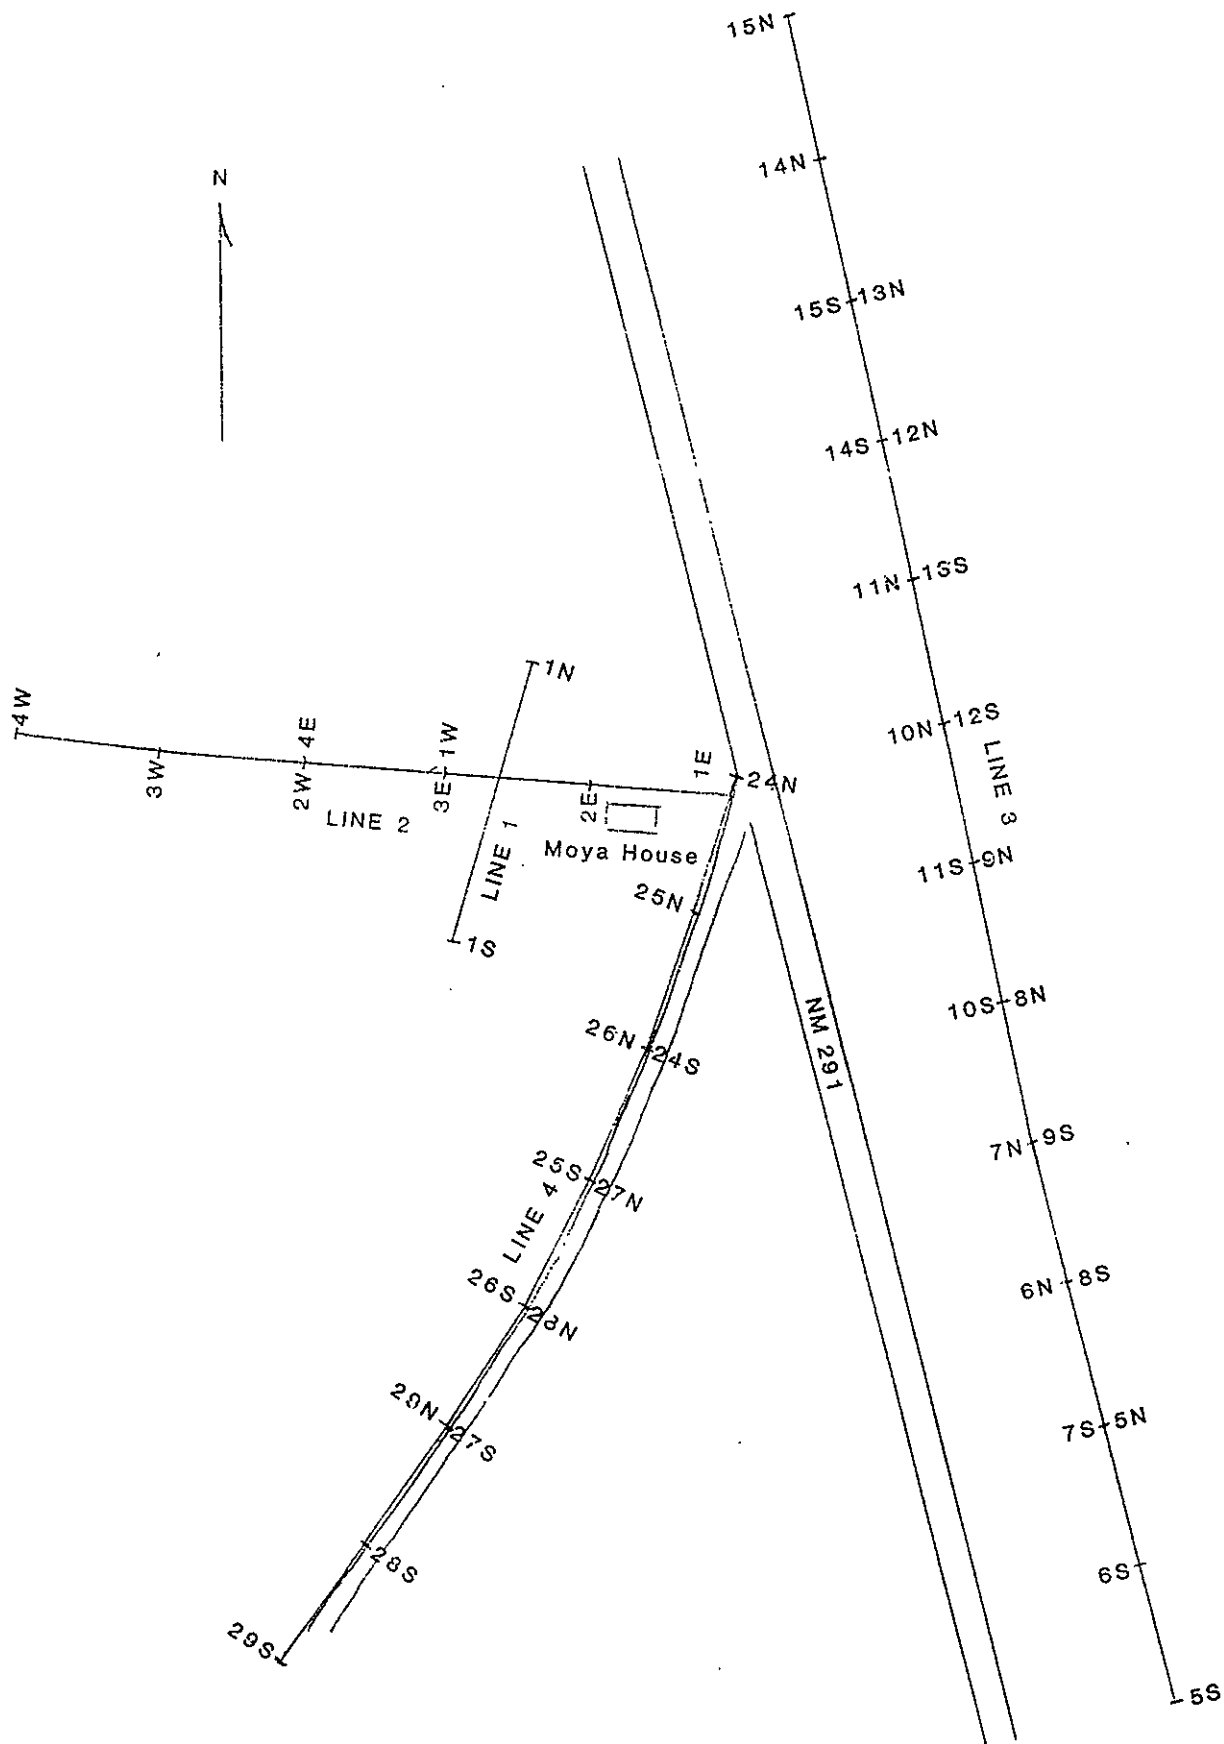
FIGURE 1 Location of Shallow Seismic Refraction Line 4  
Espanola, New Mexico  
Scale one inch equals 200 feet.

Introduction - On January 16, 1985, a second shallow seismic refraction survey was carried out in the northeastern part of Espanola, New Mexico, for the New Mexico Bureau of Mines and Mineral Resources. The survey consisted of two refraction lines, Line 4 (see Figure 1), 1050 ft long, and Line 5 (see Figure 2), 750 ft long. The purpose of the survey was, as with the previous survey (see report dated Jan. 10, 1985), to investigate the shallow subsurface geology of the area as an aid to understanding the causes of surface subsidence problems experienced in the vicinity.

An effort should be made, using existing drilling and geophysical data, to identify the nature of the shallow high velocity material indicated under the southwest part of Line 4. A further report should be issued following this suggested study. Additional seismic refraction data and further drilling will probably then be required to complete the investigation of this anomalous condition.

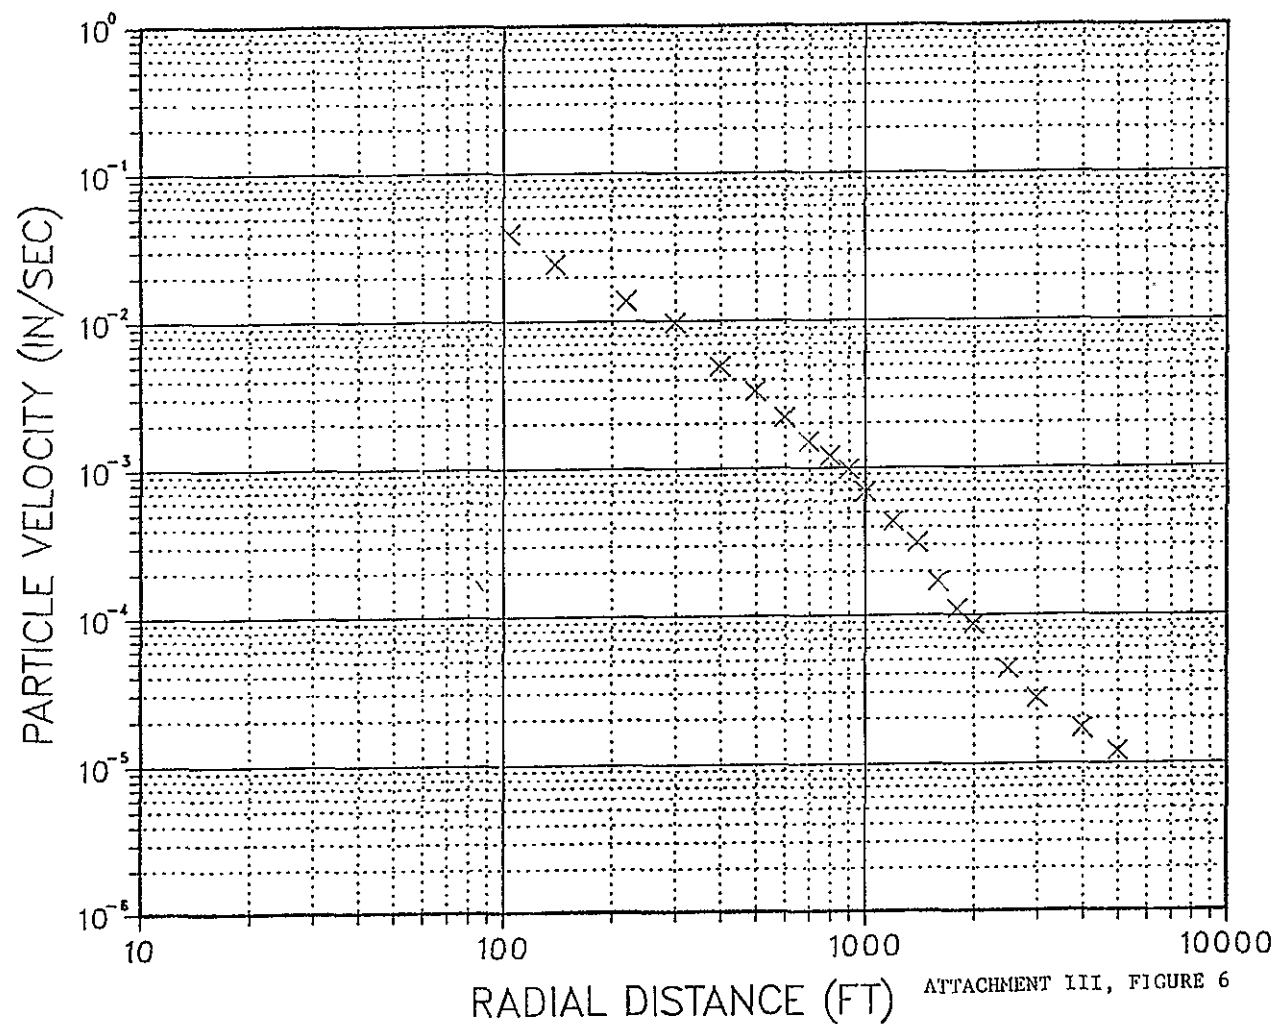
ATTACHMENT III, FIGURE 6

SWEPI's Party 120 has analyzed several shots from their line 165. Figures 2 thru 7 show graphs of velocity (inches per second) versus distance for the analyzed shots, with a label specifying charge size and hole depth. It should be noted that these shots were chosen to give a fair representation of the charge sizes and hole depths associated with Shell acquisition for line 165. In all cases the peak particle velocity recorded is well below the Bureau's suggested maximum of 0.5 inches per second. In fact, the maximum peak particle velocity found on these shots was 0.06 inches per second directly above shot 3502.

LINE 84-120-165  
SHOTPOINT 3502, 40# AT 100 FT.
