EL LLANO AND VICINITY  
GEOTECHNICAL STUDY

FINAL REPORT

VOLUME I

New Mexico Bureau of Mines and Mineral Resources  
Socorro, New Mexico 87801

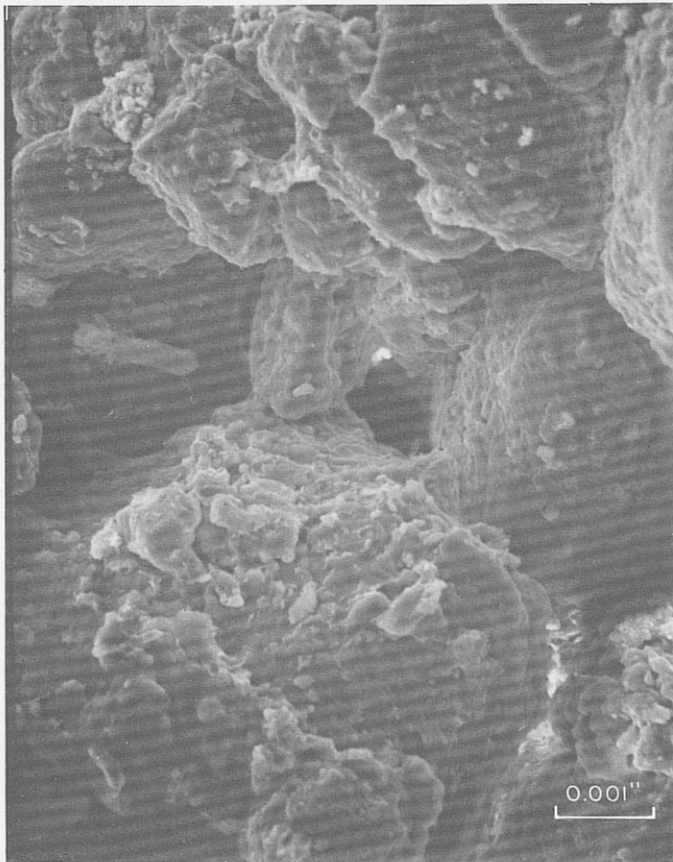
Examination indicated that soils from unirrigated areas east of the El Llano acequia (Photograph 12) tended to be more open

PHOTOGRAPH 11—Scanning electron photomicrograph of uncollapsed soil sample at well number GGSSS-1 east of El Llano acequia. Sample is from 10 feet below surface. Note open structure with larger quartz grains loosely bound with finer grained (silt and clay) material along grain-to-grain contacts.

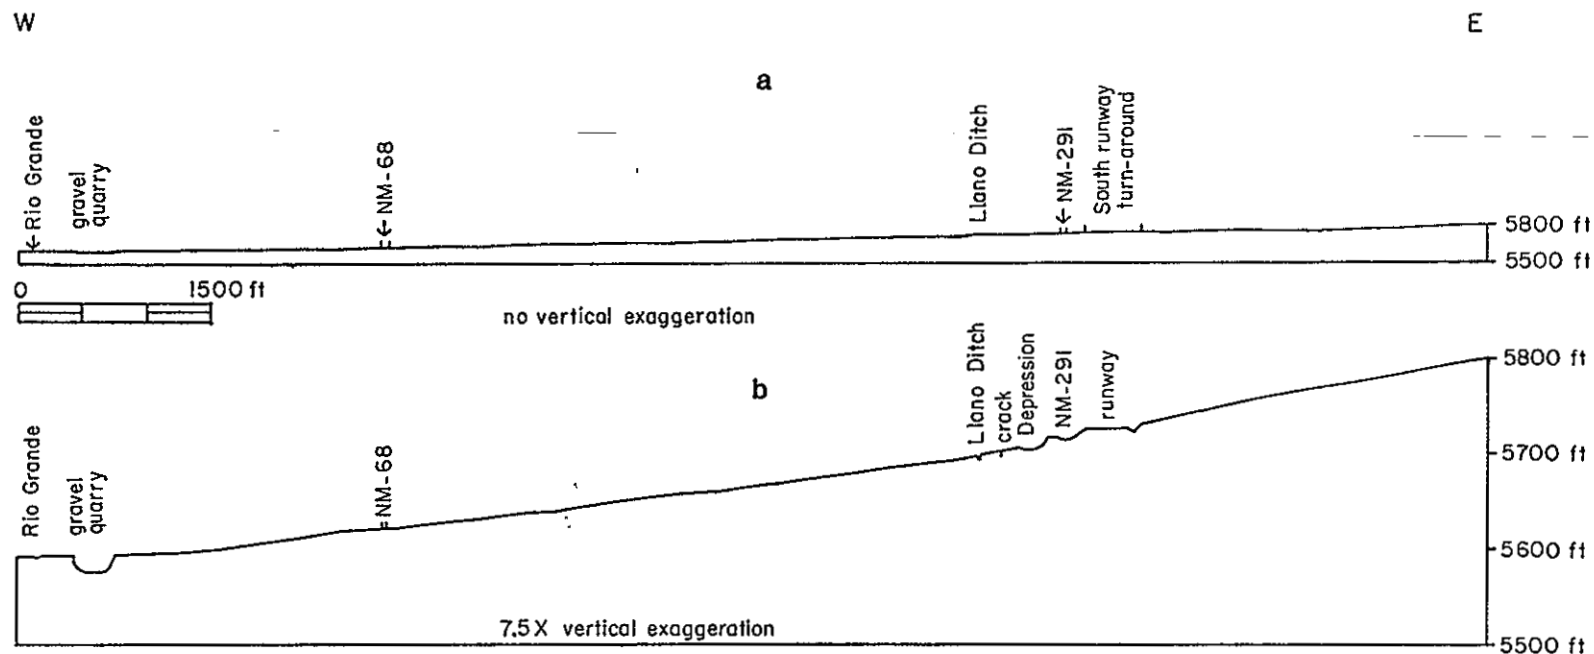
El Llano area are due to removal of gravel near the Rio Grande. Several problems arise concerning this hypothesis. First, removal of gravel is small (20 feet deep at most) and localized. Second, in order for gravel removal to cause cracks and subsidence in El Llano, tensile stresses (forces tending to pull materials apart) would have to be exerted over a distance of 7,000 feet through relatively loose soil and gravel (Fig. 10-2). The soil and gravel are not strong enough to transmit tensile stresses over such a long distance to form cracks in the El Llano area. Tensional cracks generated by gravel removal should form between gravel clasts (pebbles and cobbles) immediately adjacent to the gravel pits if at all (depending on how steep the walls of the pits are and a number of factors concerning the physical properties of the gravel deposits). Formation of the cracks and subsidence pits in El Llano appears to be physically impossible by this proposed mechanism.

Figure 10-2. Topographic profile across the El Llano area from east of the airport to the Rio Grande. Gravel quarry projected into line of profile. (a) profile with no vertical exaggeration. Note extremely gentle slope. (b) Same profile with 7.5 times vertical exaggeration.

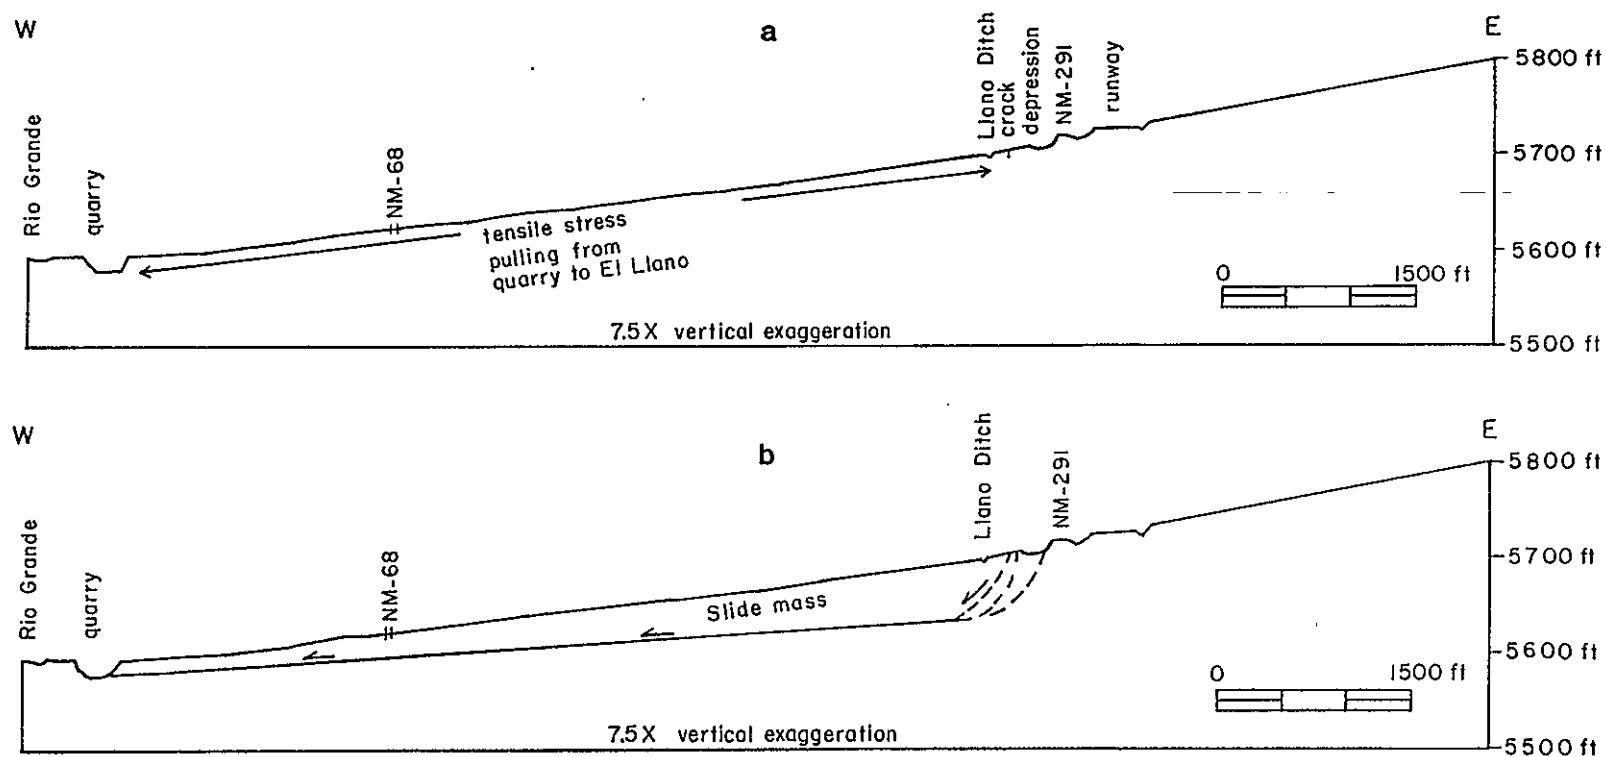
A slightly different version of the second hypothesis would be that the soil between El Llano and the Rio Grande was moving toward the quarries and the river as a giant earth slide (Fig. 10-3). The cracks and subsidence pits would then be considered features where the slide was breaking away from a more stable headwall. Removing gravel would be similar to removing the toe of the slide, causing further movement to the west. The problems with this hypothesis include 1) the extremely low slope over which the slide would have to move, 2) the apparent lack of a suitable slide surface along which slippage could occur, 3) the lack of offset (down to the west) on the cracks in El Llano, and 4) the lack of other landform features, which should be found

Figure 10-3. Illustrations of hypothetical stresses related to gravel removal. (a) Tensile stress pull-apart forces) transmitted between quarry and El Llano. (b) Landslide moving from El Llano to quarry.

from the toe to the top of the slide if the whole area had moved to the west. Each of these points could be discussed in detail, but the conclusion is that large-scale landsliding brought on by local removal of gravel is not physically possible in this case.

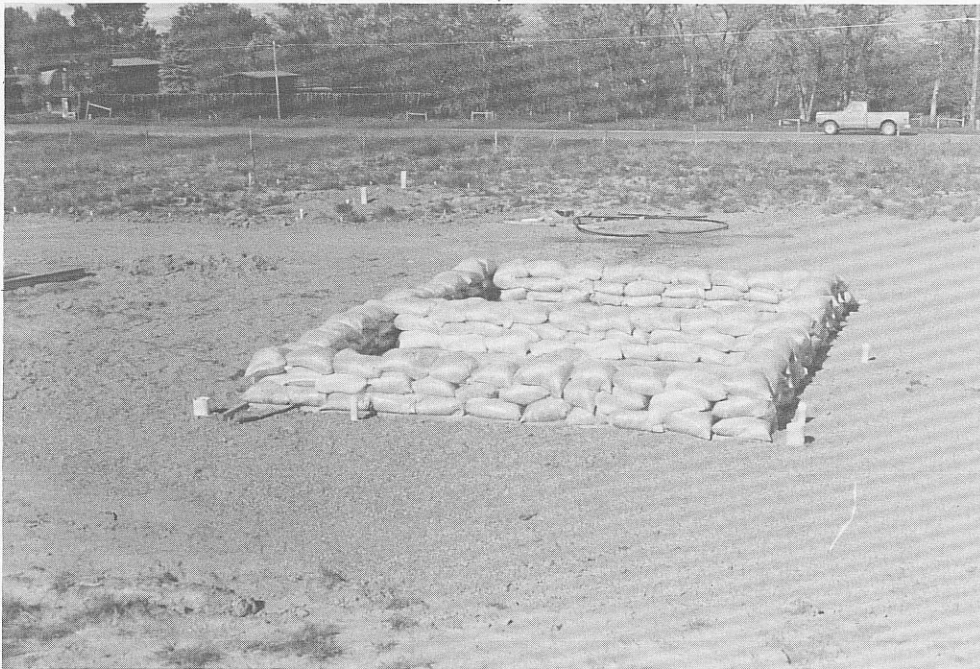
PHOTOGRAPH 8—Geotechnical ground stabilization study area 4 (GGSS-4) before collapse occurred (view to the west).

conducted at GGSS-Area 4 with two contrasting concrete foundations (photograph 8, Fig. 12-2). The two foundations (approximately 10 ft x 15 ft x 4 inches) were constructed side-by-side approximately 50 ft from areas 1 and 3 in similar-type soils. One foundation was constructed with footings and rebar support common to foundations in the El Llano area. The other foundation was constructed as a BRAB foundation, with more extensive footings and an interlocking rebar "cage" that adds greatly to the strength of the foundation. This type of foundation was devised by the Building Research Advisory Board (BRAB) for use on soils that expand when wetted. However, the foundation appears to function equally well when used with structures built on collapsible soils. Both foundations were weighted with sand bags to simulate the weight of a building. The 15 monitoring wells placed around the foundations made it possible to trace the underground water seepage and to measure the amount, the timing, and the location of the settlement.

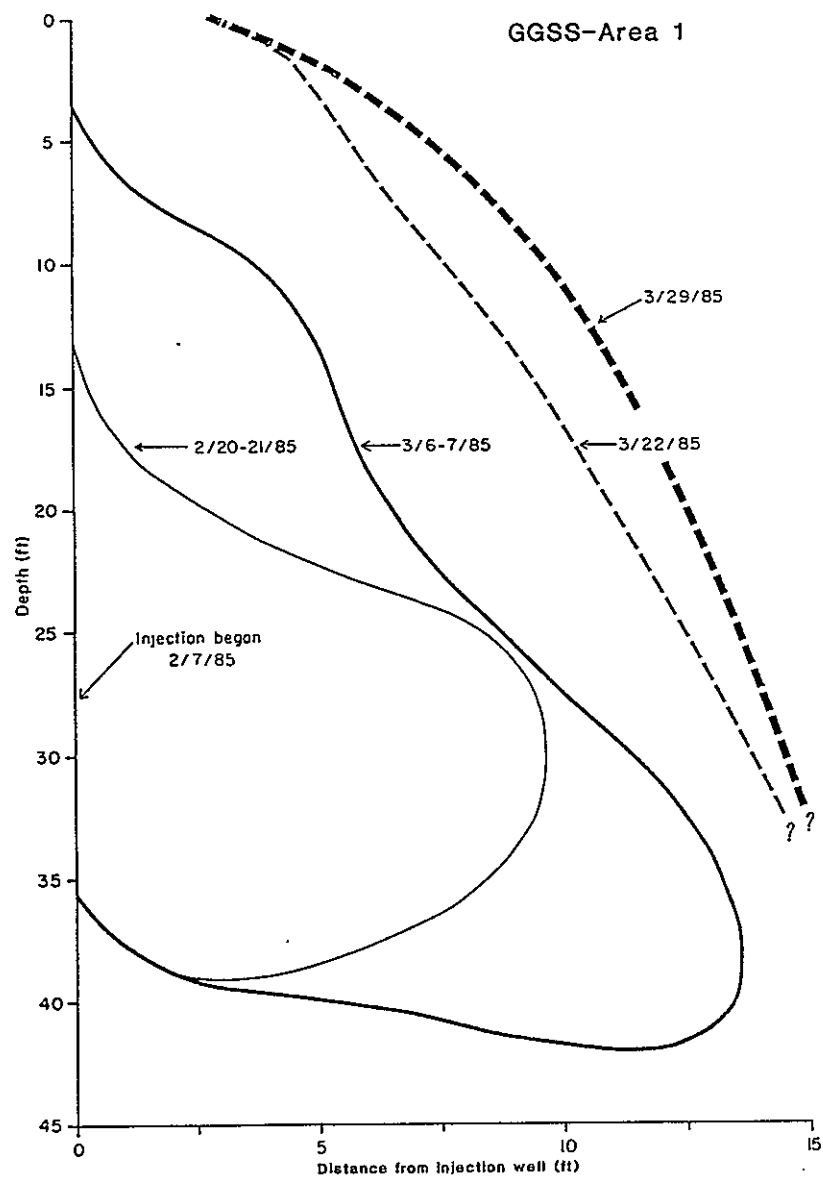
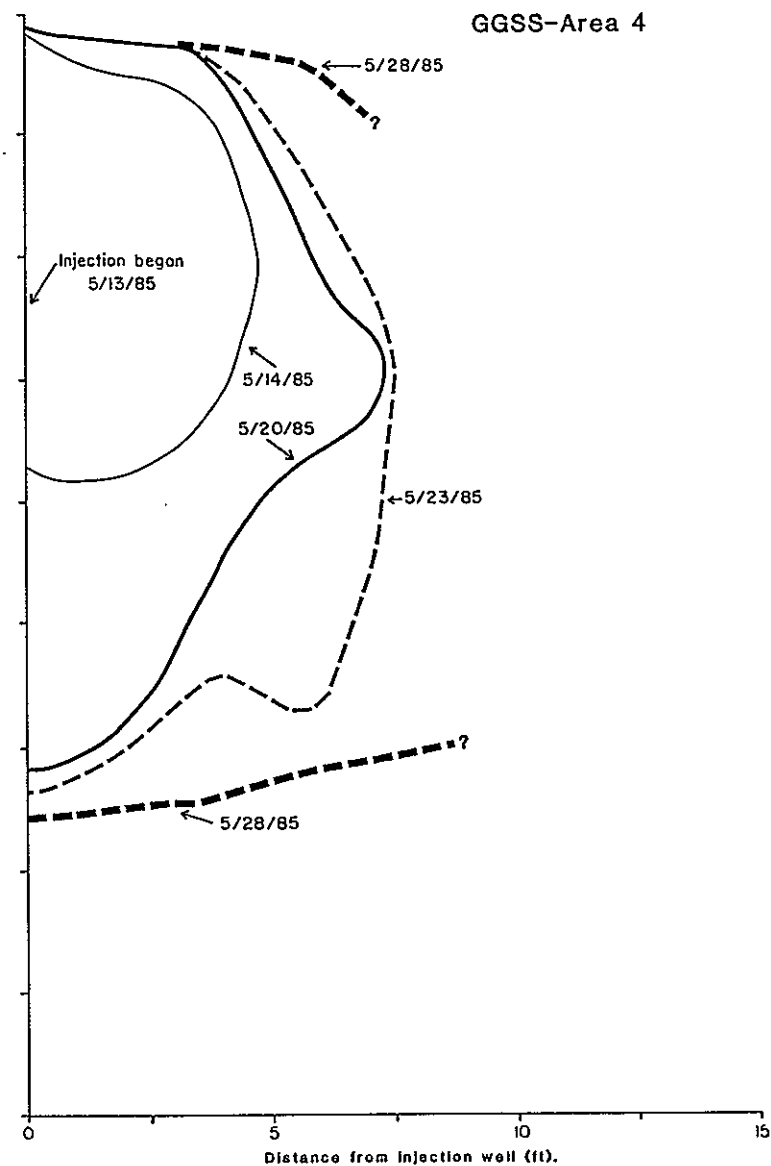
At GGSS-Area 2 subsidence did not occur even though the subsurface monitoring indicated that the volume of soil wetted was consistent with the volume wetted at areas 1, 3, and 4 (Fig. 12-1). The experiment at area 2 was continued for 84 days, at which time it was apparent that collapse would not occur. As noted above, the soils at area 2 have been wetted for a long time, and soil collapse in these irrigated lands between the two acequias appears to have ceased, although some potential for subsidence may still exist.

Figure 12-1. Changes of moisture front position with time at GGSS-Areas 1 & 4 . Positions extrapolated from drill hole log information, moisture samples, and down-hole nuclear probe data.

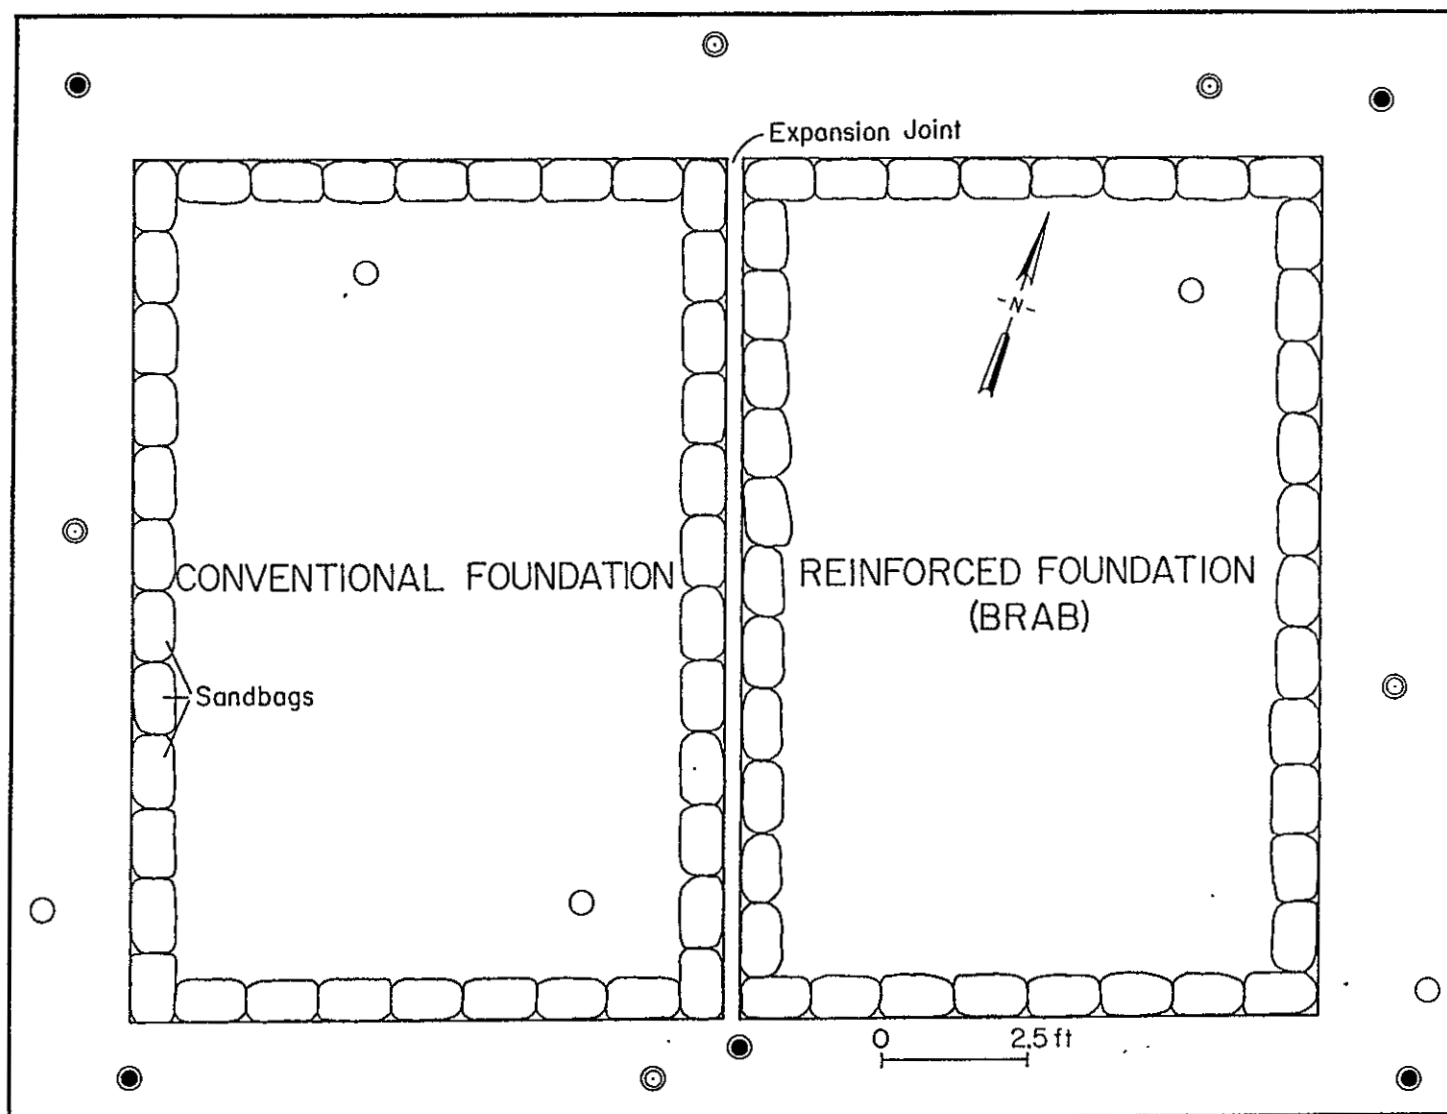
The foundations began to subside uniformly within 13 days, after 19,881 gal of water had been injected into the five water-injection wells which were 10-ft deep (Photograph 9). Injection

Figure 12-2. Map of GGSS-Area 4 (concrete foundations) showing well locations.

A significant advantage of the BRAB foundation-type design is that it remains intact subsequent to any differential settlement of soils. In contrast to conventional foundations, its strength allows it to be releveled if differential settlement should occur. Any structure on the BRAB foundation remains essentially undisturbed. Conventional foundations in the El Llano area commonly fracture when subjected to the stresses that arise from differential settlement.

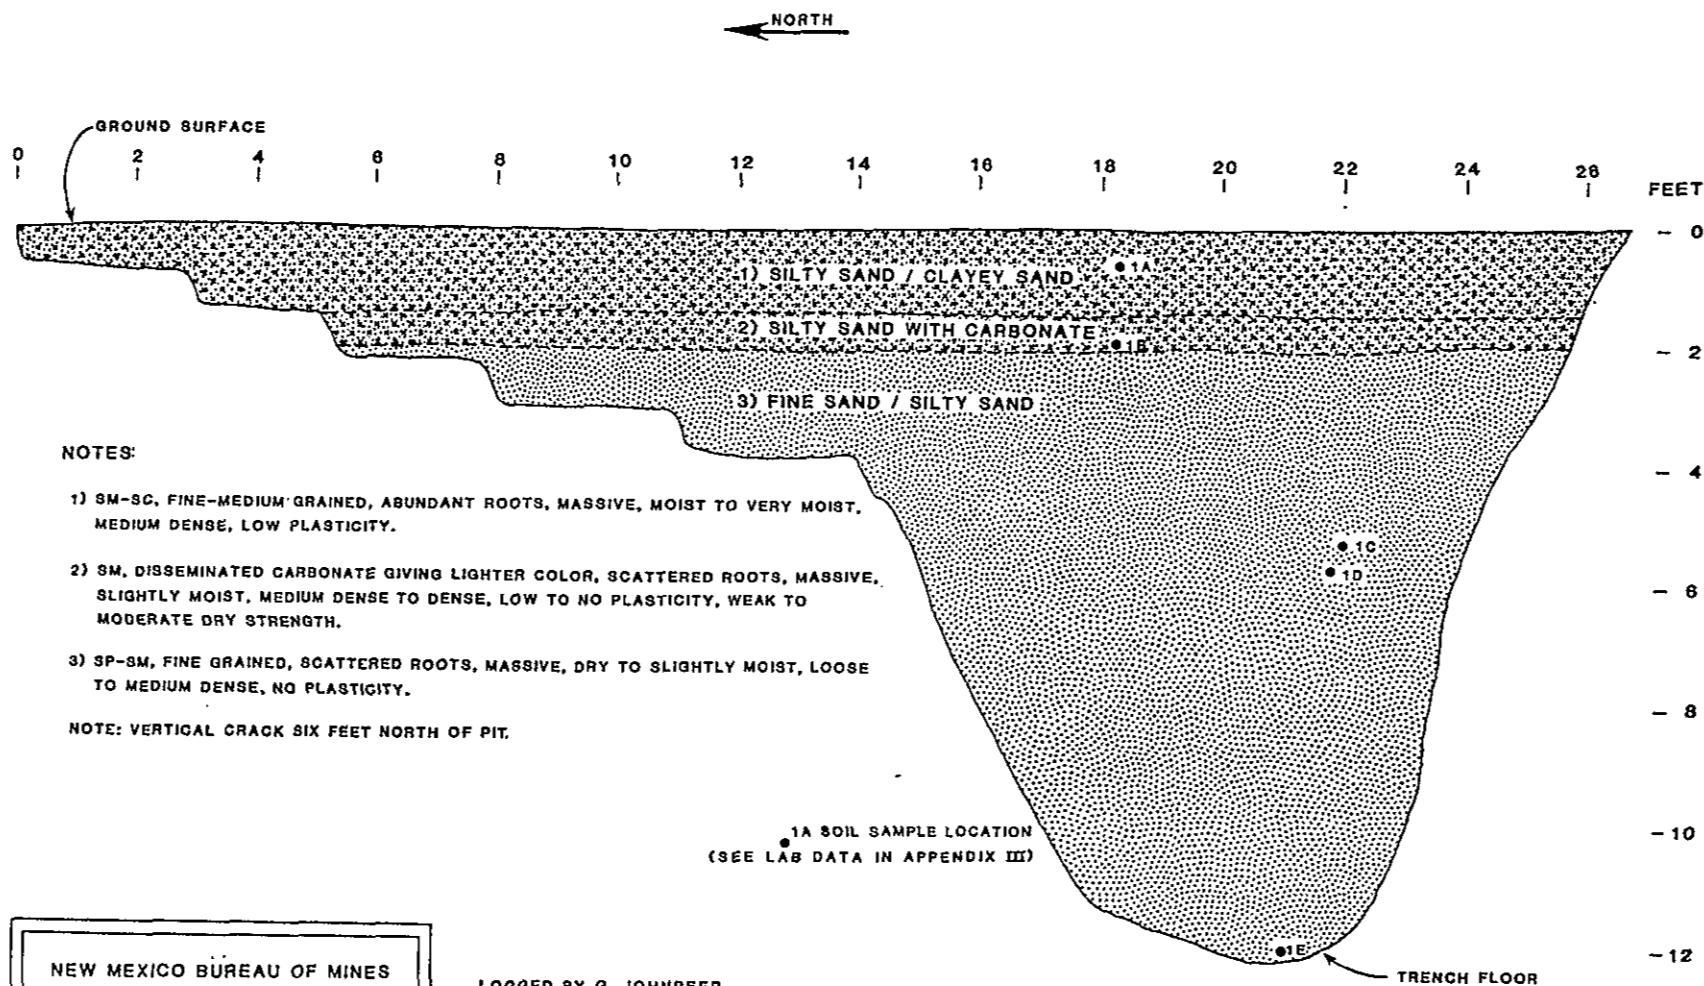
NEW MEXICO BUREAU OF MINES  
AND MINERAL RESOURCES  
EL LLANO SUBSIDENCE PROJECT  
LOG OF TRENCH ESBH-1  
FINAL 28 JUNE 1985

Eleven trenches, ranging in depth from 7 to 12 feet, were excavated, shored, gridded, and logged in detail to characterize shallow subsurface conditions and to investigate the nature of cracks at depth (Photograph 4). The logs of the trenches are presented in Appendix II. In places, the trench logs show a relationship between cracks and animal burrows (krotovina) and typically show the inactive character of most cracks at depth. The implications of these fundamental findings are discussed in Section 10.11.

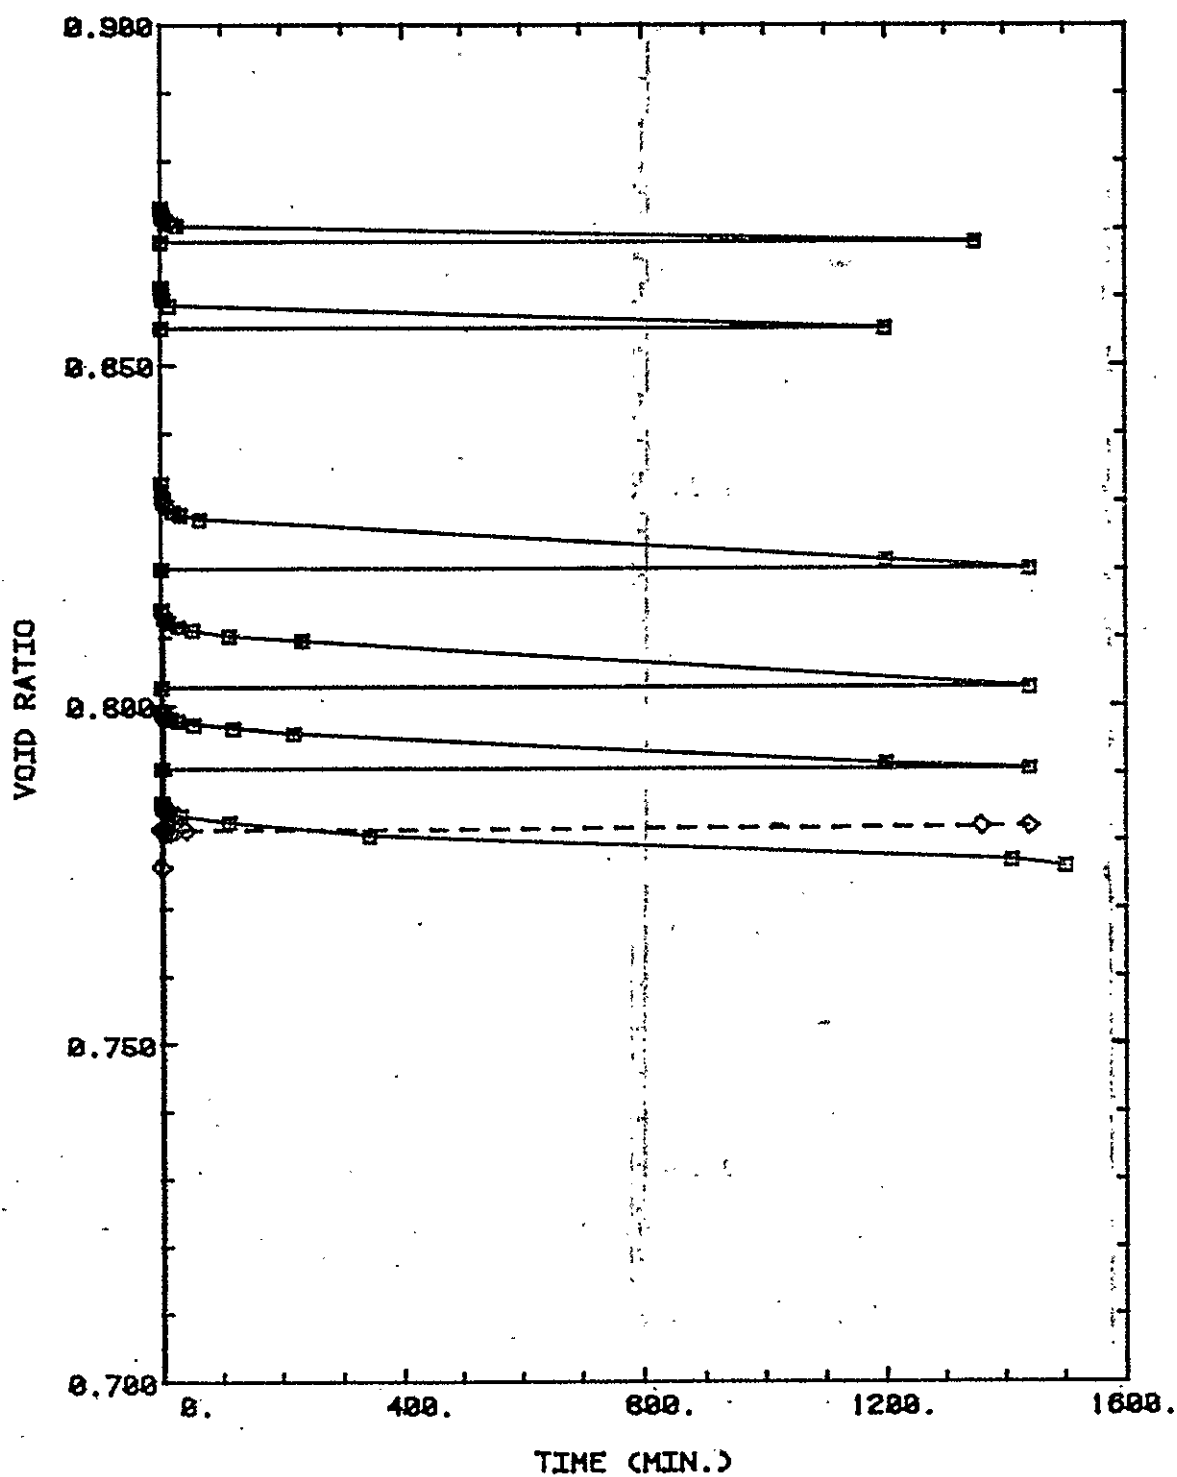
Figure 6a. Collapse observed during loading in consolidation cell at background moisture content. Dashed line shows rebound.

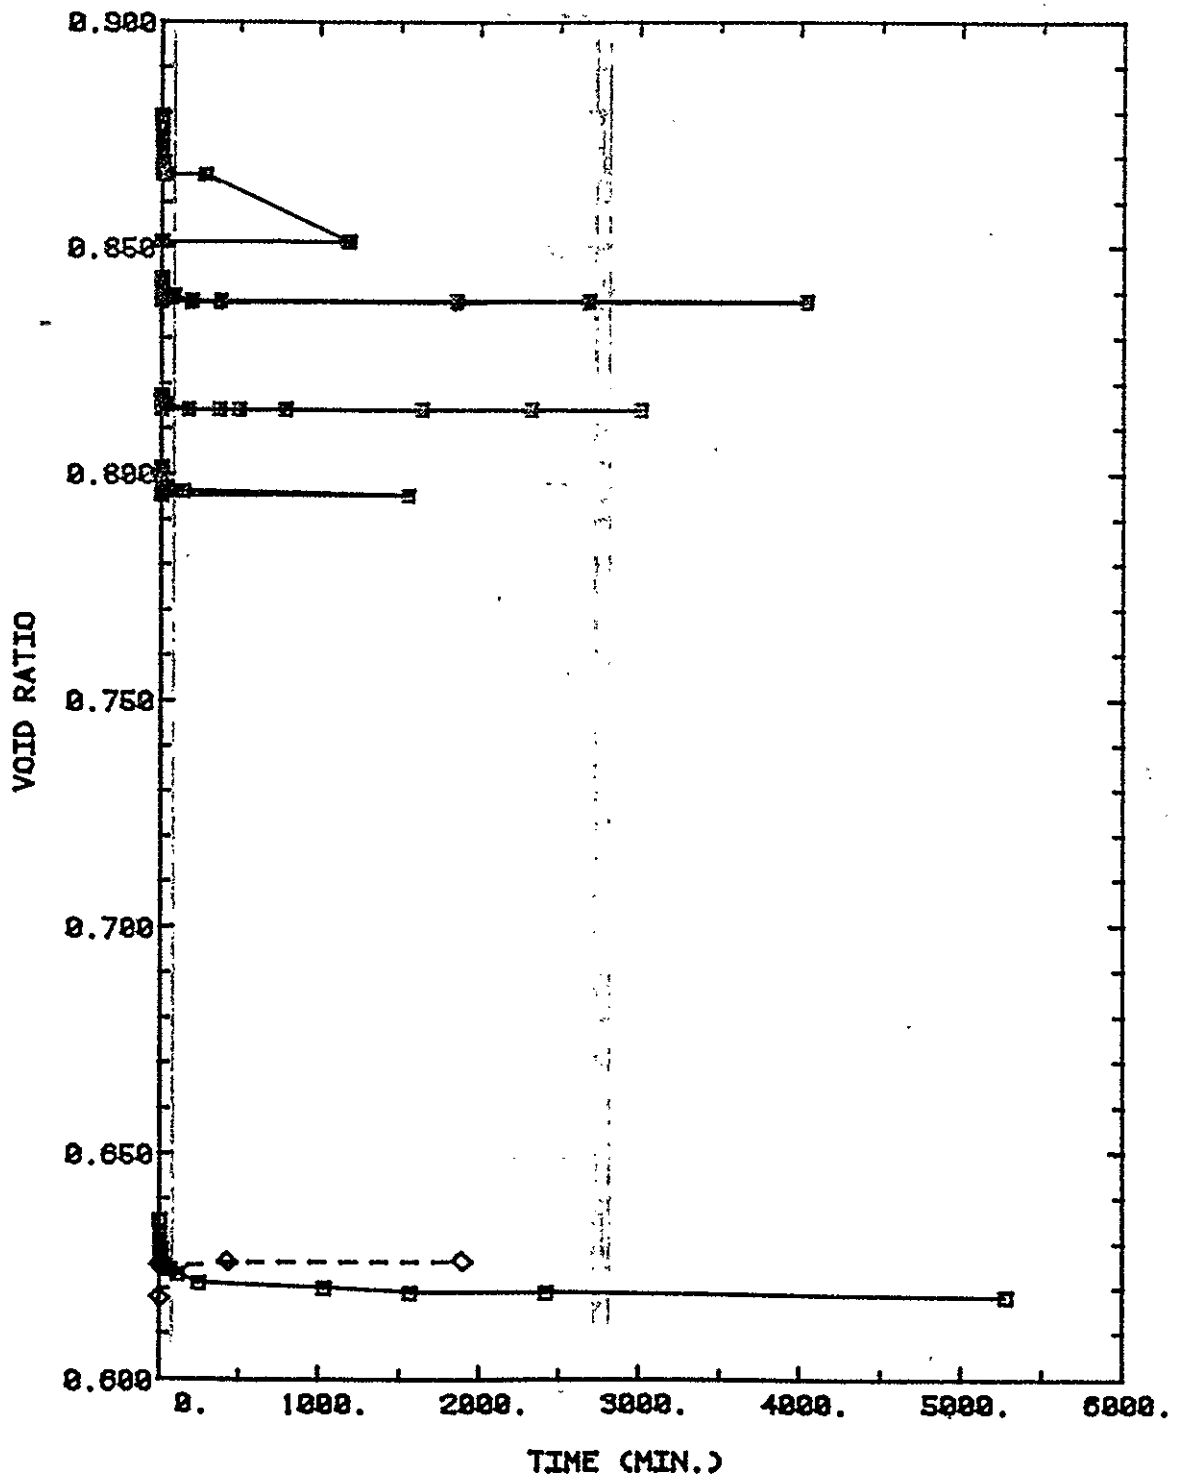
Figure 6b. Collapse observed during loading in consolidation cell at saturation. Dashed line shows rebound.

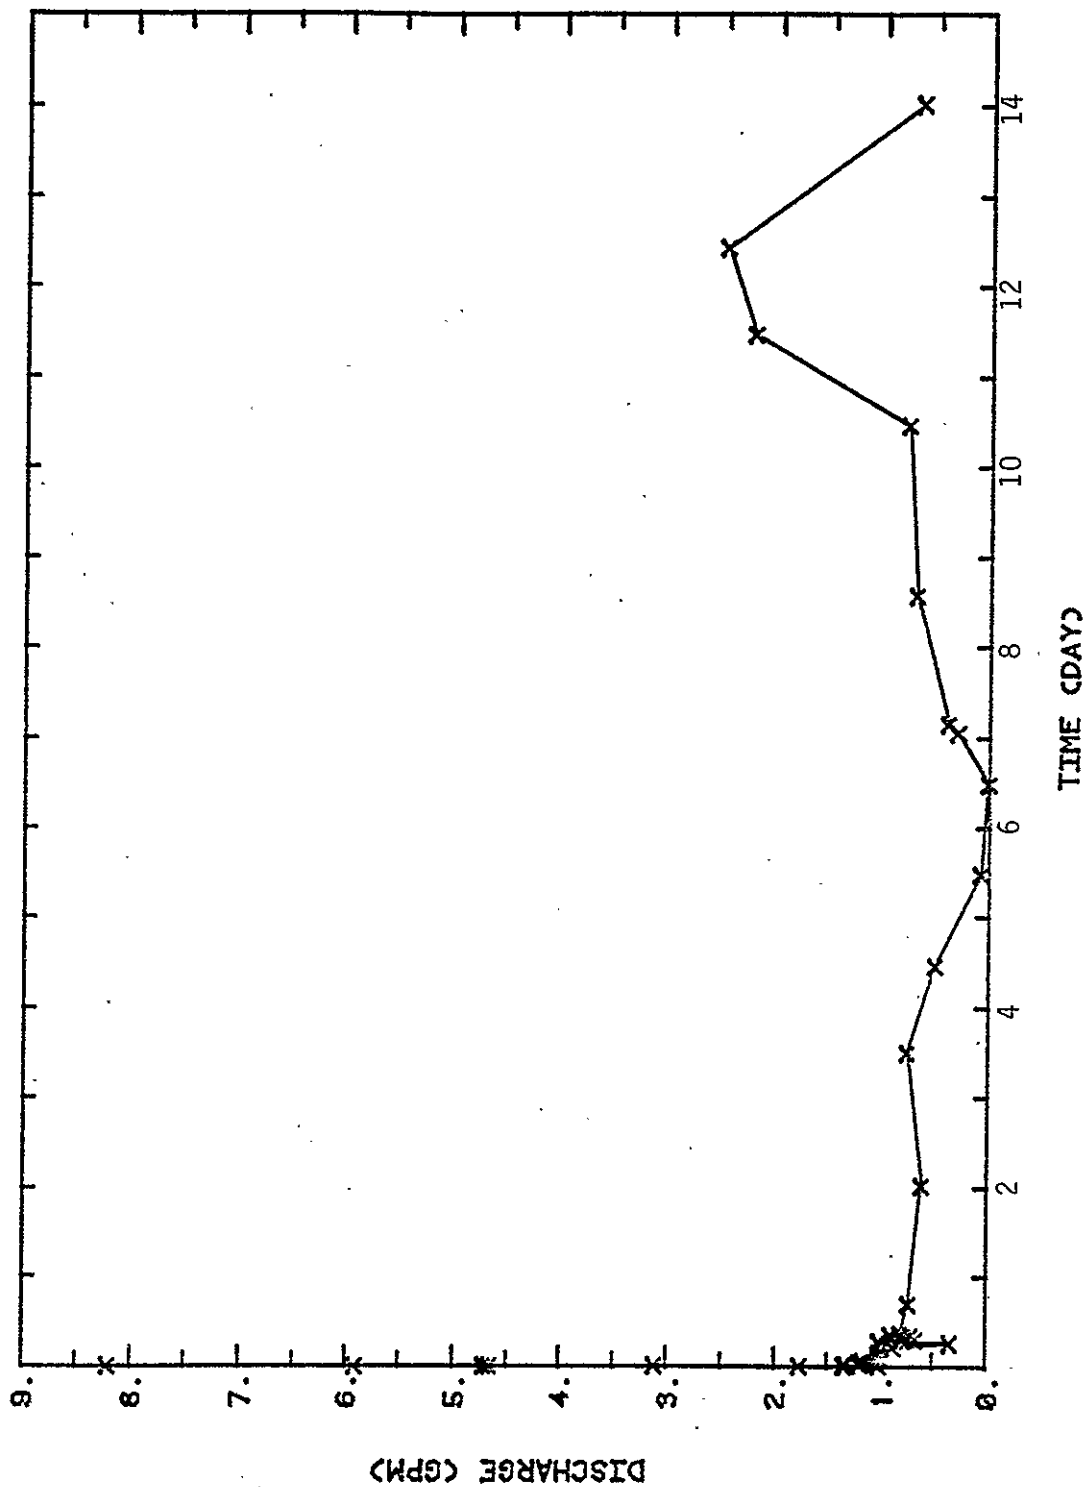
During the 15 day field experiment, a total of  $6.66 \times 10^4$  liters (17,592 gallons) of water were injected. The infiltration rate versus time plot (Figure 10) shows a rapid decrease in infiltration rate at early time. When the head in the borehole is constant, it is expected that the infiltration rate will decrease, as capillary effects diminish during wetting. After a few hours, the infiltration rate was relatively steady at about  $43 \text{ cm}^3/\text{s}$  (0.7 gallons per minute). The reason for the decrease in infiltration rate after about 4 days was due to a problem with maintaining a constant head in the borehole; at times the level dropped at least 0.44 m. The increase in flow rate after about 11 days is apparently due to water ponded on the surface; however, the opening of channels and fissures by flowing water may also be a contributing factor.

Figure 10. Observed infiltration rate versus time during field test.

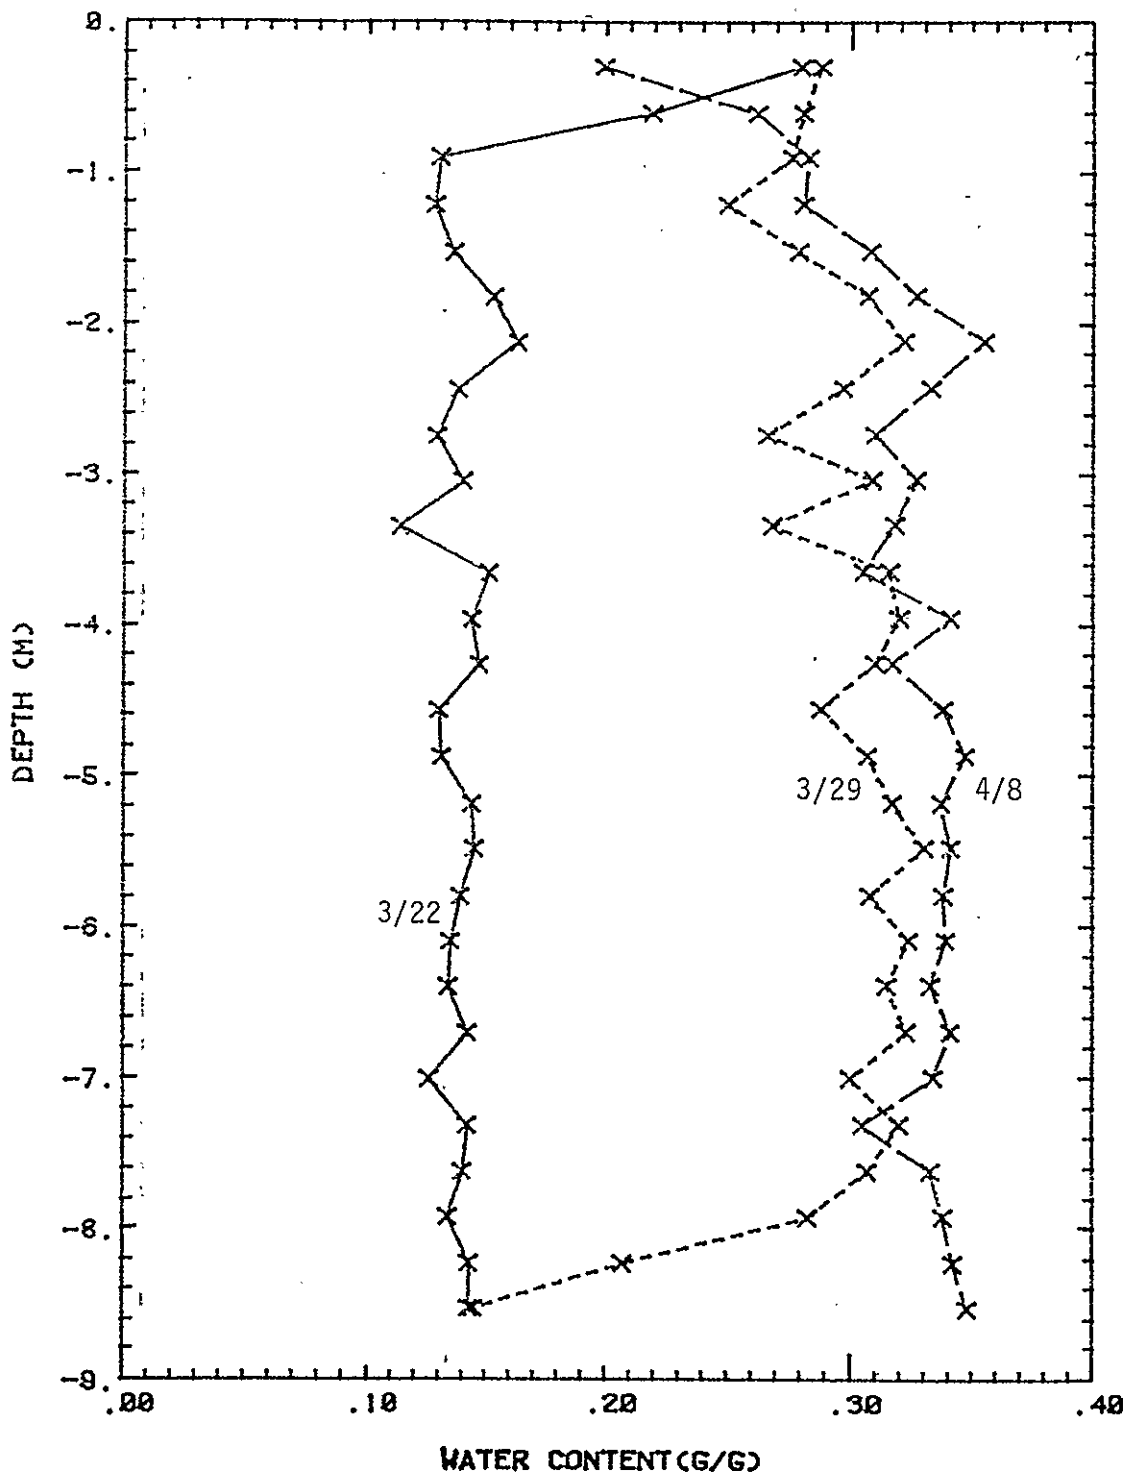
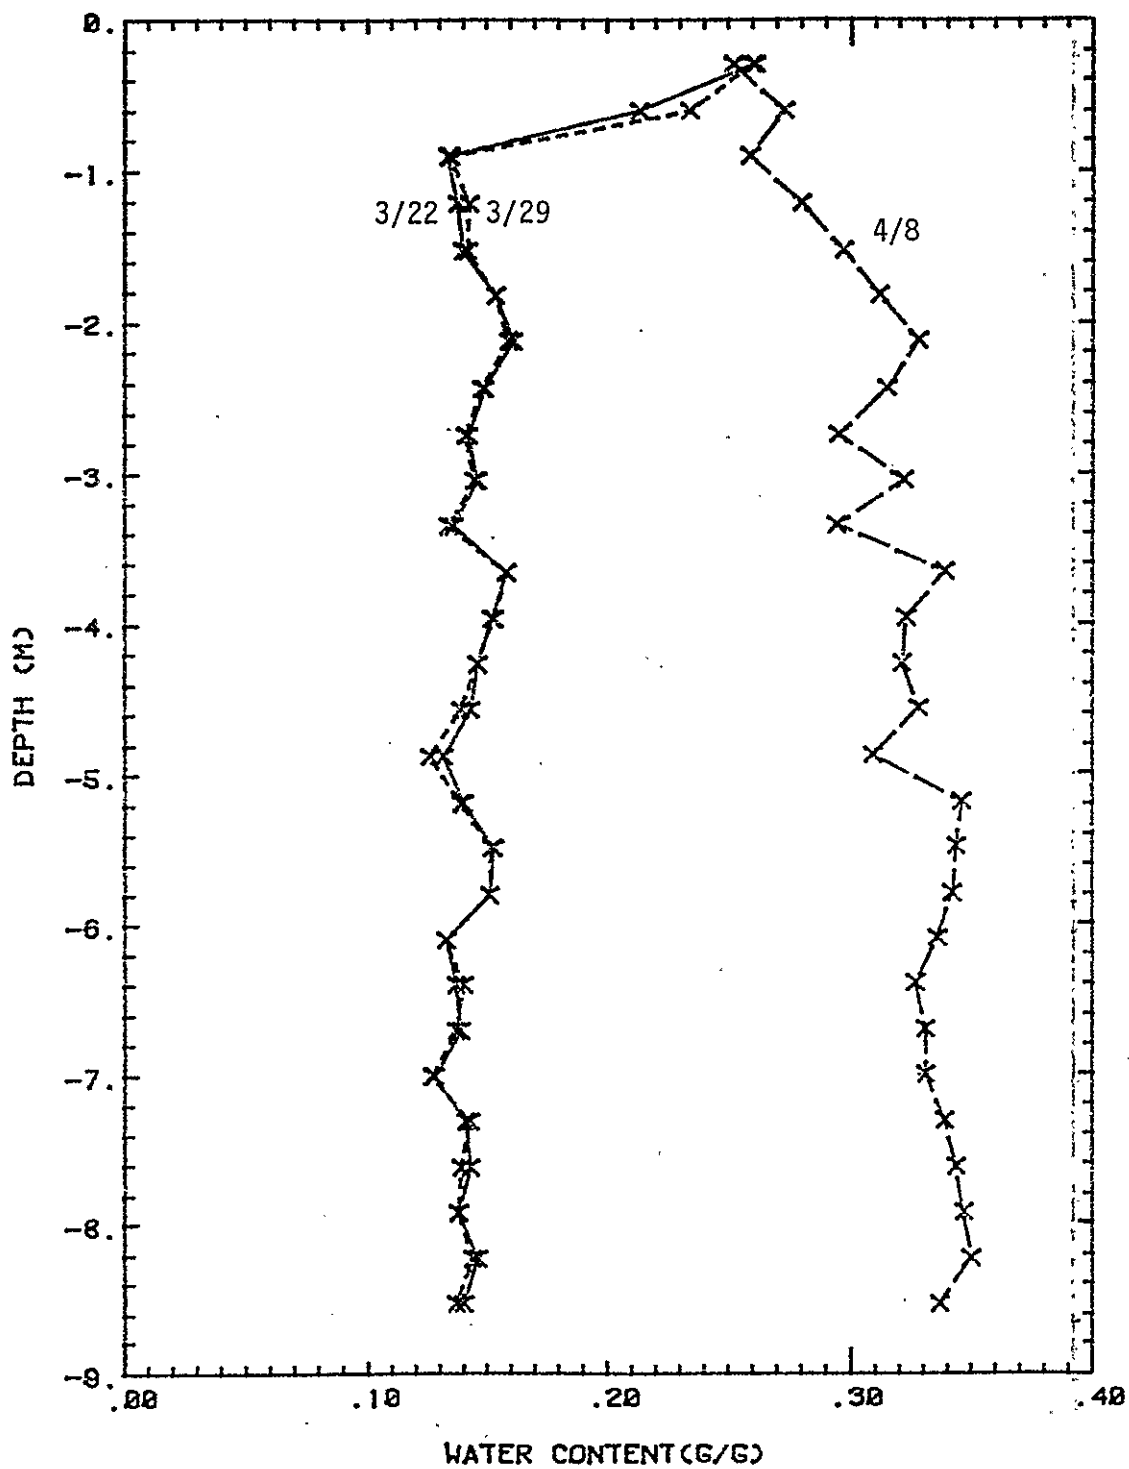
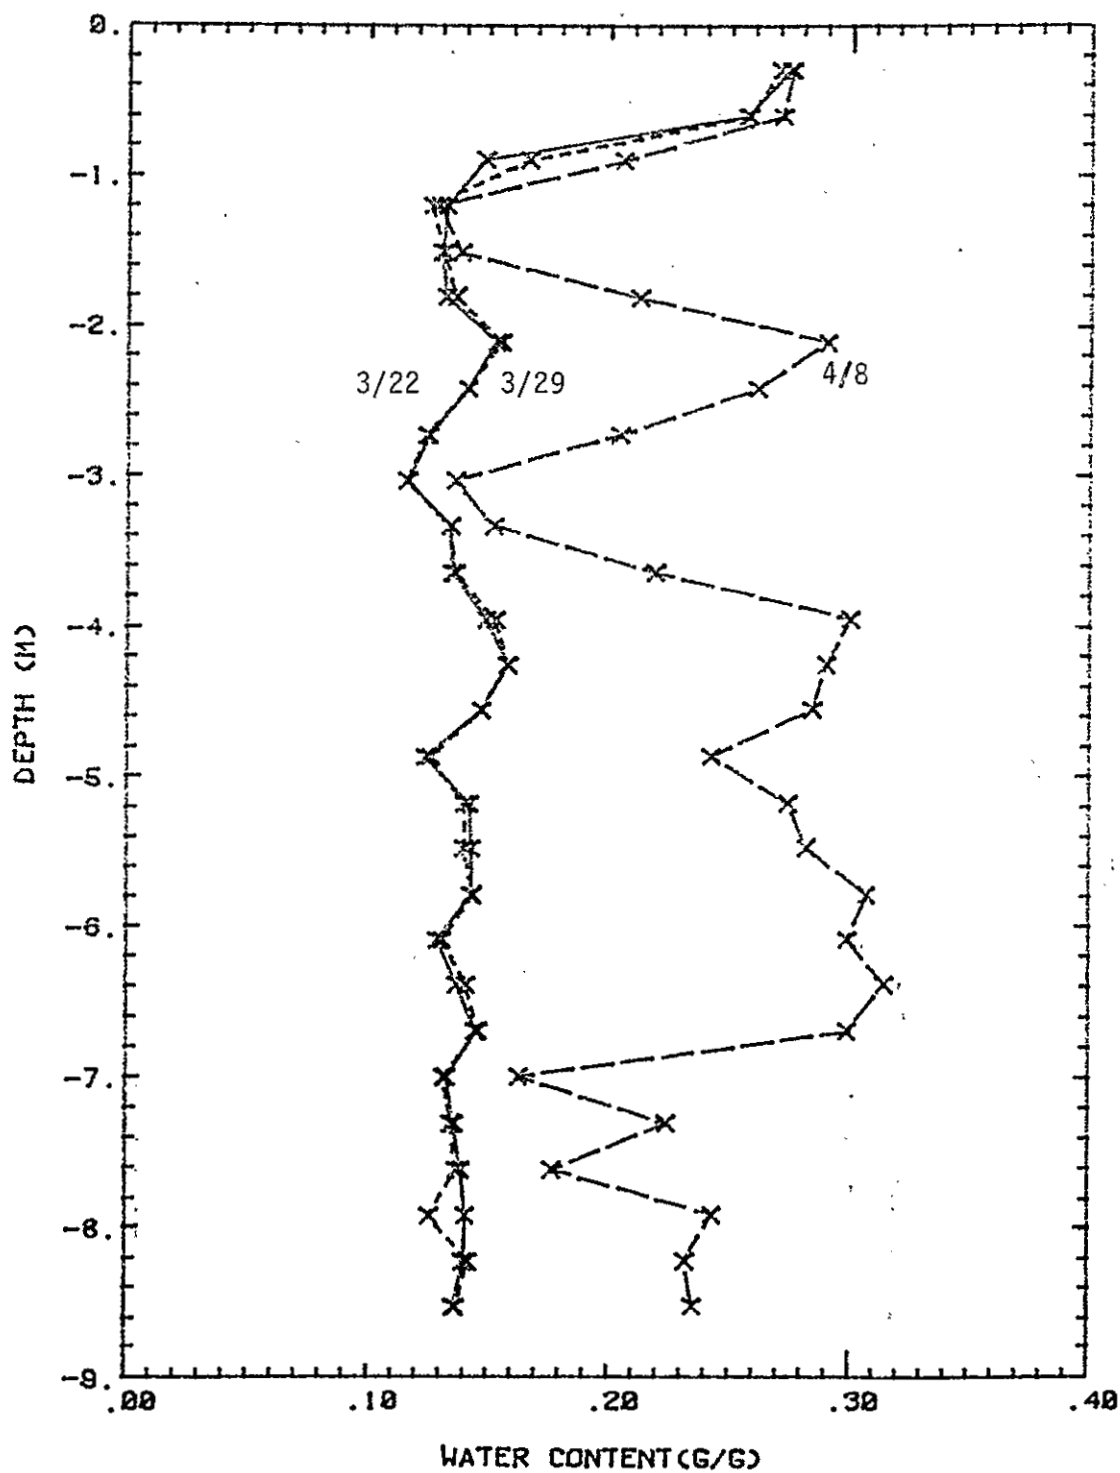
The observed distribution of moisture surrounding the borehole is illustrated in Figures 11a-c. After the wetting front reached a particular distance and the soil collapsed, the elevation of the top of the neutron probe decreased; this makes comparisons of moisture at the same depth at different times only approximate. As Figures 11a-c indicate, the wetting front did not penetrate below the 8 m depth at the 1.5 m radius until after about one week of infiltration. At this same time, the wetting front had not yet reached the 3.0 m depth. As expected from other numerical model studies of infiltration from a borehole (Stephens and Neuman, 1982), the wetted region is elongated downward in response to gravity.

During the second week of infiltration, the wetting front advanced to a radial distance of 4.5 m. The irregular nature of the wetting front is shown in Figure 11c at 4/8/85 (two days after infiltration stopped); behind this

Figure 11a. Moisture content distribution at 1.5 m distance from borehole.

Figure 11b. Moisture content distribution at 3.0 m distance from borehole.

Figure 11c. Moisture content distribution at 4.5 m distance from borehole.

The values of the field-measured neutron probe data in Figures 11a-c reflect an inconsistency with average laboratory-measured moisture retention data in Figure 7. The average saturated moisture content on a volumetric basis used in the model is about  $0.35 \text{ cm}^3/\text{cm}^3$  (Figure 7), based on the laboratory data. In contrast, the neutron probe measurements near the borehole exceed about  $0.45 \text{ cm}^3/\text{cm}^3$  (0.30 g/g water content on a mass basis, as shown in Figure 11). One source of this apparent inconsistency could be due to spatial variability in unsaturated hydraulic properties; as shown in Figure 7 and Figure 2e, one sample did in fact exhibit a near saturated water content of about  $0.50 \text{ cm}^3/\text{cm}^3$ . A more representative mean retention curve could lie
