EL LLANO AND VICINITY  
GEOTECHNICAL STUDY

FINAL REPORT

VOLUME I

New Mexico Bureau of Mines and Mineral Resources  
Socorro, New Mexico 87801

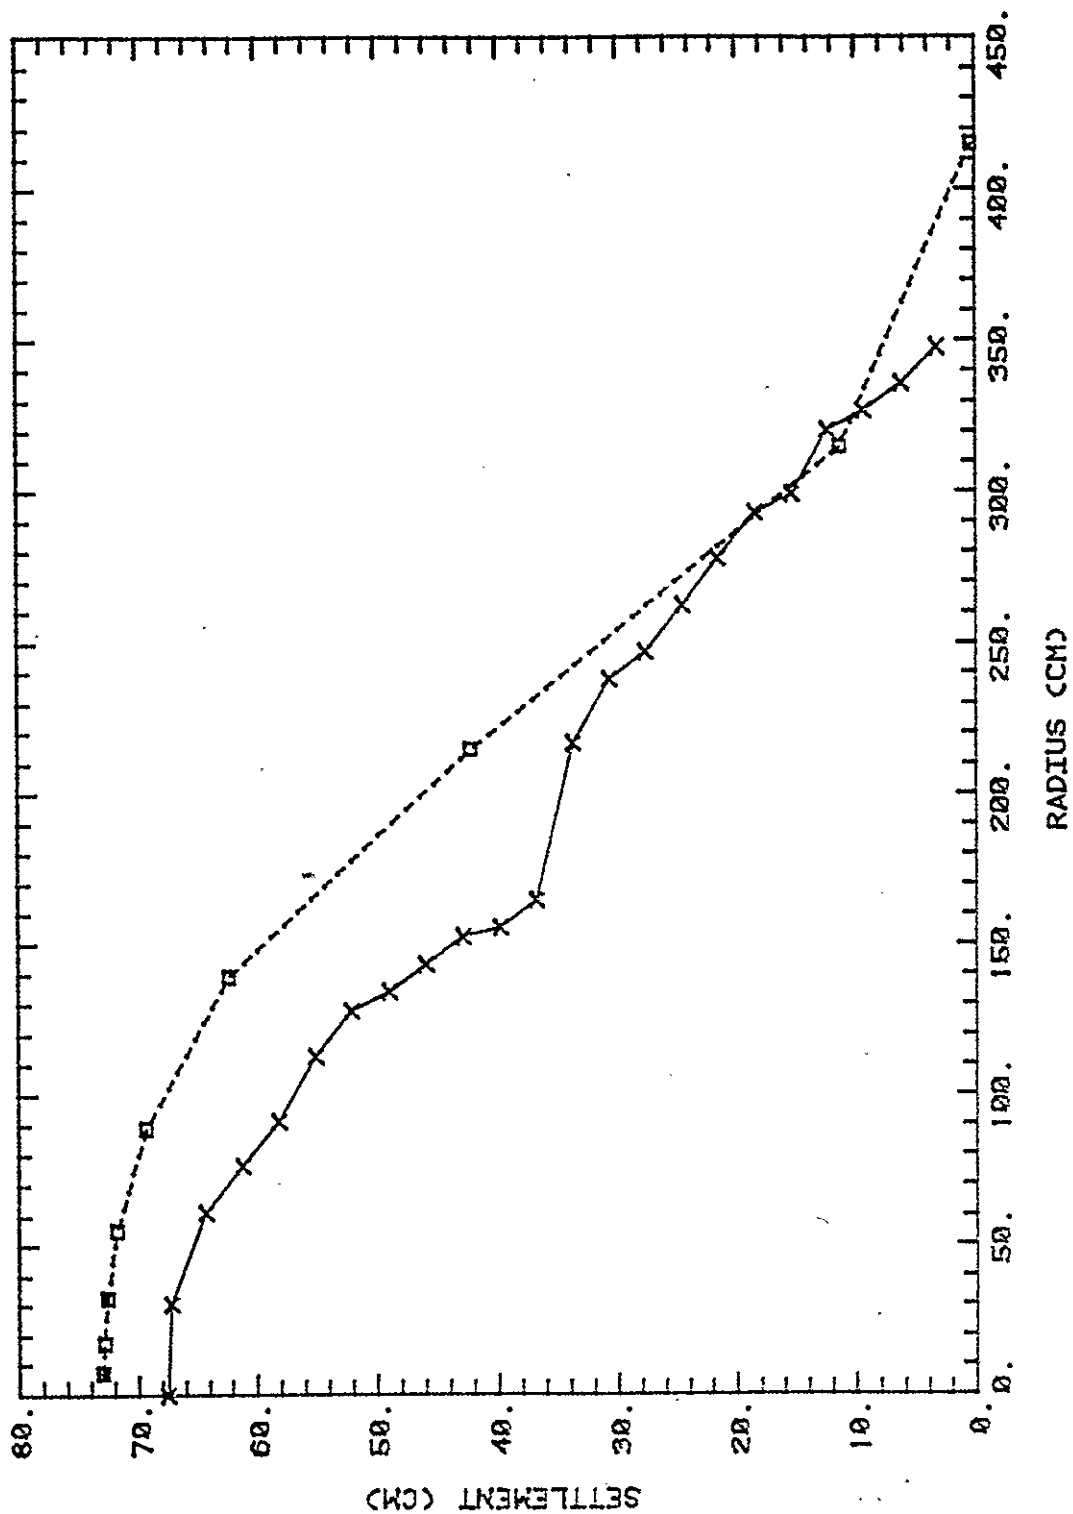
The collapse potential is 5%, as defined in equation 1 and calculated from our laboratory results with equations 4 and 5. According to Jennings and Knight (1975) moderate trouble to trouble with collapsing soil is to be expected. The collapse indicated by daily measurements in the Sondex wells did not produce results which were consistent with observations in the field. Reasons for this failure may include slippage between the Sondex tubing and surrounding gravel. The only data available to us from the NMBMMR were measurements at the end of the field infiltration test using vertical distances between a horizontal grid and land surface (Figure 12).

The observed collapse decreased almost linearly from the borehole to a distance of more than 3.5 m. The collapse at about 1.5 m reflects the step-wise nature of the collapse due to fissuring. Photographs and maps by the NMBMMR in the Final Report of the El Llano Geotechnical Investigation clearly show concentric fissures surrounding the borehole. Because the onset of collapse and its progression were not recorded in the field we do not know whether there is a time delay between the arrival of the wetting front and the

Figure 12. Observed and calculated collapse after 15 days, assuming  $K_S = 2.0 \times 10^{-4} \text{ cm/s}$ .

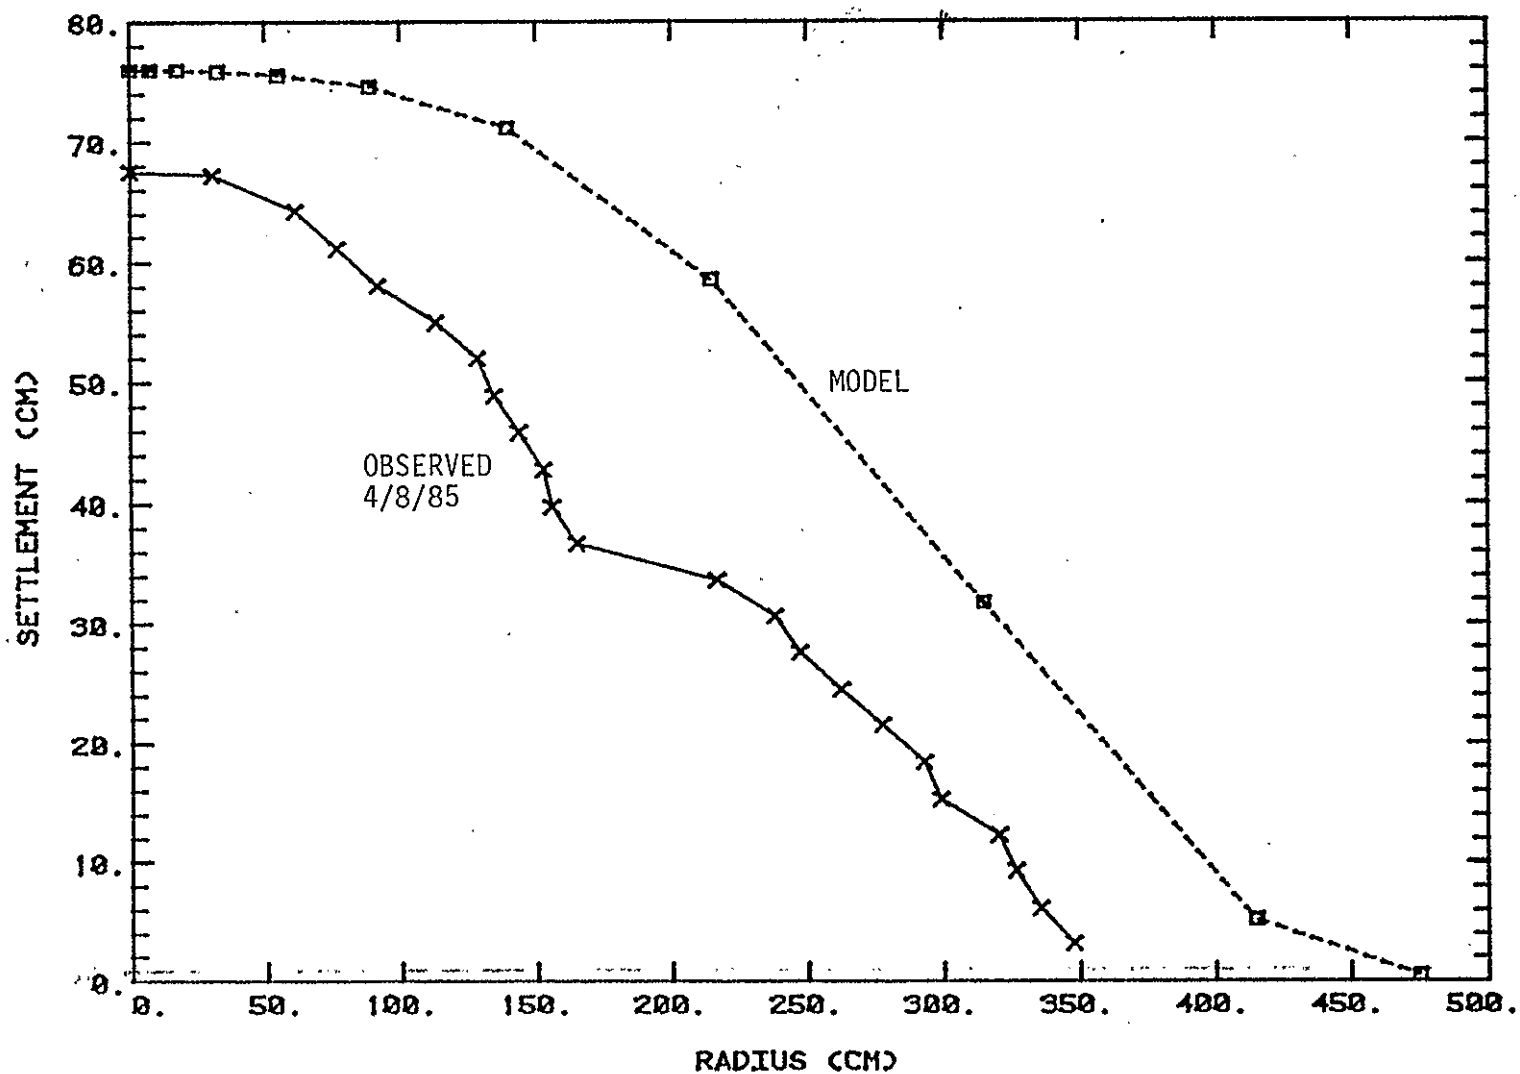
The calculated collapse is shown in Figure 12 using model predicted moisture content from run #1 at 15.1 days. Even at this time, the calculated collapse is greater than that observed by less than about 20 cm. The collapse calculated for run #2 at 3.01 days is shown in Figure 17; recall that this collapse would be the same as run #1 at 30.1 days. The similarity in model predicted results in Figures 12 and 17 indicate that the flow field is nearly steady at the end of both runs. These differences in observed and predicted collapse may be attributed to many factors: a time lag between wetting and collapse; unrepresentative laboratory measurements of collapse and hydraulic properties; or over simplifications in the empirical approach, such as the assumption of a linear increase in collapse with increasing moisture. Nevertheless, our errors are reasonably consistent with the experience summarized by Dudley (1970) who indicated that the collapse calculated from laboratory tests similar to ours could be divided by a factor of two in some cases.

The profile above a depth of about 10 m (the vertical extent of collapsible soil) may continue to increase in moisture content beyond the state shown in Figure 13, although the increase would be small based on our numerical simulations. Therefore, differences between calculated and observed collapse may actually decrease if there is a time delay factor present. The observed radial limit of collapse is predicted reasonably well by the model as shown in Figures 12 and 17.

Figure 17. Observed collapse after 15 days and calculated collapse after 3.01 days assuming  $K_s = 2.0 \times 10^{-3}$  cm/s.
