IDENTIFICATION OF ALLUVIAL VALLEY FLOORS IN STRIPPABLE COAL AREAS  
OF NEW MEXICO

Report to Emery Arnold, Director  
Mining and Minerals Division  
Energy and Minerals Department  
Santa Fe, New Mexico

D.W. Love and J.W. Hawley  
New Mexico Bureau of Mines and Mineral Resources  
New Mexico Institute of Mining and Technology  
Socorro, New Mexico 87801

October 26, 1981

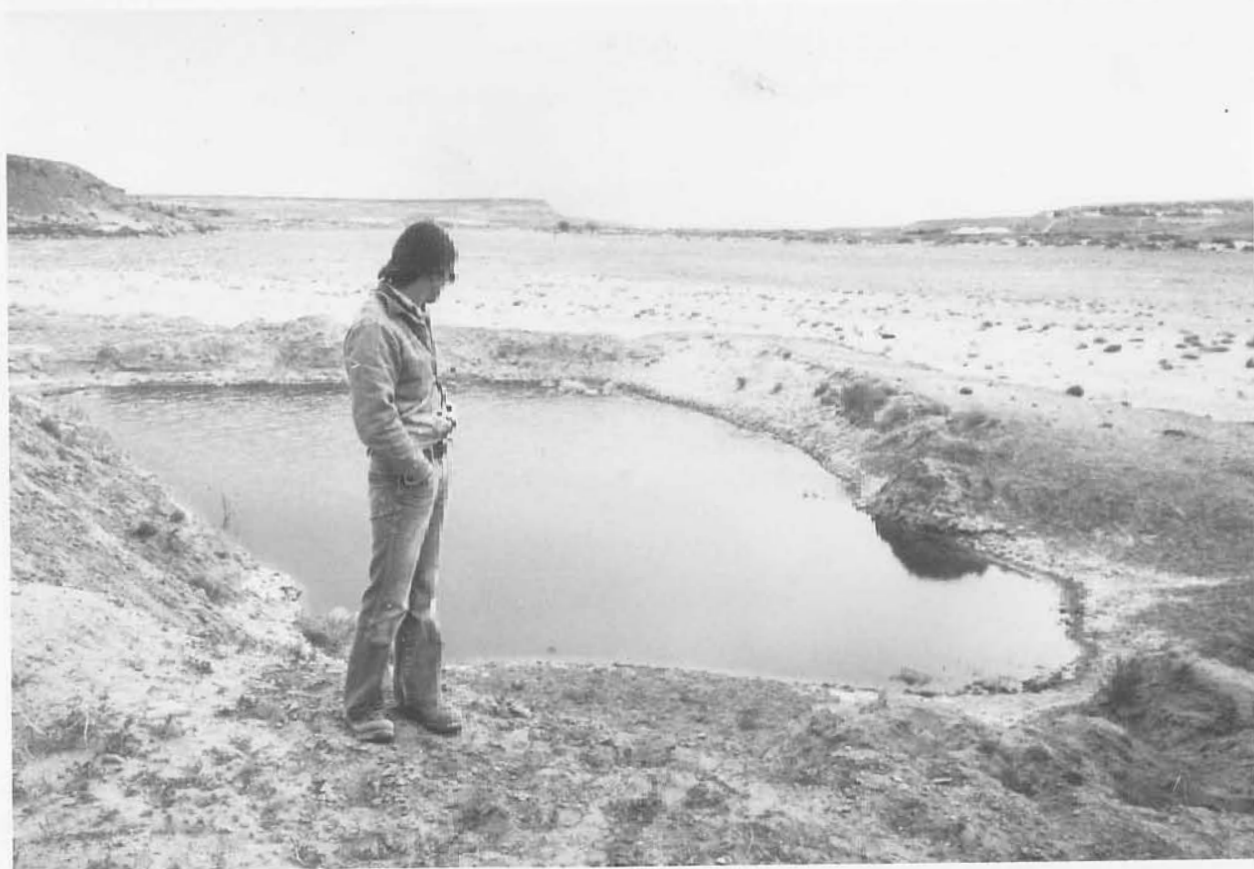
11

11. Shallow groundwater beneath braided channel of Chaco River near La Vida Mission. View east southeast (10/16/80).
12. Brimhall Wash 2 miles upstream from Burnham, New Mexico, viewed to west (10/15/80).

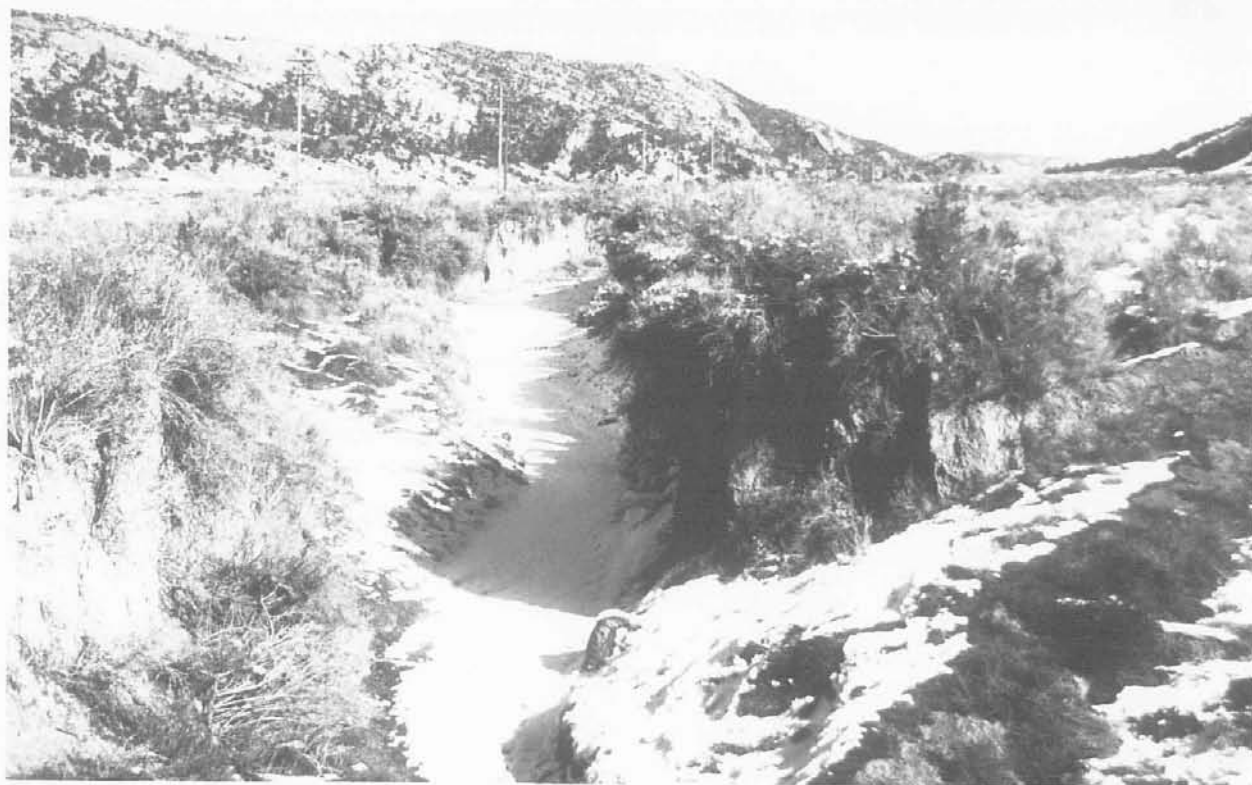
16

15. Coal Mine Wash, tributary to Tse Bonita Wash near Tse Bonita Trading Post. View northeast. Arroyo walls are about 12 feet high (12/10/80).
16. Burned Death Wash viewed to southwest toward Carbon Coal Company's processing plant (12/11/80).

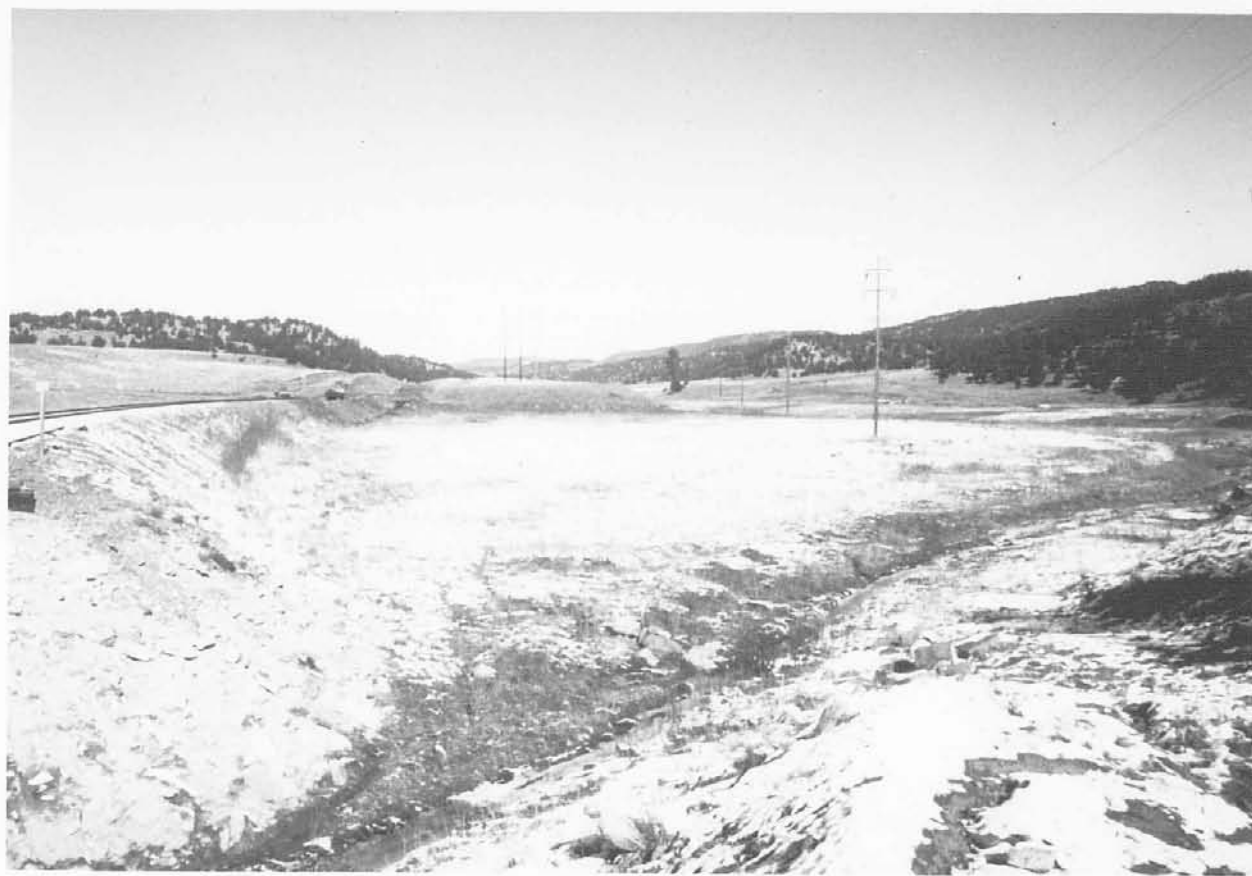
20

19. Mouth of York Canyon drainage viewed to northwest. Water in stream is primarily return flow from use of water pumped from Vermejo River to coal treatment facilities (11/19/80).
20. Area of springs in Sawmill-Cottonwood Canyon contributing flow to the Caliente drainage. View northeast. The entrenched channel is ephemeral upstream from the springs (11/19/80).
21. Caliente drainage viewed to northwest upstream at confluence with Chimney Canyon (11/19/80).
22. Ephemeral drainage downstream through Dillon Canyon in the Brilliant District (11/20/80).
