An Update on the Hydrogeology of Magdalena, Socorro County, New Mexico

Open-file Report 556

August 2013

New Mexico Tech
New Mexico Bureau of Geology
and Mineral Resources

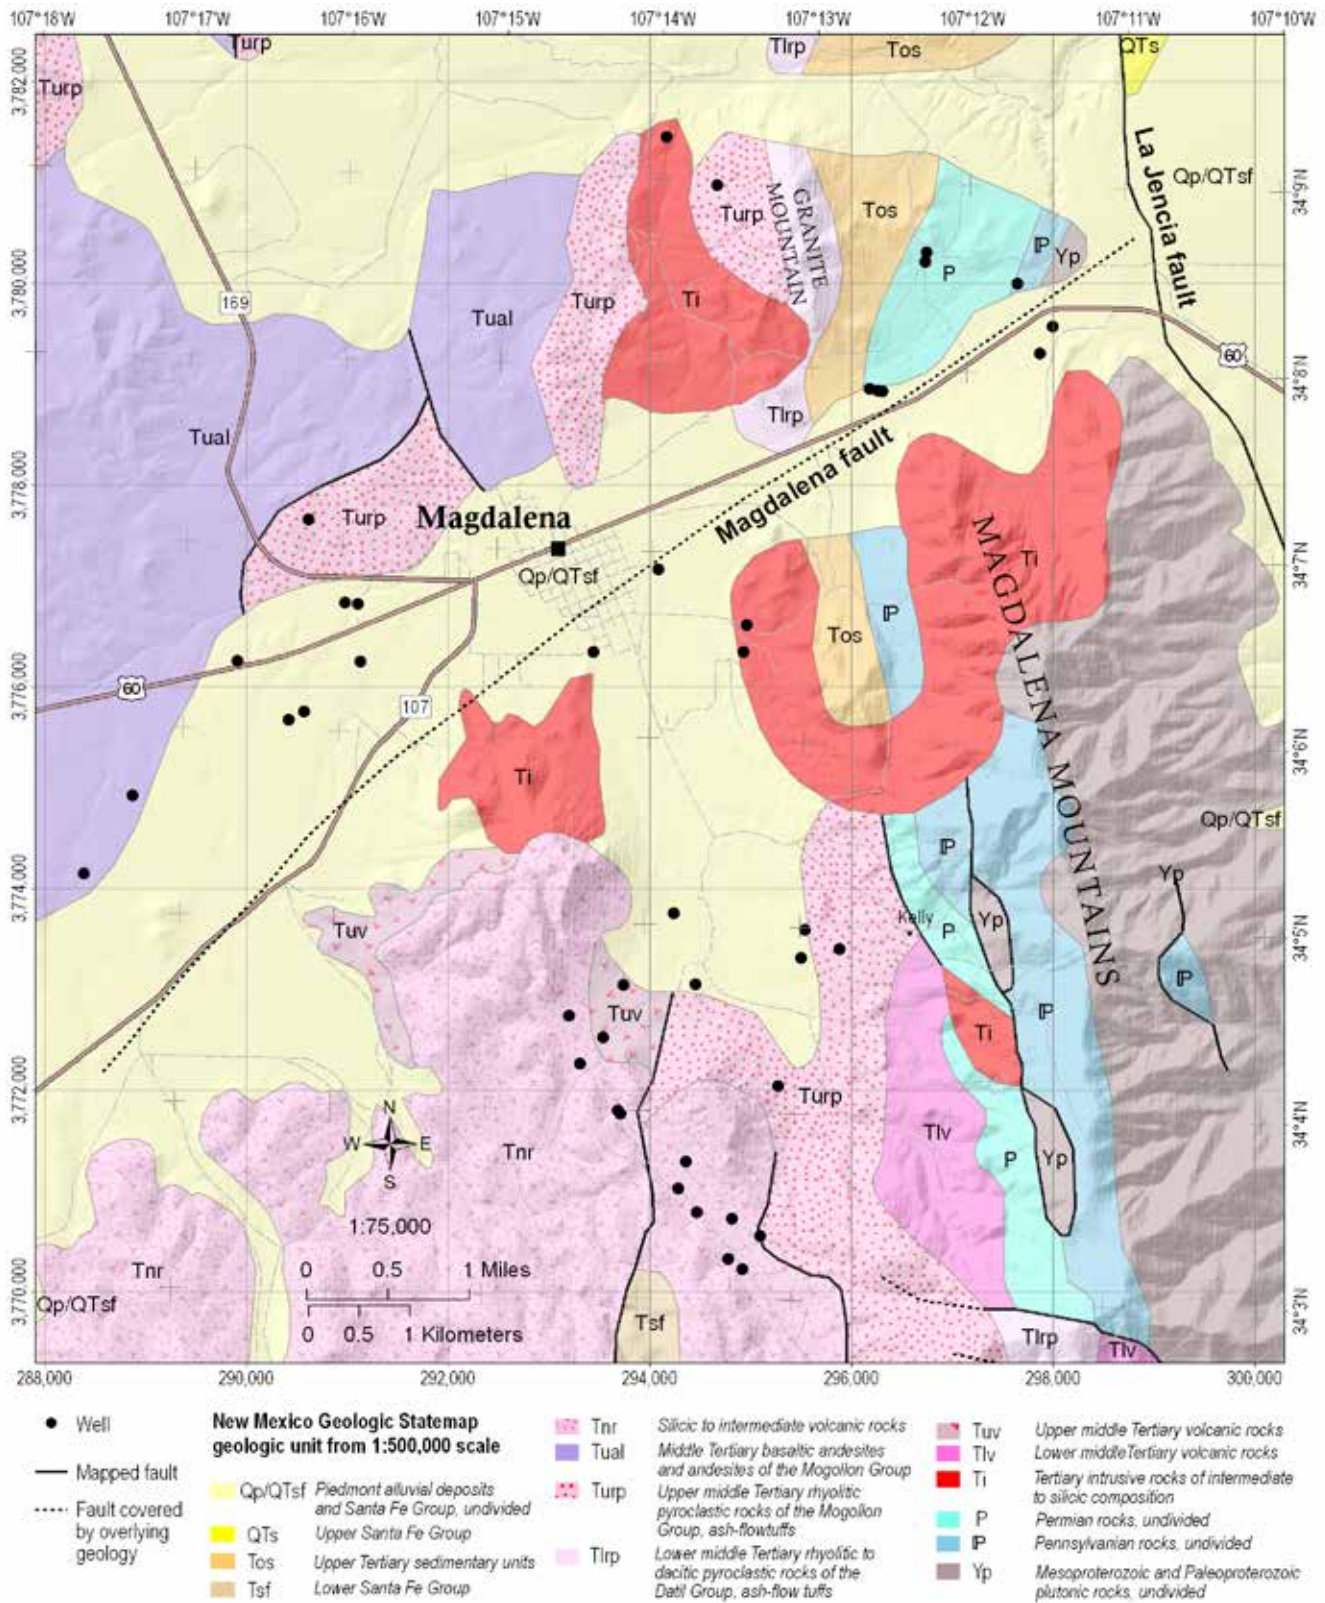
Figure 2—Generalized geologic map. The major geologic structures are the Magdalena and the La Jencia faults. These faults are likely fault “zones” and are not limited to the linear feature on this map. Additional faults and fractures (not shown) trend in northwest-southeast and northeast-southwest directions. This is a very simplified geologic map from the 1:500,000-scale Geologic Map of New Mexico (2003). Black points identify wells used for this study. Many of the northwest trending faults indicated on Summers (1975) map are not shown in this map. See Appendix 1 included with this report for the Summers (1975) and included geologic map.

Important structural features are the La Jencia fault on the east side of Magdalena and the northeast trending Magdalena Fault (Fig. 2). Numerous northwest trending faults related to rifting in the Rio Grande region have been identified by previous mapping (Summers, 1975), and likely play a role in groundwater flow. Unfortunately, detailed subsurface geologic data is limited, making interpretations of the subsurface features and their relationship to groundwater especially challenging.

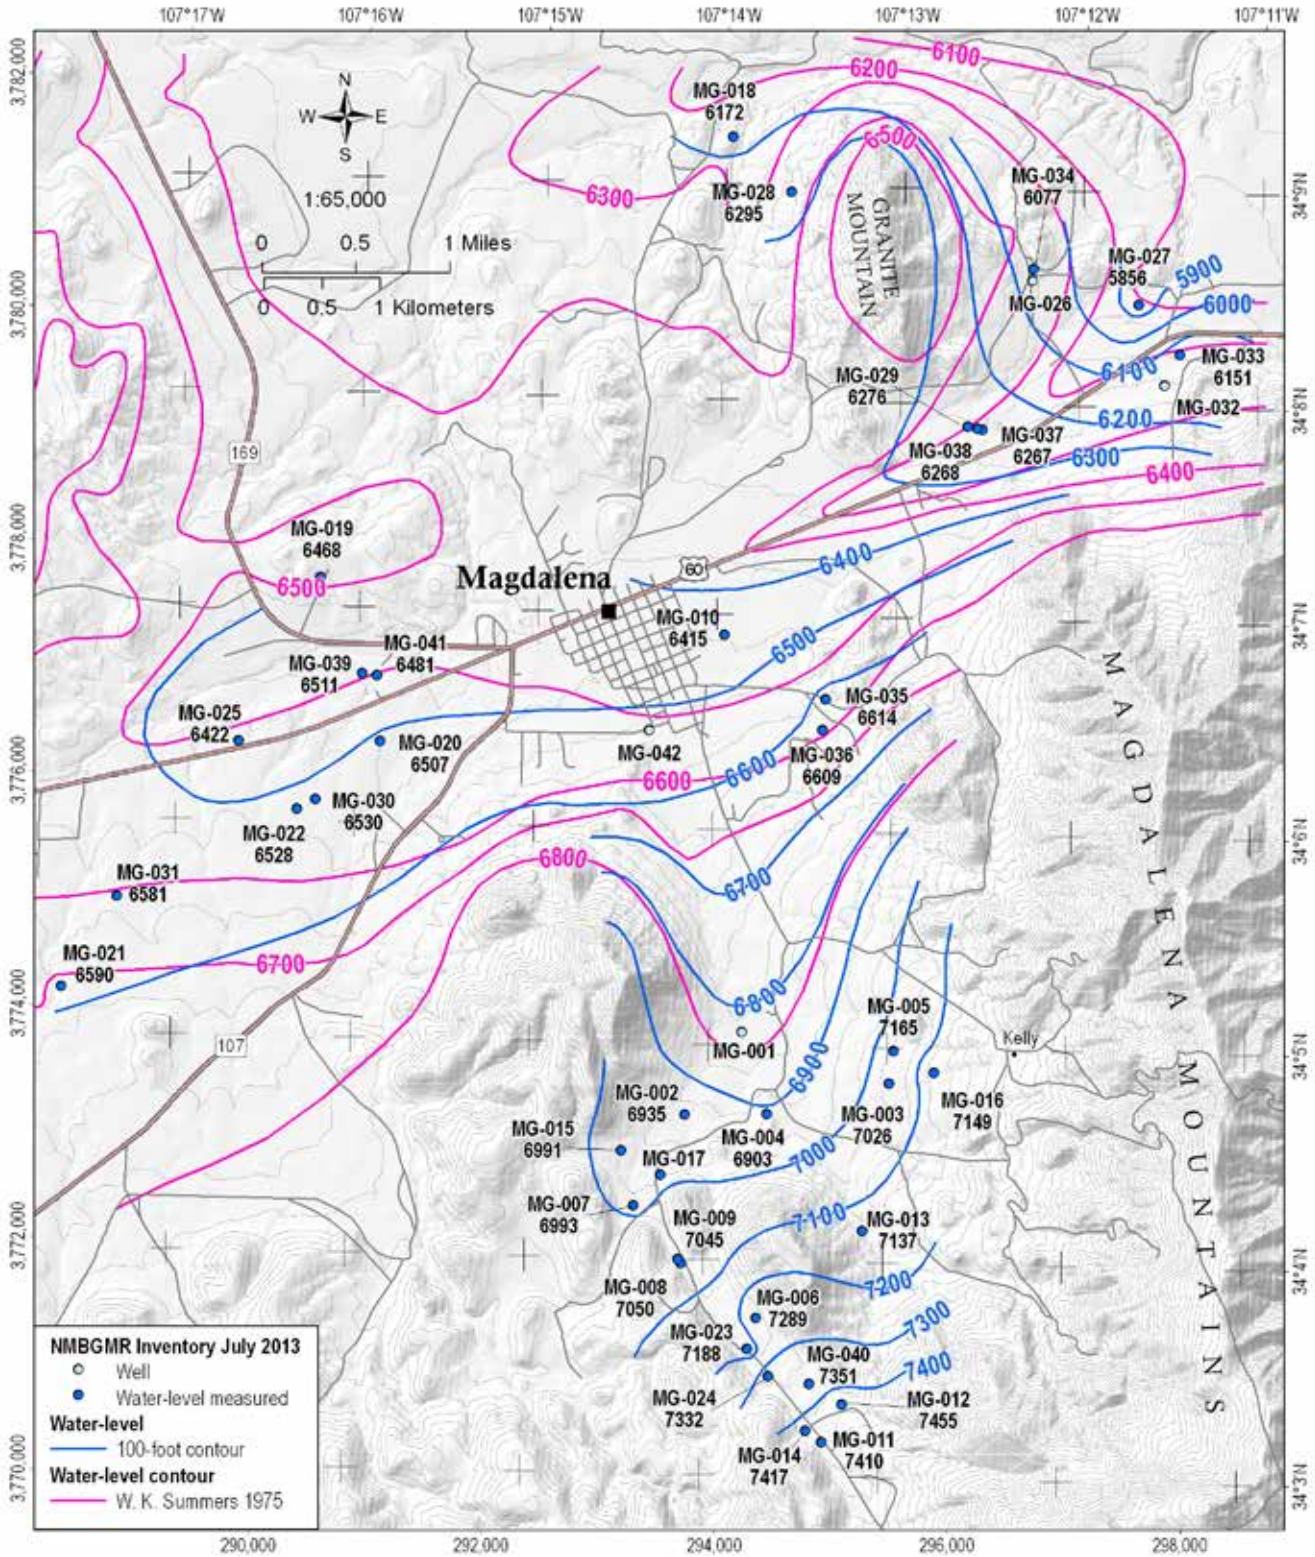
Figure 4—Comparison of recent and historic water table elevations. The pink groundwater elevation contours, from Summers (1975), are compared with the current water levels (2013) in blue. In general, present day groundwater flow mimics the trends observed in the 1970’s. However, there is significant decline in the water levels in the area on the east side of the map, along Highway 60, where 1975 vs. 2013 contours differ as much as 200 feet.

Using the water level elevation contours from June 2013 (blue lines, Fig. 4), we compared current water levels with a water table elevation map created by Summers (1975) (pink lines, Fig. 4). In most areas, the water table is roughly the same as it was in 1975; however, in the region east of the Village of Magdalena, there is marked water level declines (100 to 200 feet).

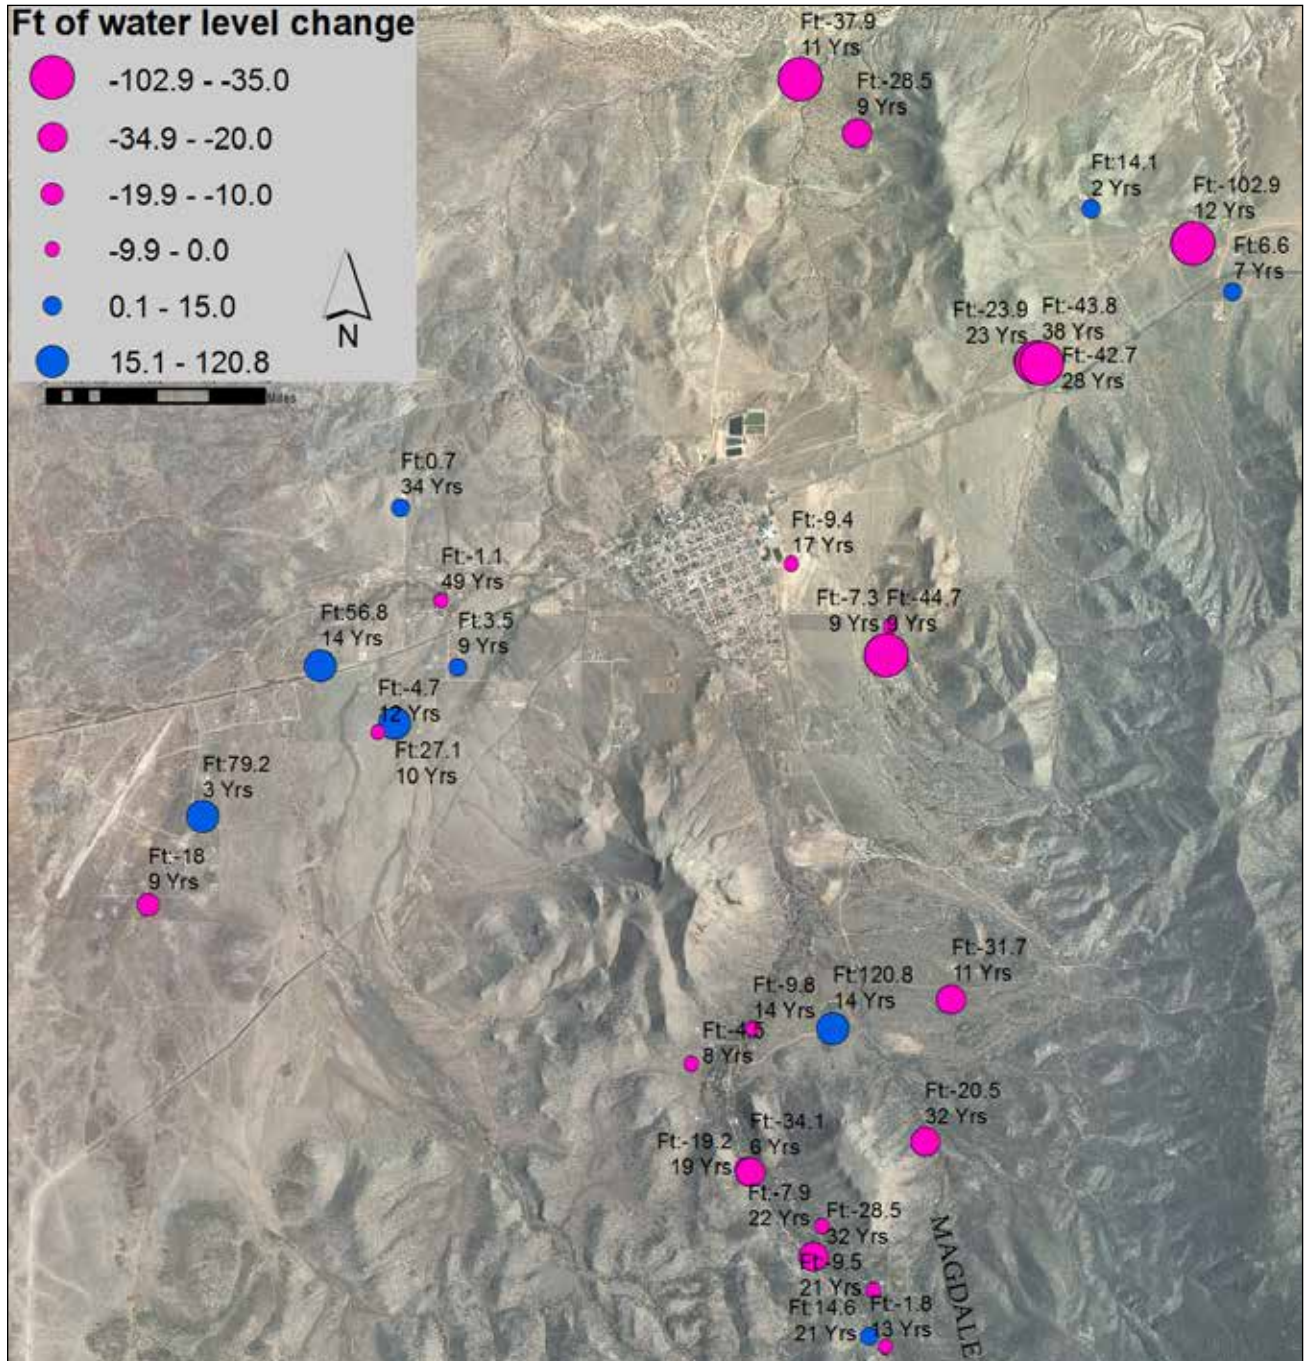
Figure 5—Comparison of driller’s static water levels with summer 2013 water levels within the same well. The difference in depth to water (ft) was calculated by subtracting the 2013 water level from the original static water level noted on the OSE driller’s record. The pink points indicate wells where water levels have dropped, as noted by “Ft,” which is a negative number (feet of water level change). Blue points indicate wells where water levels have risen since the well was drilled. The number of years is the difference between the drilled date and the recent date of measurement. The symbol size is proportional to the amount of change in the water level (i.e. larger declines have larger symbols).

Further analysis of water level declines was performed by comparing static water levels at the time of drilling, with current 2013 water levels (Fig. 5, Table 2). This was only possible where wells could be matched with a OSE well record to provide a historic static water level from time of drilling. On Figure 5, the pink symbols indicate water level declines ranging from 1.8 to 102.9 feet below their driller's static water level. Approximately 70% of the measured wells

Using a comparison with the static water level upon drilling must be examined carefully though, as these declines occur over various time scales (shown in years, Fig. 5). In addition, the method of static water level measurement by the driller is not provided in the OSE well records.

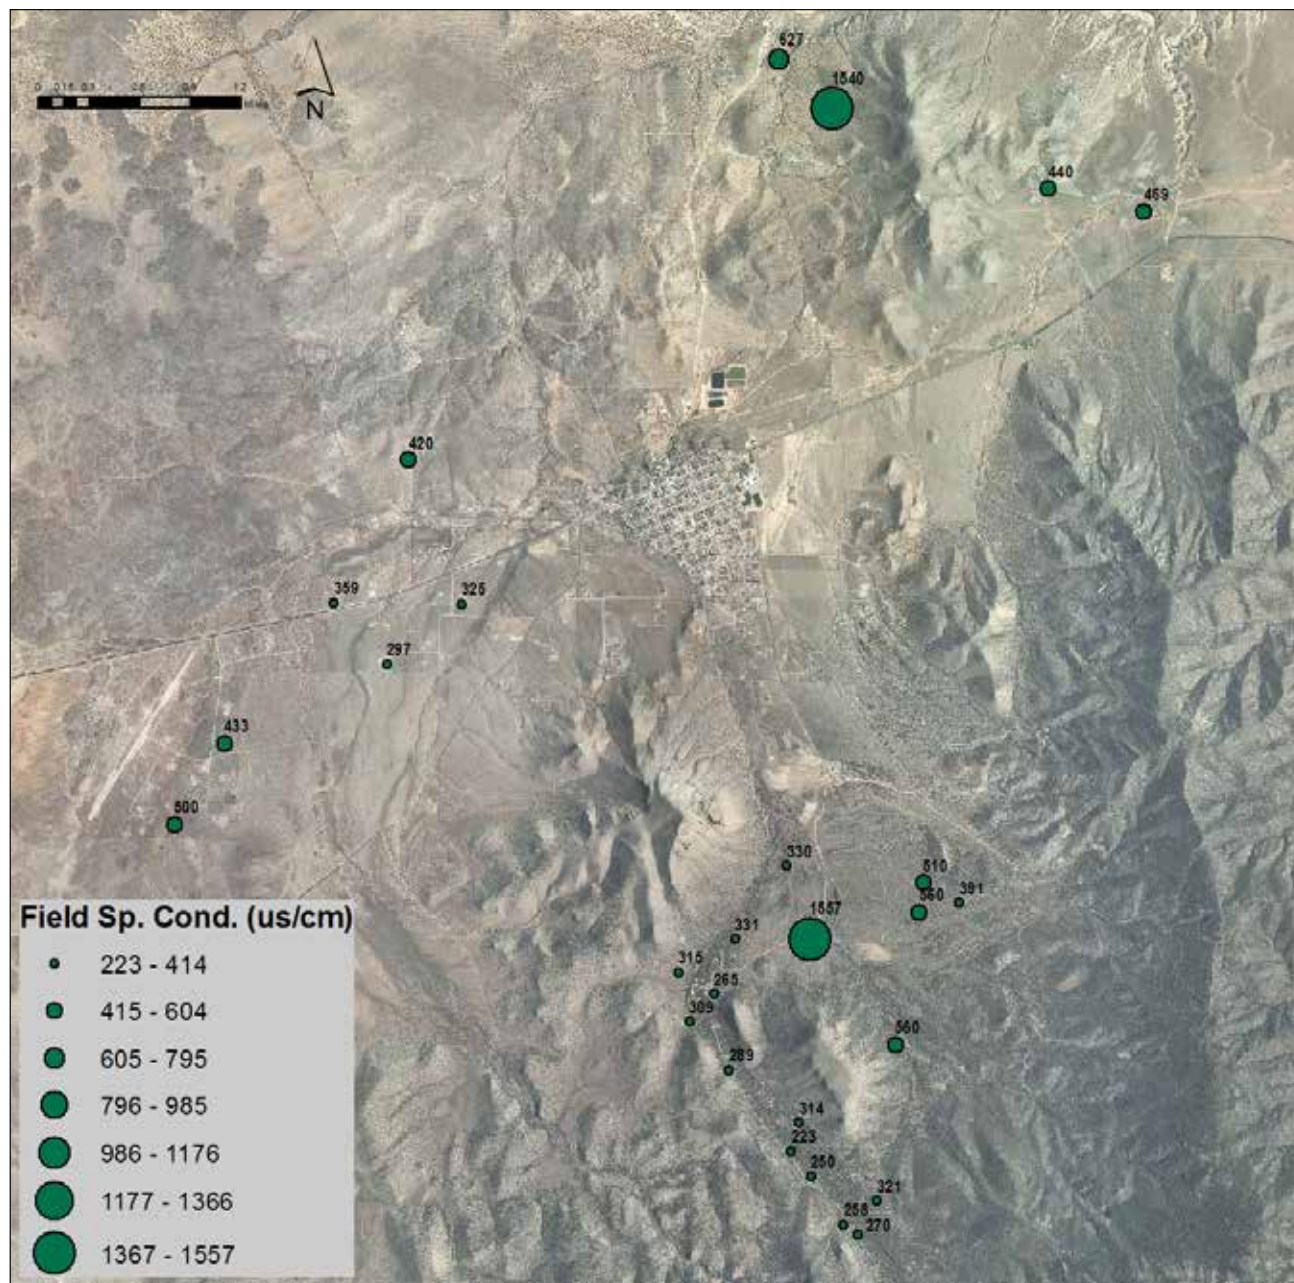
Figure 6—Field measurements of specific conductivity in the Magdalena area. High specific conductivity measurements are due to Paleozoic carbonate rocks that these wells access for groundwater. Units are microsiemens/centimeter ($\mu\text{S}/\text{cm}$).

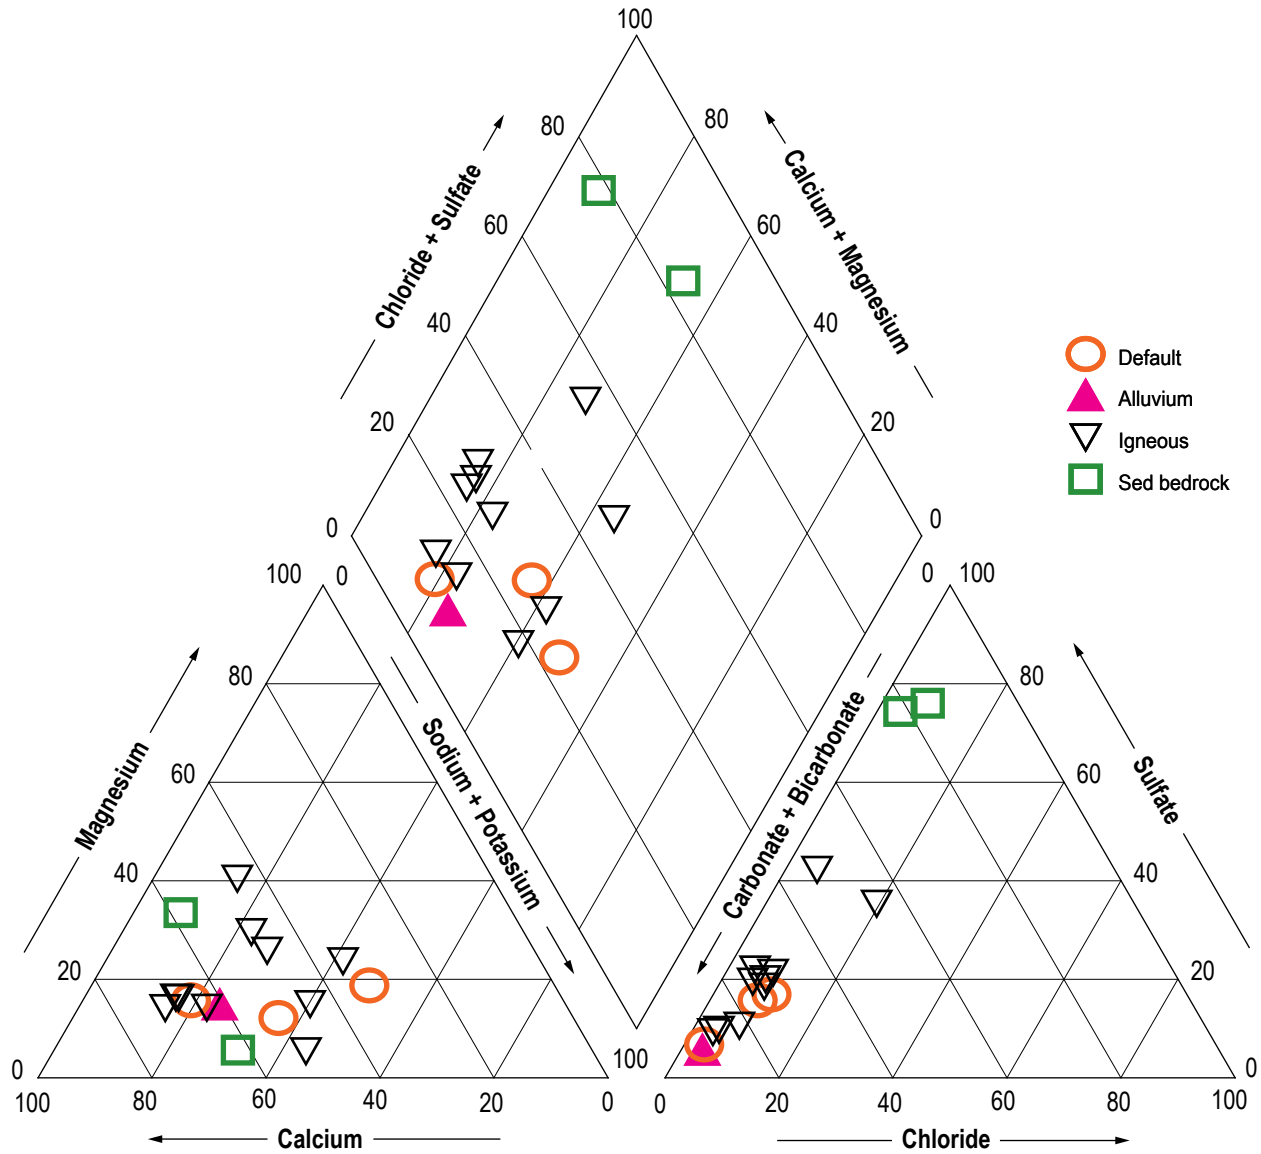
Figure 7—Piper diagram showing percentages of major cations and anions. The Piper diagram also indicates the geology of the sampled wells interpreted from the OSE well records. For simplicity, these were grouped into general categories of igneous, sedimentary, and alluvium. Any wells which were sampled, but did not have a drillers record available were labeled “default.”

Plotting concentrations of ions on a Piper diagram (Fig. 7) shows the percentages of 1) cations (calcium (Ca), sodium + potassium (Na+K) and magnesium (Mg)) and 2) anions (bicarbonate + carbonate ($\text{HCO}_3 + \text{CO}_3$), chloride (Cl) and sulfate (SO_4)). The dominant anion in the sampled water in this area is HCO_3 , while a few samples have higher SO_4 . Calcium is the dominant cation. However, some samples have nearly equal percentages of Ca to Na+K. In samples with higher levels of sodium, there has likely been more groundwater interaction with clay minerals providing opportunities for cation exchange. In this region, igneous rocks that have weathered to clay or localized sedimentary deposits of clay provide sources for this cation exchange to occur.

The Piper diagram shown in Figure 7 also shows symbols to represent the geology

still useful as with the two wells previously noted with high specific conductance, hardness, and TDS, which also plot with high sulfate on the Piper diagram (Fig. 7). Review of the OSE well driller's records for these two wells indicate that they are likely accessing water from Paleozoic carbonate rocks.
