Animas River GROUNDWATER LEVEL MONITORING after the Gold King Mine 2015 mine-water release

Ethan Mamer Stacy Timmons Cathryn Pokorny

NM Bureau of Geology and Mineral Resources A Division of NM Tech

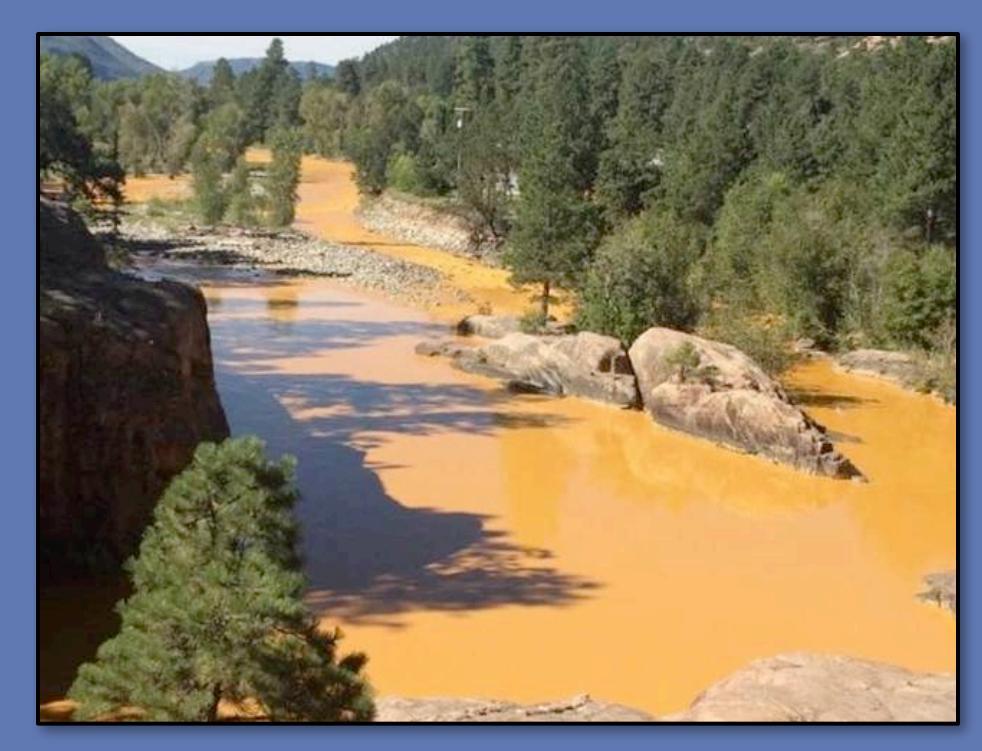
- More than 3 million gallons of acid mine water discharged into Cement Creek – Animas River
- Orange water containing high concentrations of As, Cd, Fe, Pb, Mn, Hg and Zn
- New Mexico determined that much of the river was a gaining river and quickly lifted the ban on using water after the spill water had passed through

The contaminated pulse of water has flowed through *HOWEVER* it deposited mine waste on streambed which may still leach into groundwater

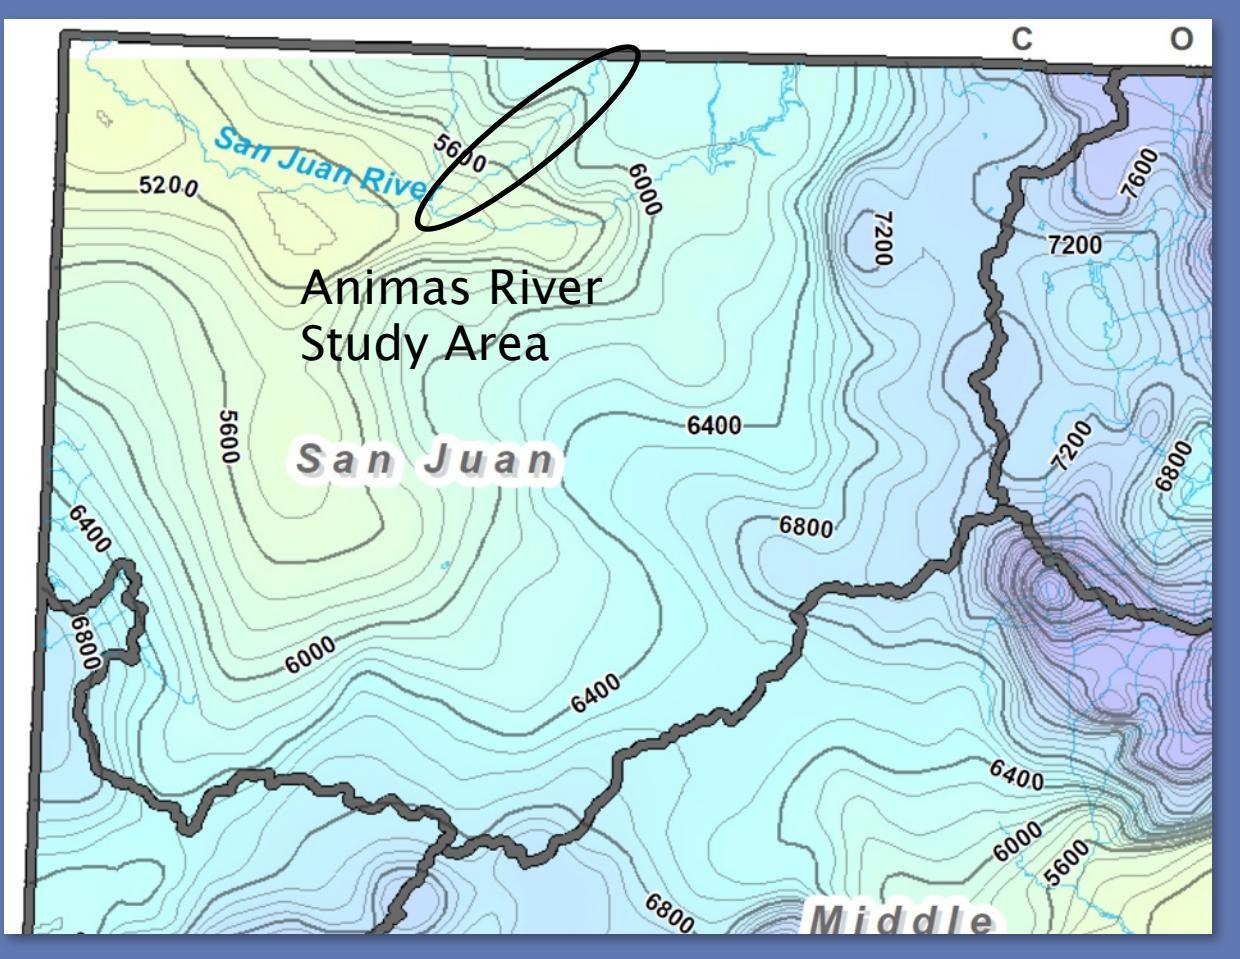
Regional groundwater flow

NMOSE Water Resource Atlas, 2002

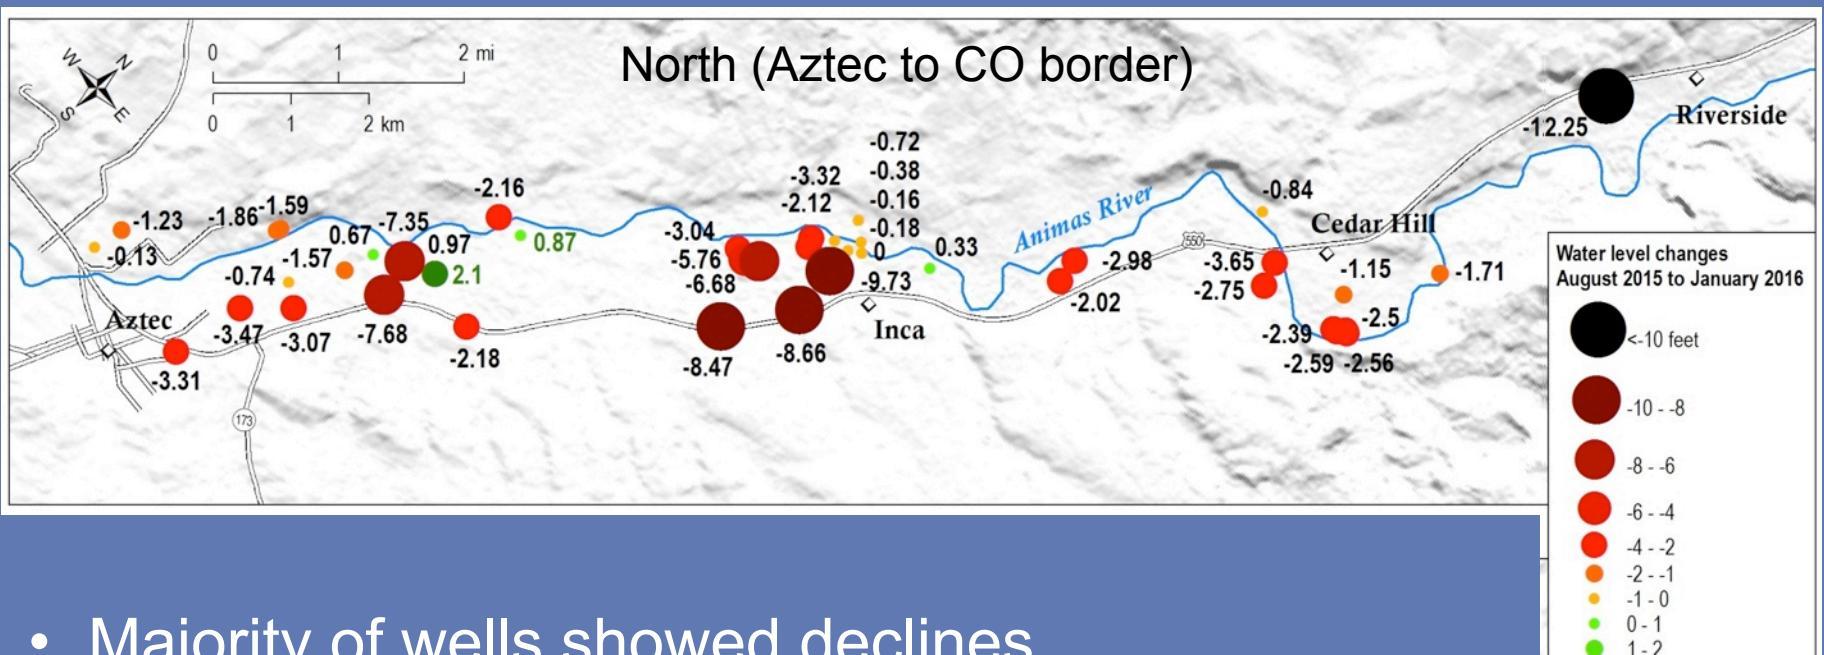
Water Level Change

>2 feet

- Majority of wells showed declines
 - Average of -2.1 ft
- North of Aztec declines were more pronounced

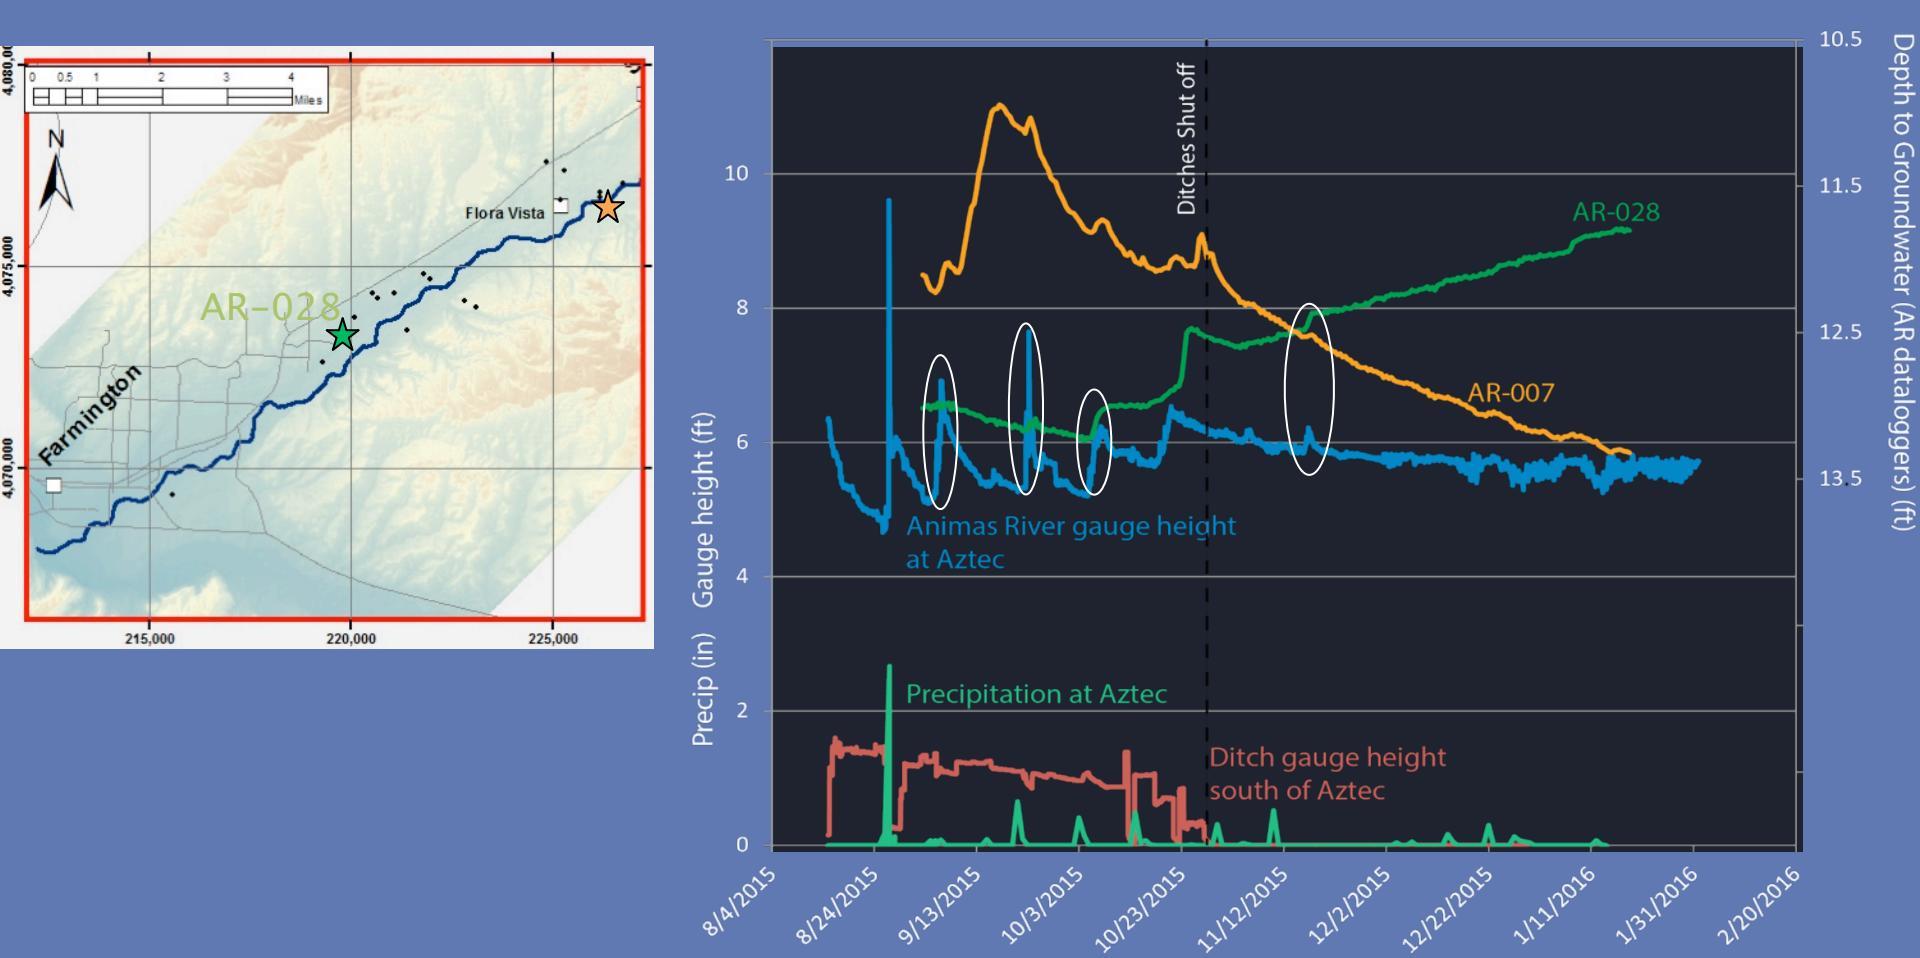
Hydrographs

- Pressure transducers installed in two wells:
 - AR-028: north of Farmington, 1475 ft west of river, 20 ft deep
 - Short term spikes in record correlate with spikes in river stage.
 - 3ft rebound in water level starting in mid-October.

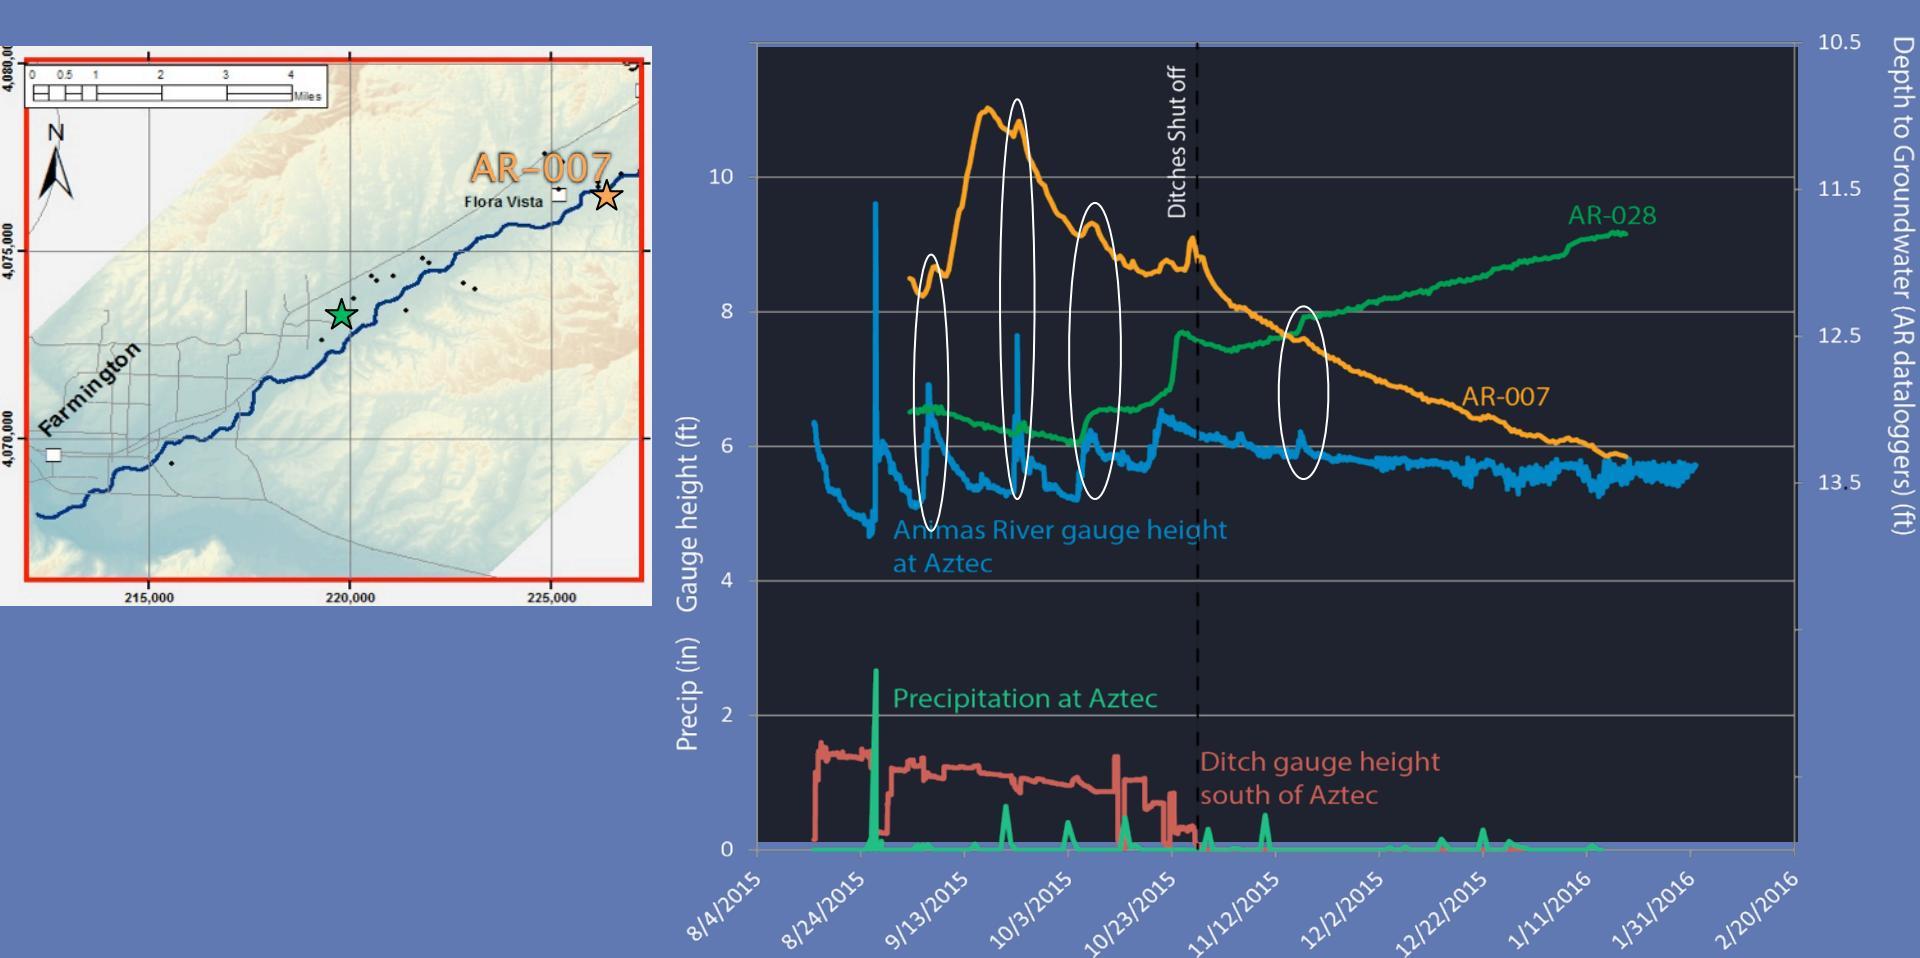
Hydrographs

- Pressure transducers installed in two wells:
 - AR-007: 4 miles south of Aztec, 300 ft east of river, 32 ft deep.
 - Short term spikes in record correlate with spikes in river stage.
 - 3 ft decline after irrigation ditches were shut off on November 1st.

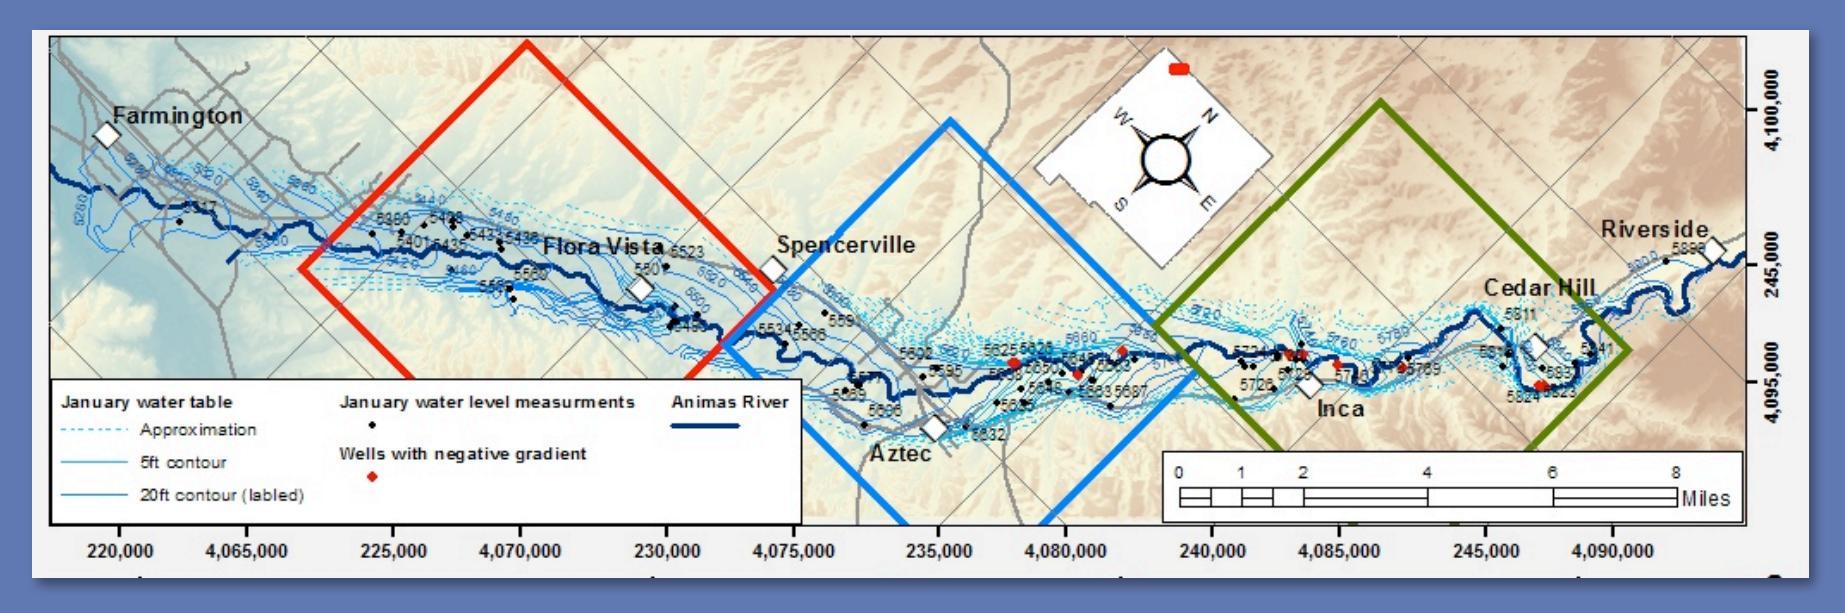
Water Table Maps (January 2016)

- 70 steel tape water level measurements
- LiDAR elevation model

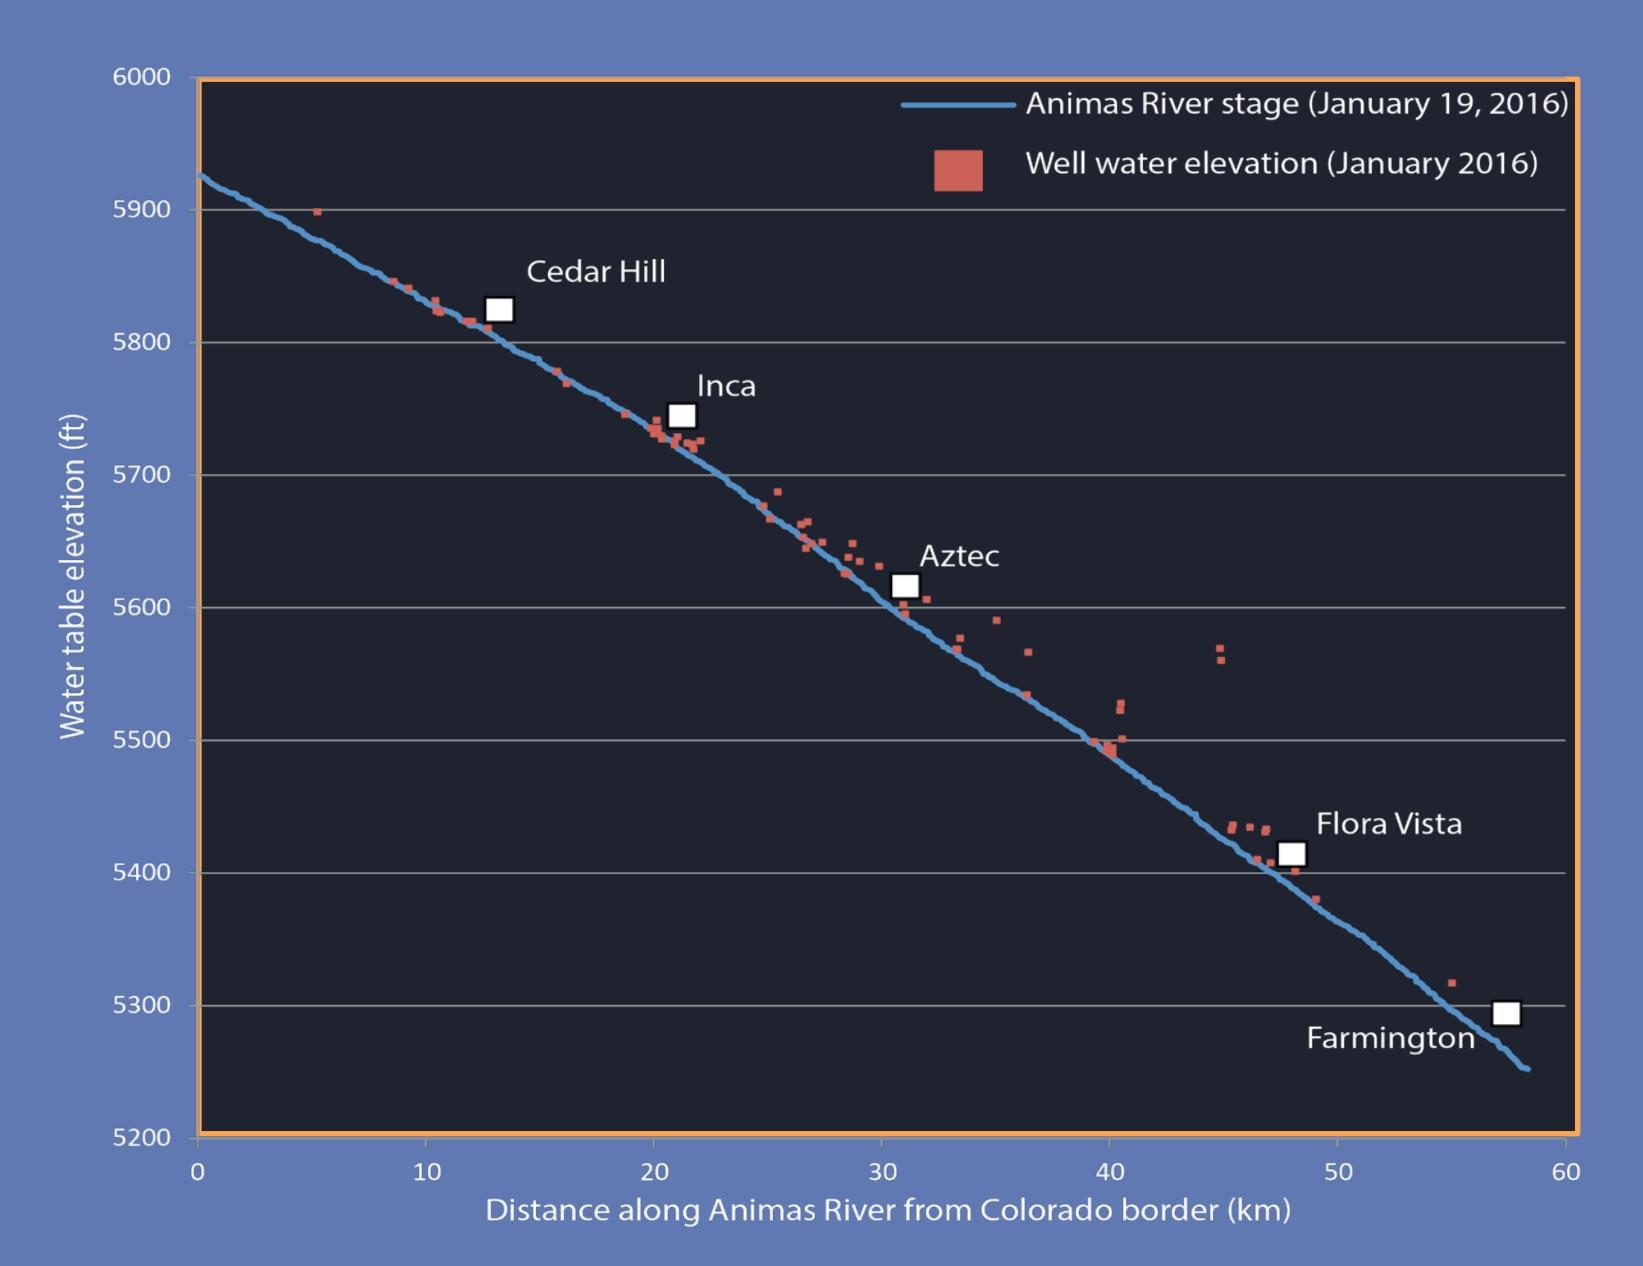
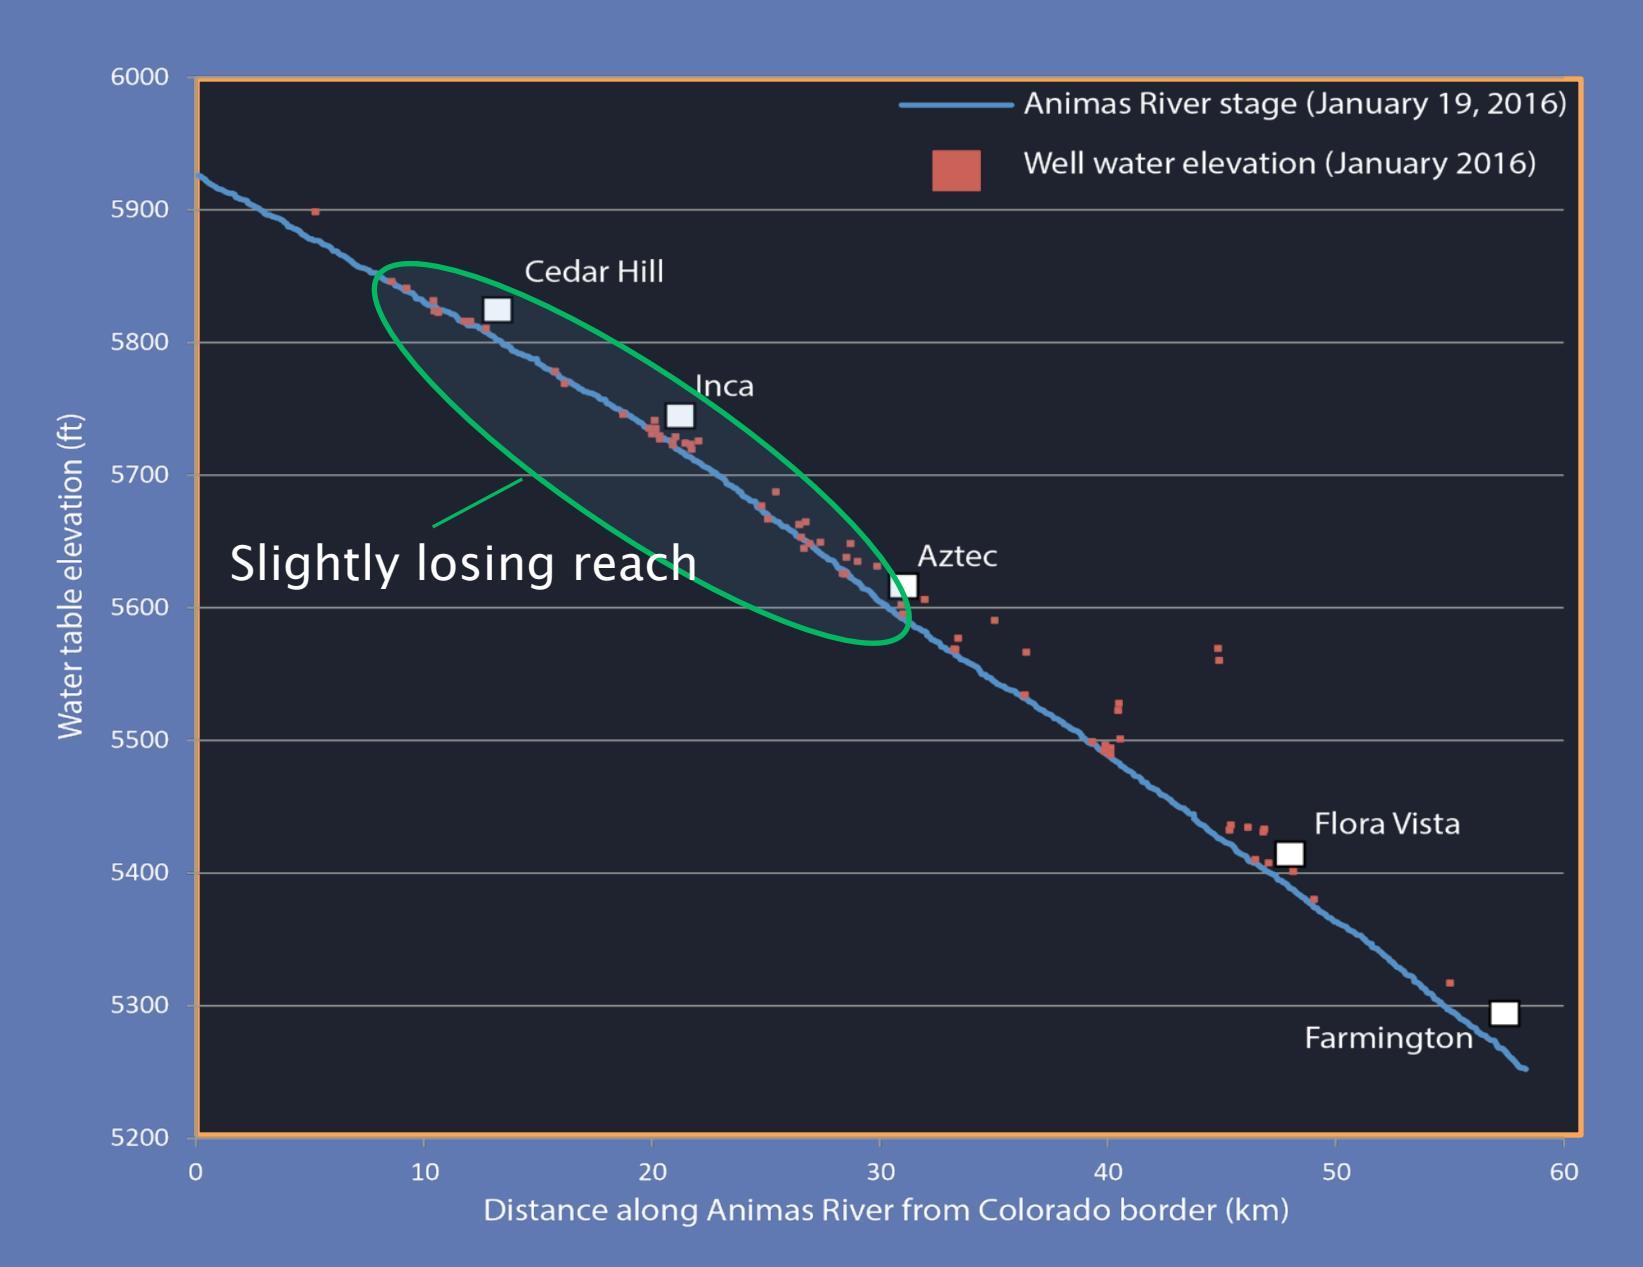
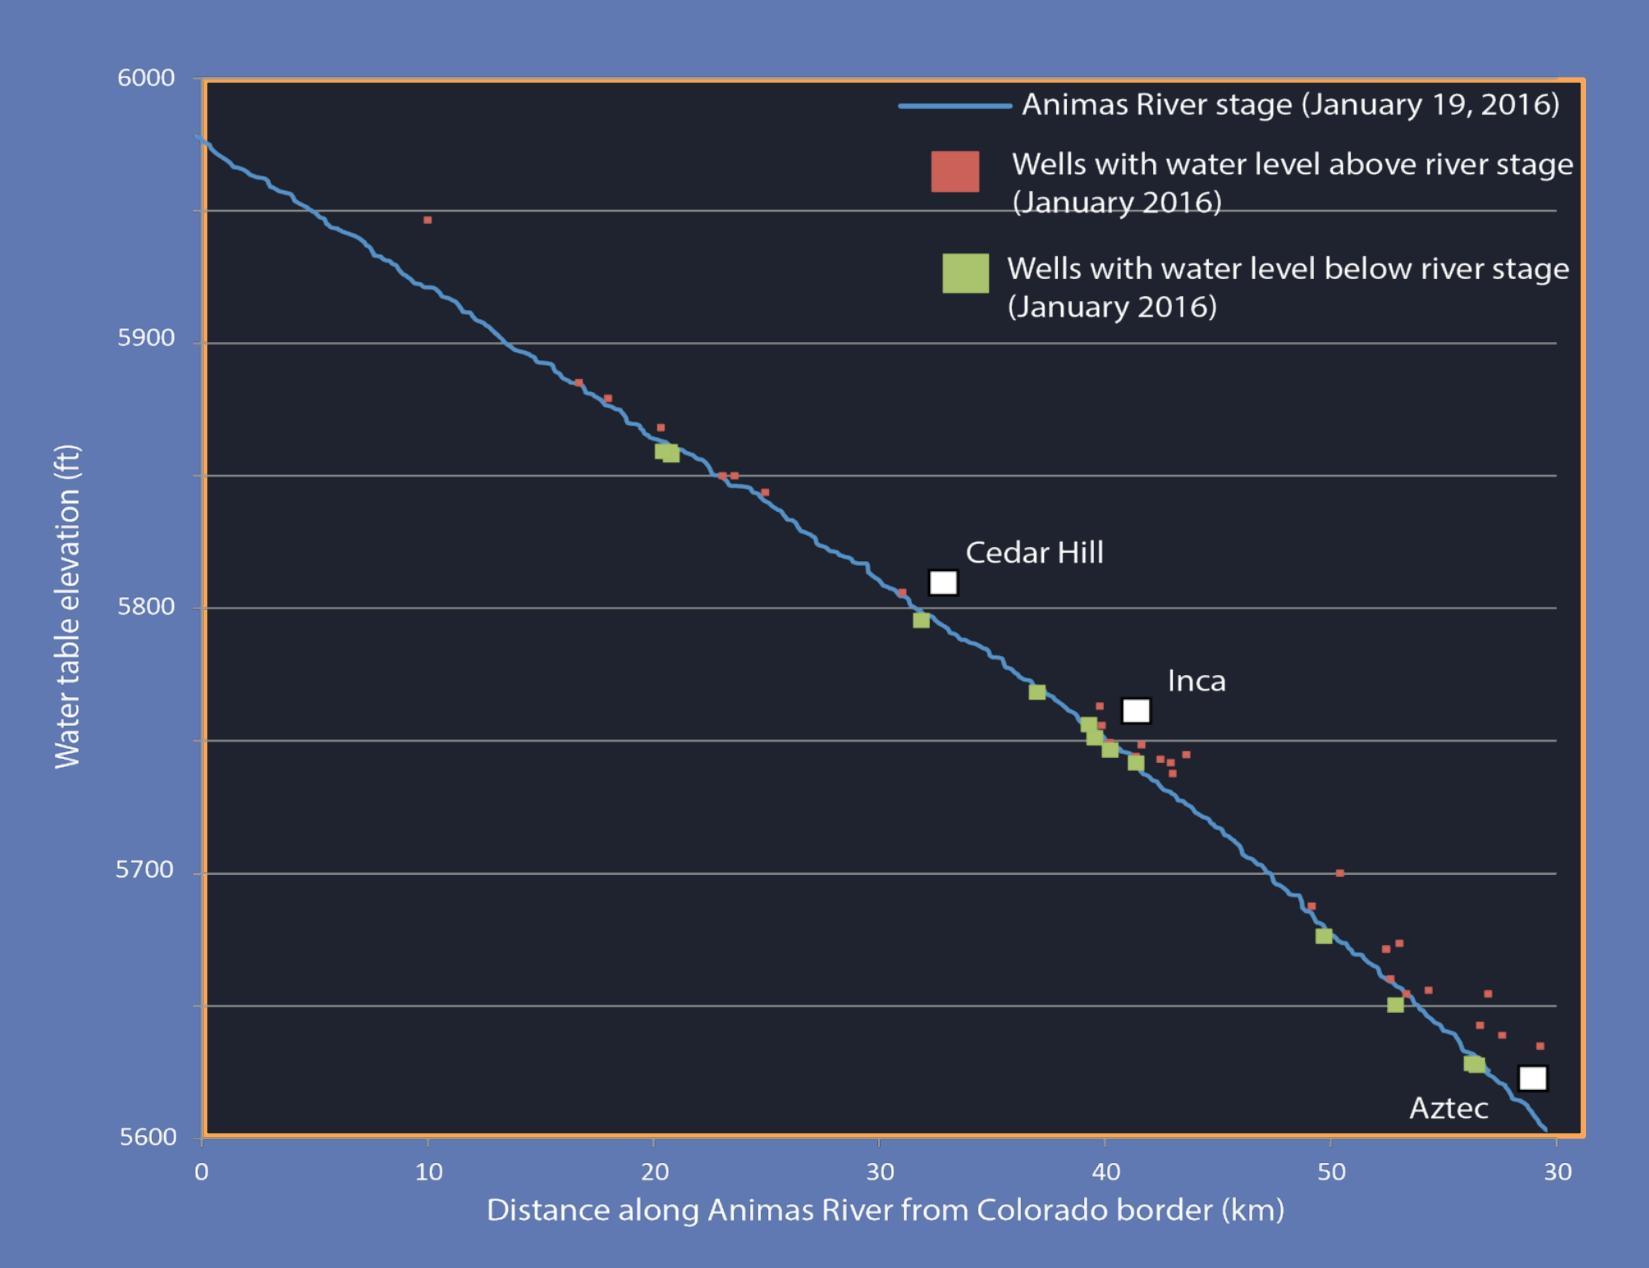
August 2015

5 wells with water level below river stage
Average of 0.6 ft below river
Average of 150 ft from river

January 2016

13 wells with water level below river stage
Average of 1.2 ft below river
Average of 270 ft from river
