PLATE 1. GENERALIZED GEOLOGIC MAP OF EASTERN VALENCIA COUNTY, N. MEX.

Geology compiled by F. B. Titus, Jr., 1960.

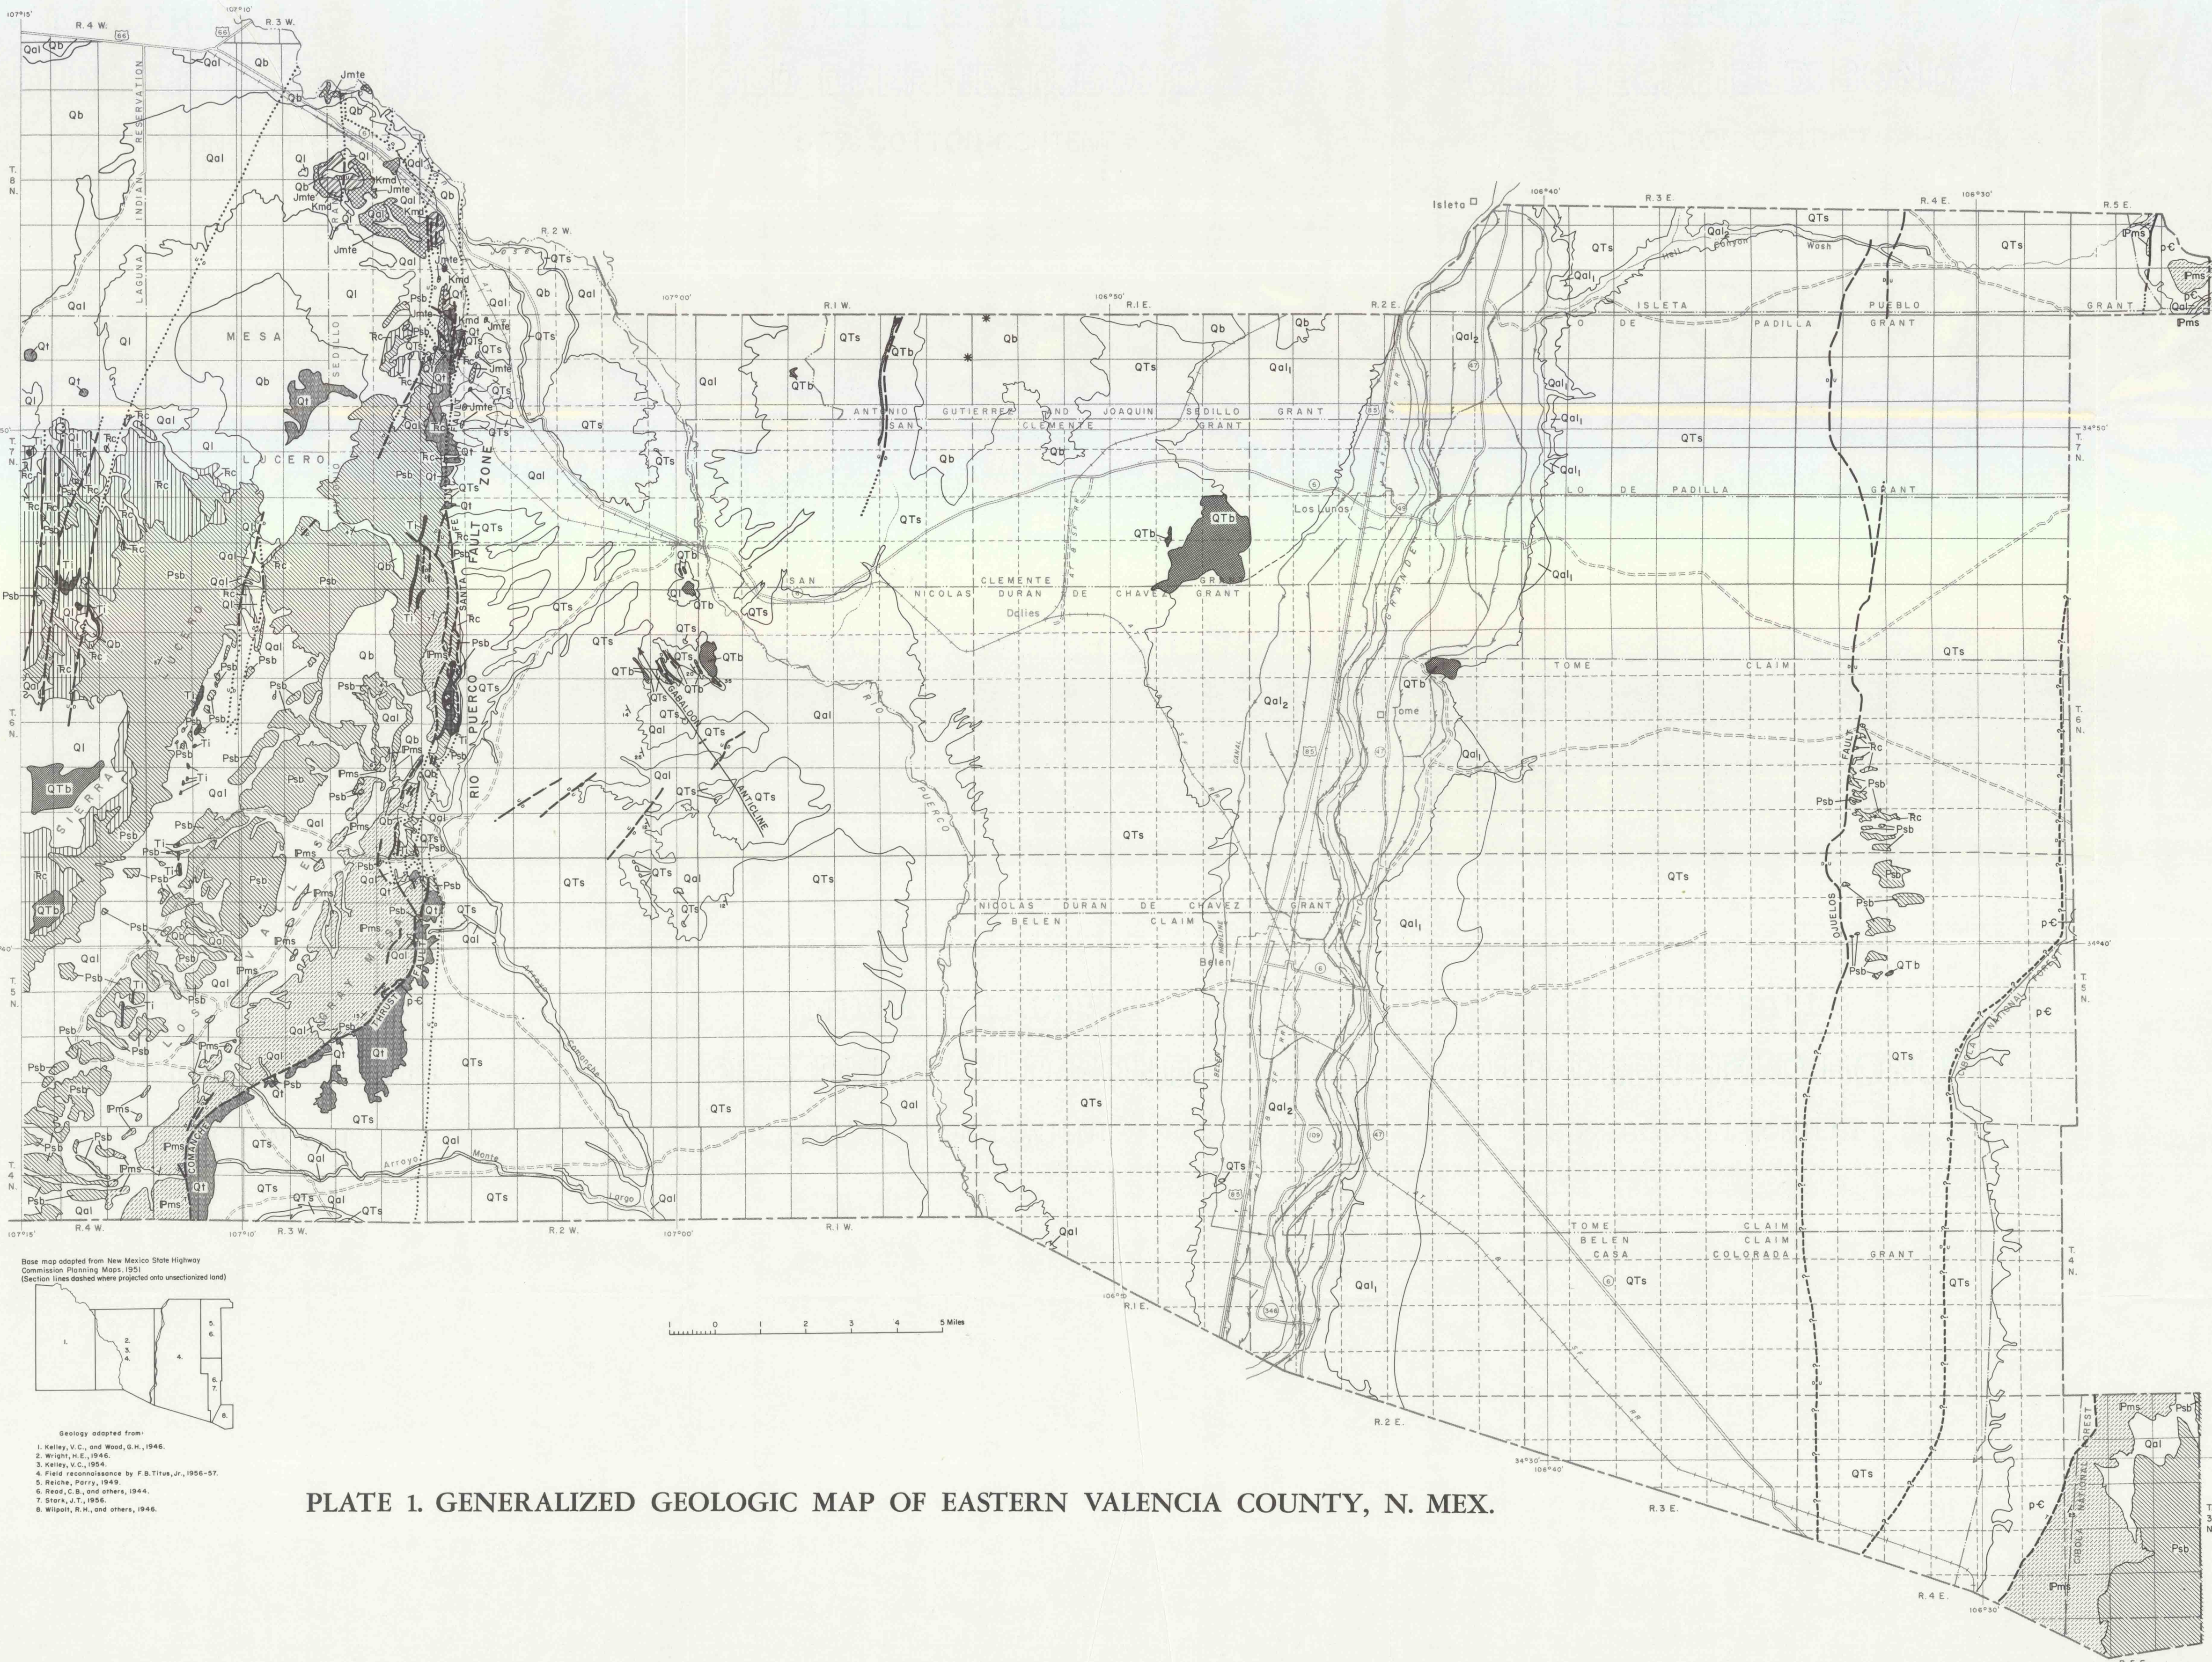
Recent
 Alluvium
Sand, silt, gravel, and clay. In and near the Rio Grande valley two units recognized: Qal₁, alluvium under the flood plain of the present river, and Qal₂, older alluvium associated with terraces above the present river level. Older alluvium most places is above the water, but probably aids recharge. Alluvium under the present Rio Grande flood plain is prolific aquifer. Elsewhere quality of water in alluvium is poor to impotable.

Upper Cretaceous
 Santa Fe Group
Sand and silt with clay and gravel, poorly consolidated. As mapped, includes caliche and surficial lag gravels. Probable maximum thickness is over 5,000 feet. Yields over 1,000 gpm to a few wells near the Rio Grande valleys; smaller yields obtainable throughout area of occurrence. Quality of water generally good but becomes poor few miles west of line roughly through Belen and Dales

Permian
 San Andres Limestone, Gorieta Sandstone, Yaso, Abo, and Bursum Formations
The San Andres and Yaso yield highly mineralized water to several wells and springs on and west of the Rio Puerco fault zone. The Abo in Los Valles and the Abo and Bursum in the southeast corner of the county yield small amounts of water to a few wells

Lower, Middle and Upper Pennsylvanian
 Madera Limestone and Sandia Formation
The Madera yields highly mineralized water to springs along the Rio Puerco fault zone and to wells in Los Valles; one spring produces water from the Madera in the southeast corner of the county. The Sandia may be water bearing, but no wells penetrate it in the area
